Final Workshop on J-RAPID-Nepal
June 21st and 22st, 2016

Re-evaluation of seismic vulnerability on historic structures based on damage investigation of the 2015 Nepal earthquake and proposal of retrofitting methods (Research period: 2015.07~2016.06)

Final Workshop on J – RAPID – Nepal
June 21st and 22nd, 2016

Damages of Historical Structures Strengthening/Retrofitting Techniques

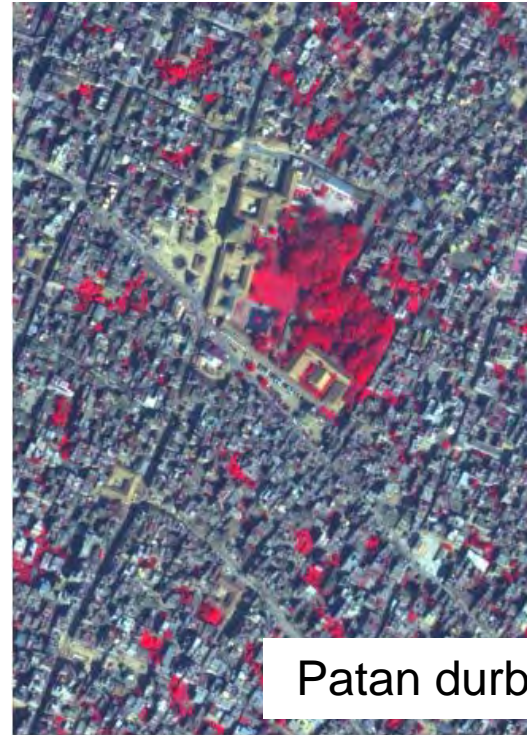
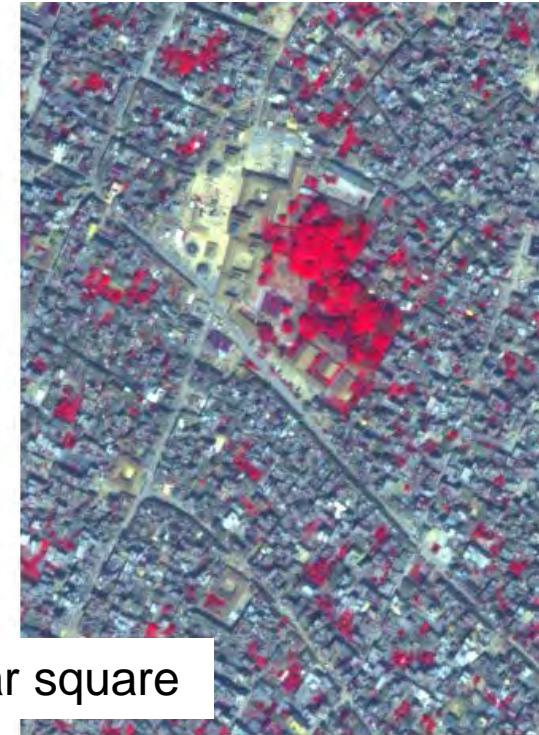
Patan durbar square

Damage assessment for world heritage sites and targeted area in Lalitpur.

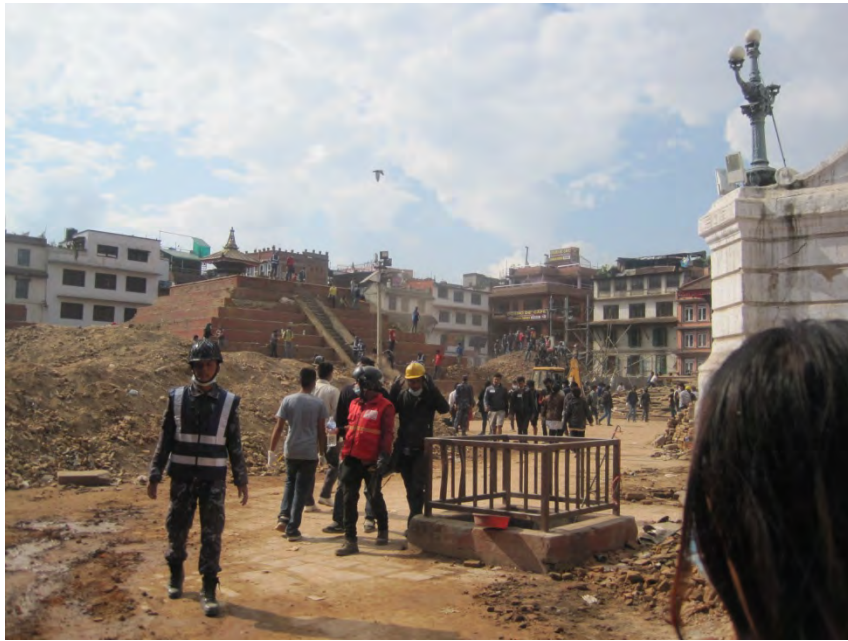
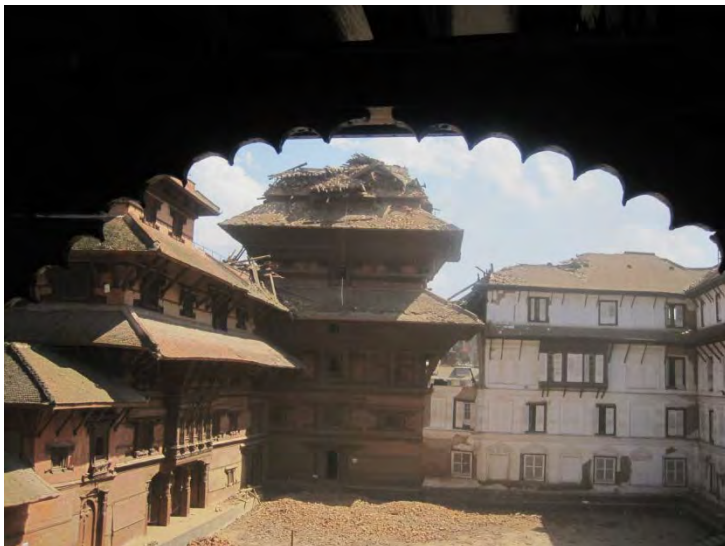
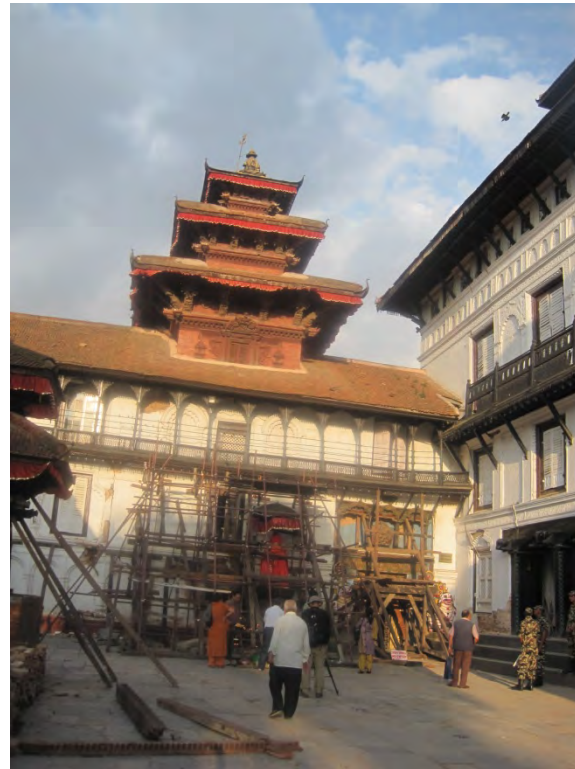
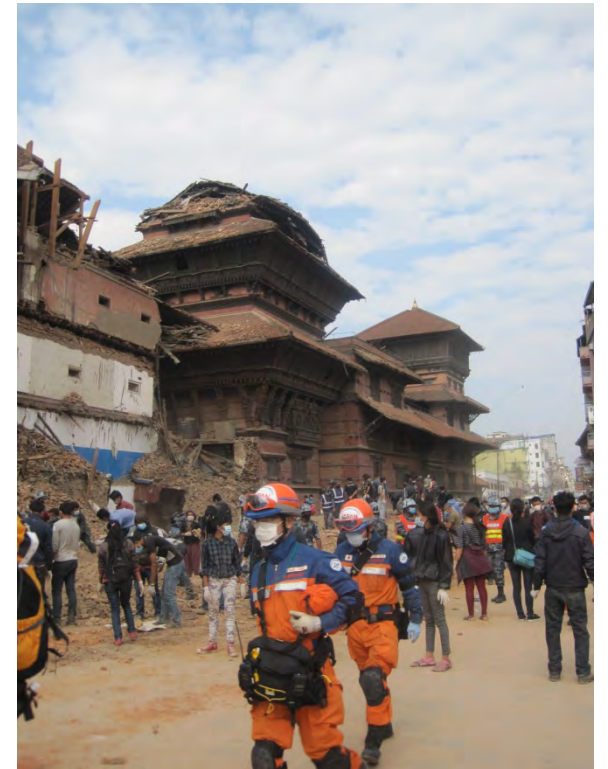
Kathmandu Durbar Square

- In the **Kathmandu Valley**, many buildings and structures of historical importance have collapsed or sustained severe damages.
- In the **Kathmandu Valley** only more than **30 monumental structures** completely collapsed, and about **120 historical structures** heavily or partially damaged. In general, the earthquake damage in the cultural heritage sites is unprecedented and unexpected. Most of the structures in the monument zones were constructed in **17th and 18th centuries** and some of them dates back to even **15th century**. These are heritage structures and the monument zones are **heritage sites of cultural importance**.

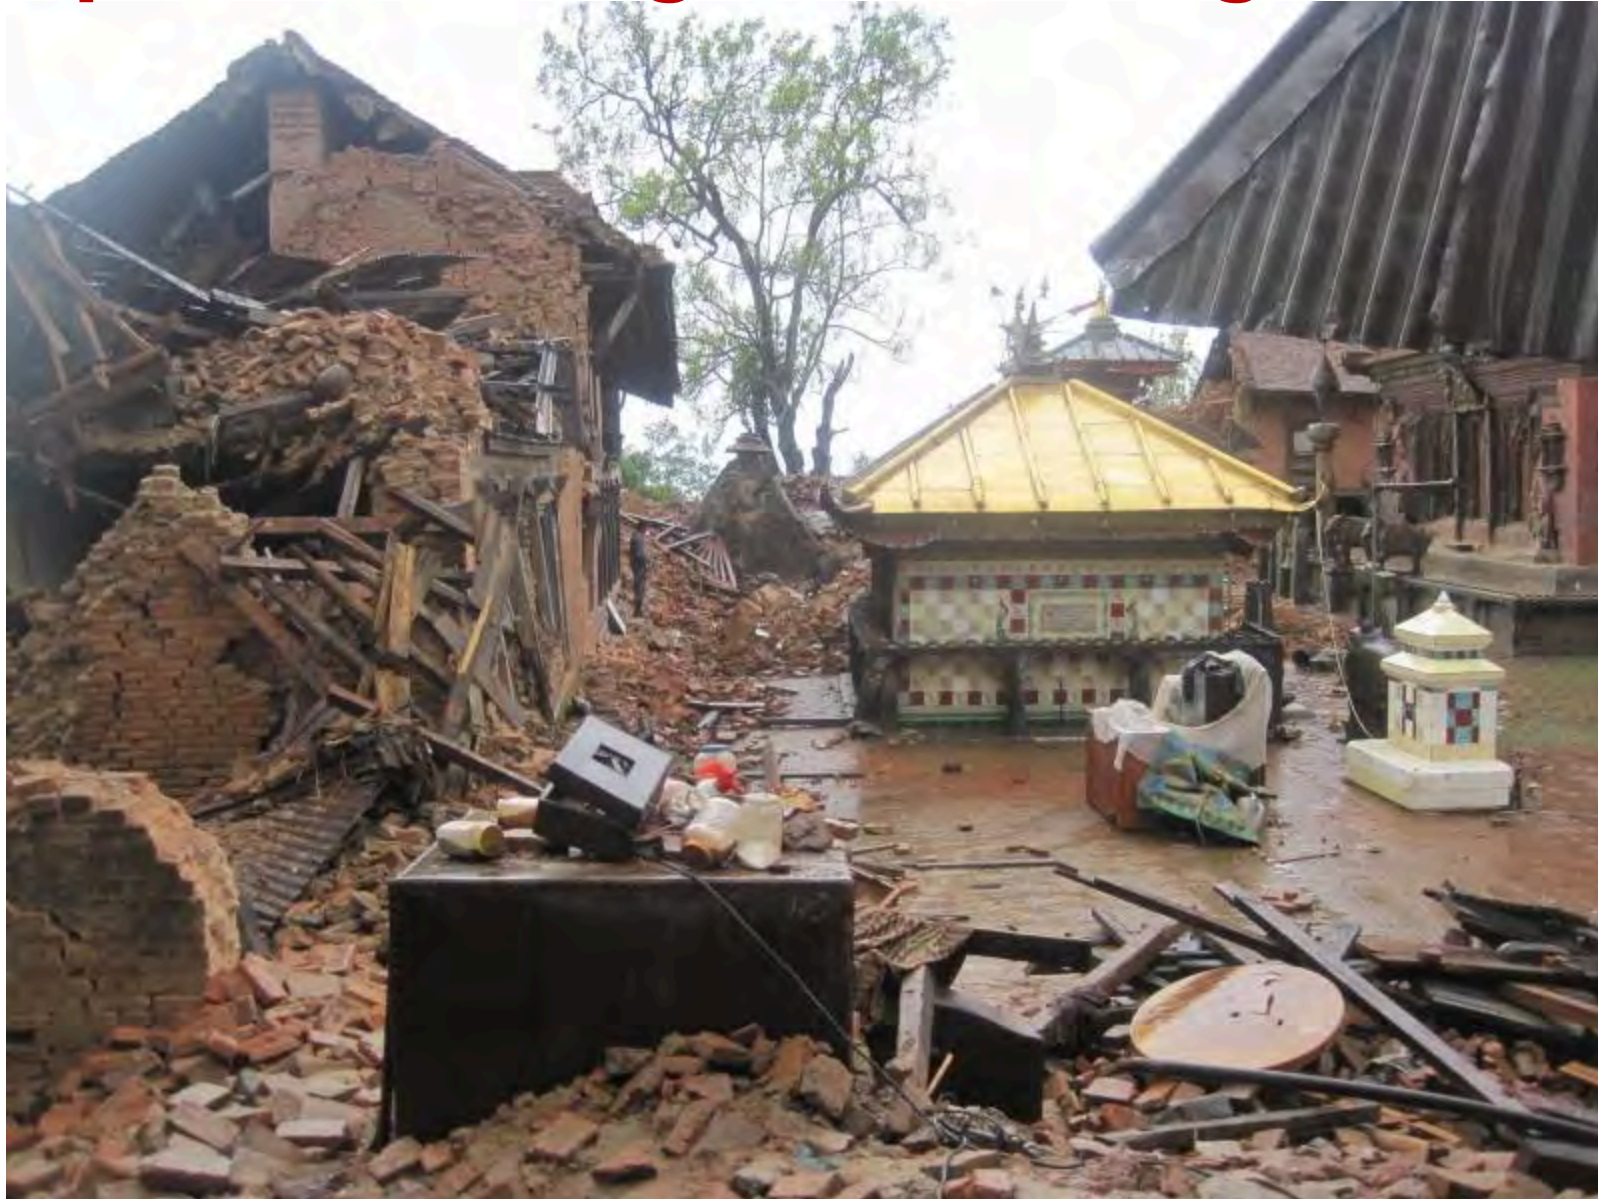
Earthquake Damage of Heritage Structures

- During the visual assessment, based on the nature of damages of the structures, the main reasons for the extensive damages of the heritage structures, in general, are:
 - **Lack of maintenance and repair**
 - **Deterioration of materials**
 - **Ageing of materials**
 - **Isolated alteration of structural elements/connections**
- However, a detailed investigation is recommended to establish the structural reasons for failure or damage of individual structure. It should be recognized that such a detailed structural investigation require **a substantial resource in terms of time and effort.**
