Damage assessment and vulnerability modeling of structures in the 2016 Kumamoto earthquake based on the data acquired from field investigation and remote sensing

March 4, 2017

Symposium on J-Rapid-Kumamoto

Recent Earthquakes in Nepal, Thailand, and Japan *My impression about building vulnerability and ground motion*

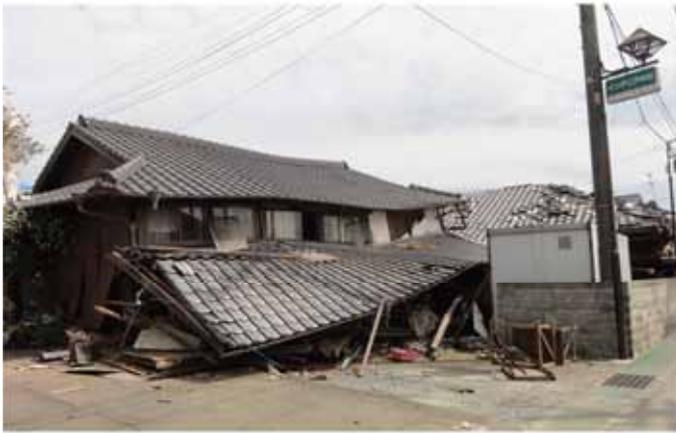
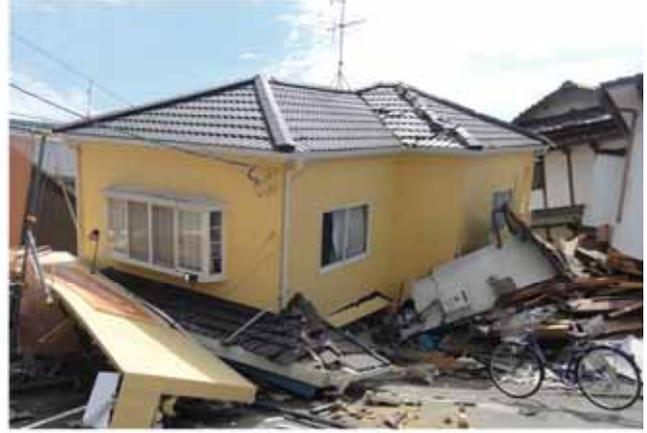
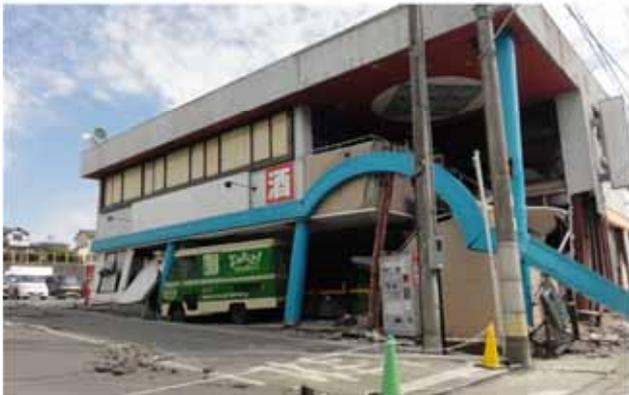
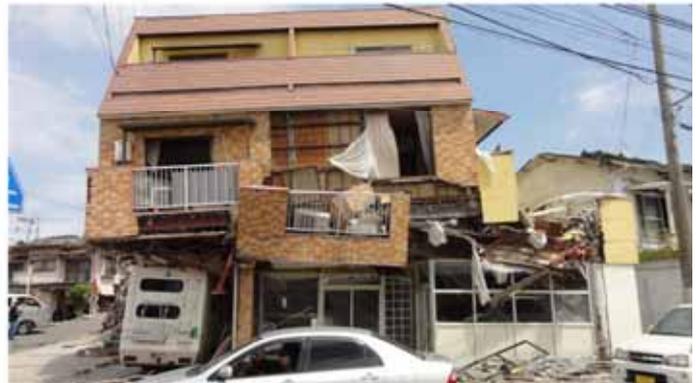
Building damage in Mashiki Town

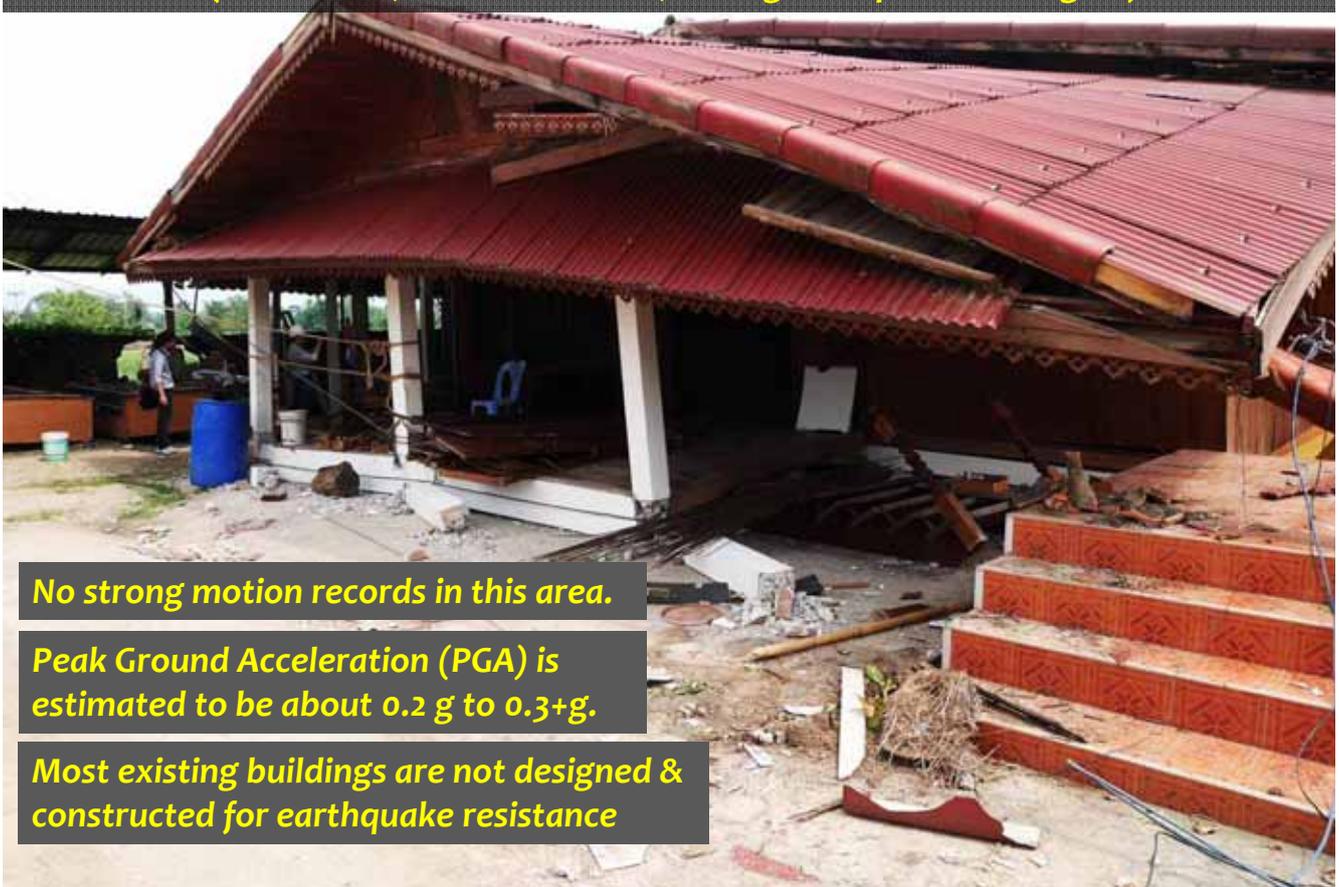
Building collapse by the failure of all columns in the first story
(Ban Tamao, Mae Lao District, Chiang Rai: Epicentral Region)

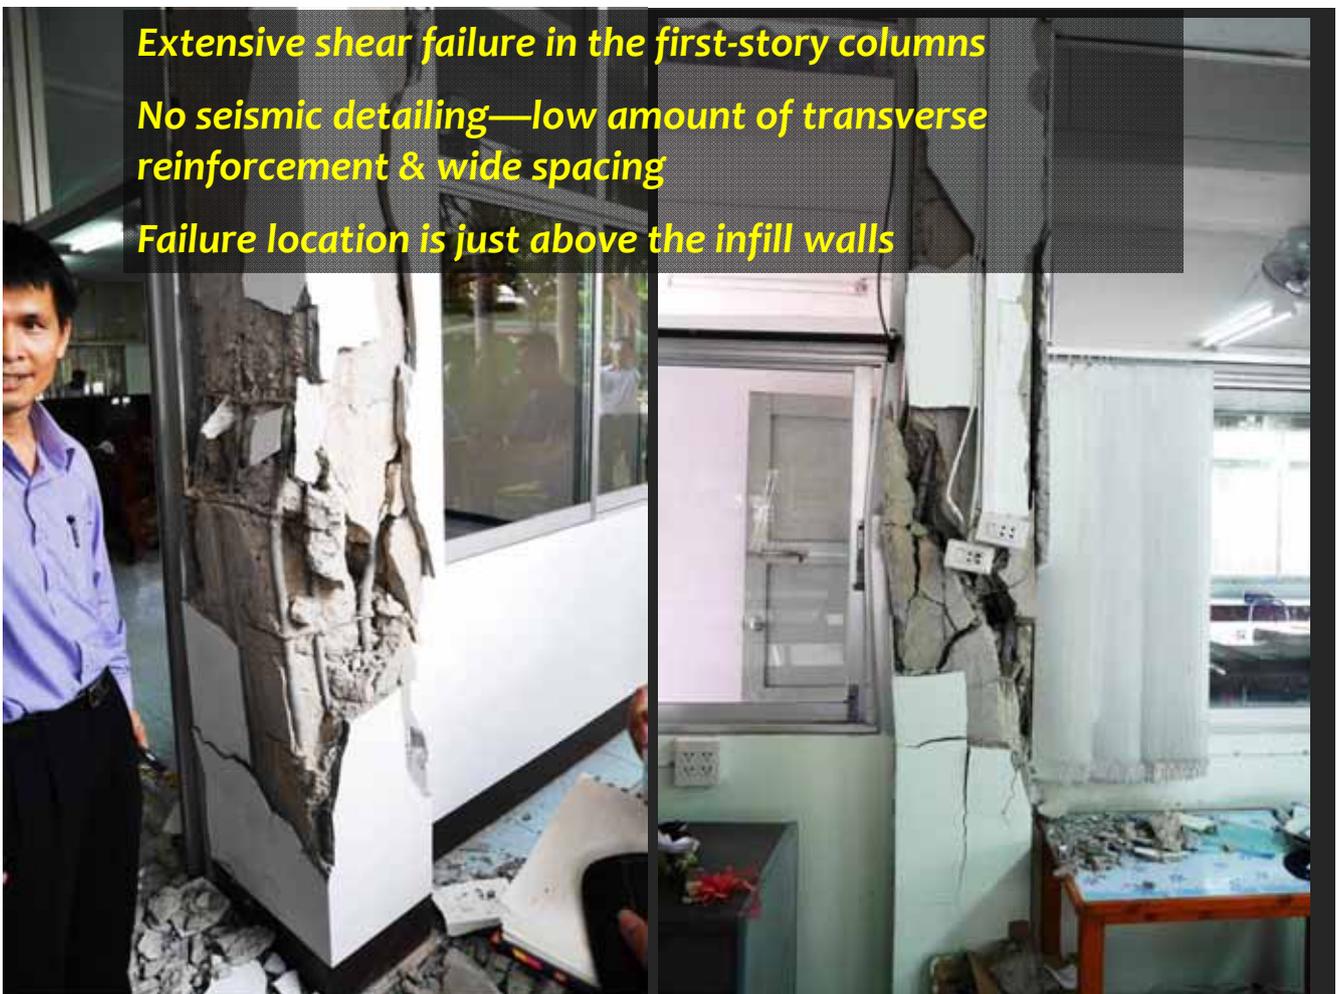
Extensive shear failure in the first-story columns
No seismic detailing—low amount of transverse reinforcement & wide spacing
Failure location is just above the infill walls

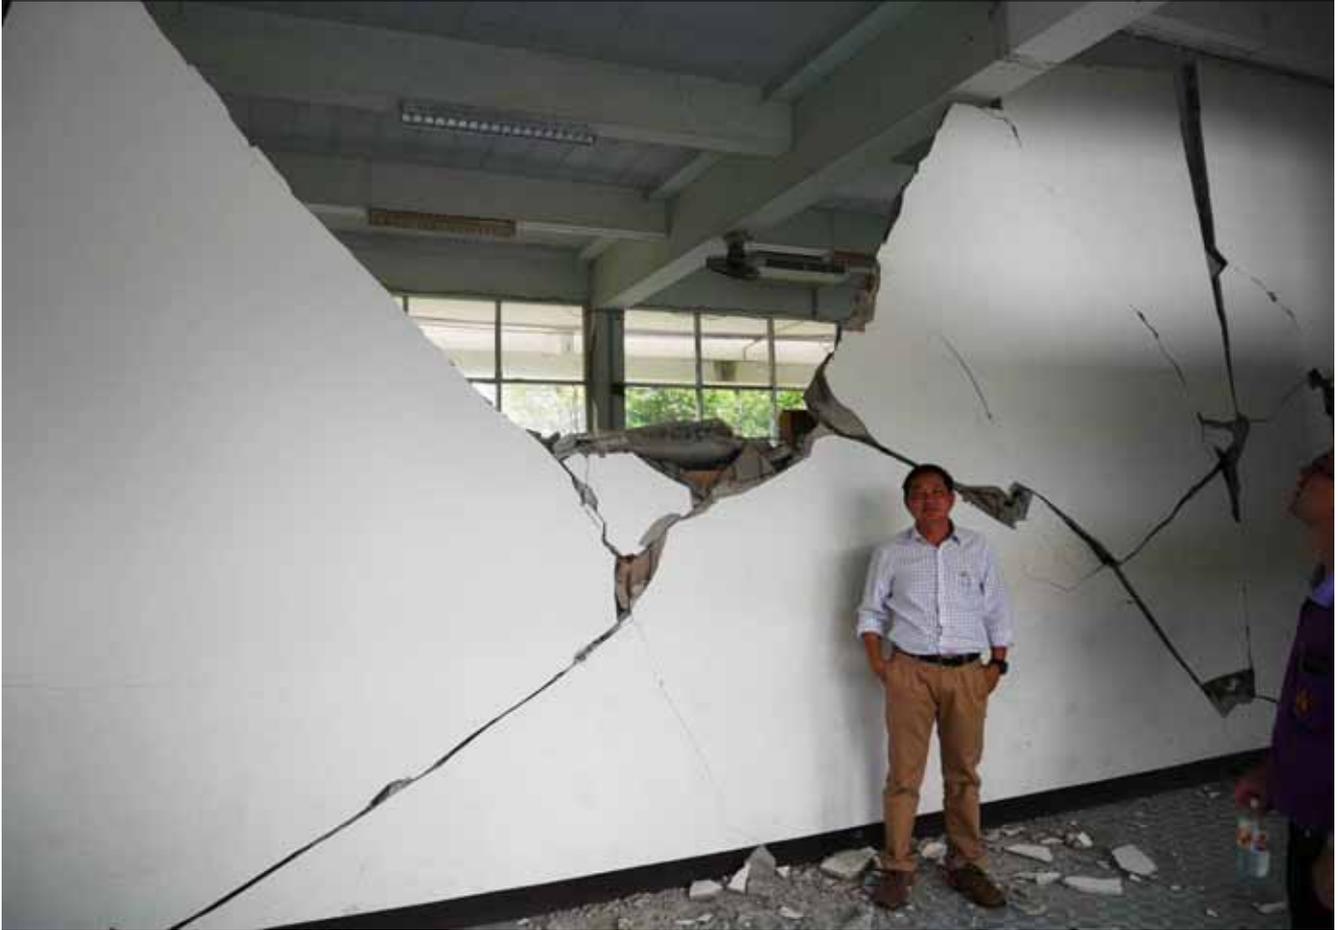
Collapse of Masonry Infill Walls inside the Building

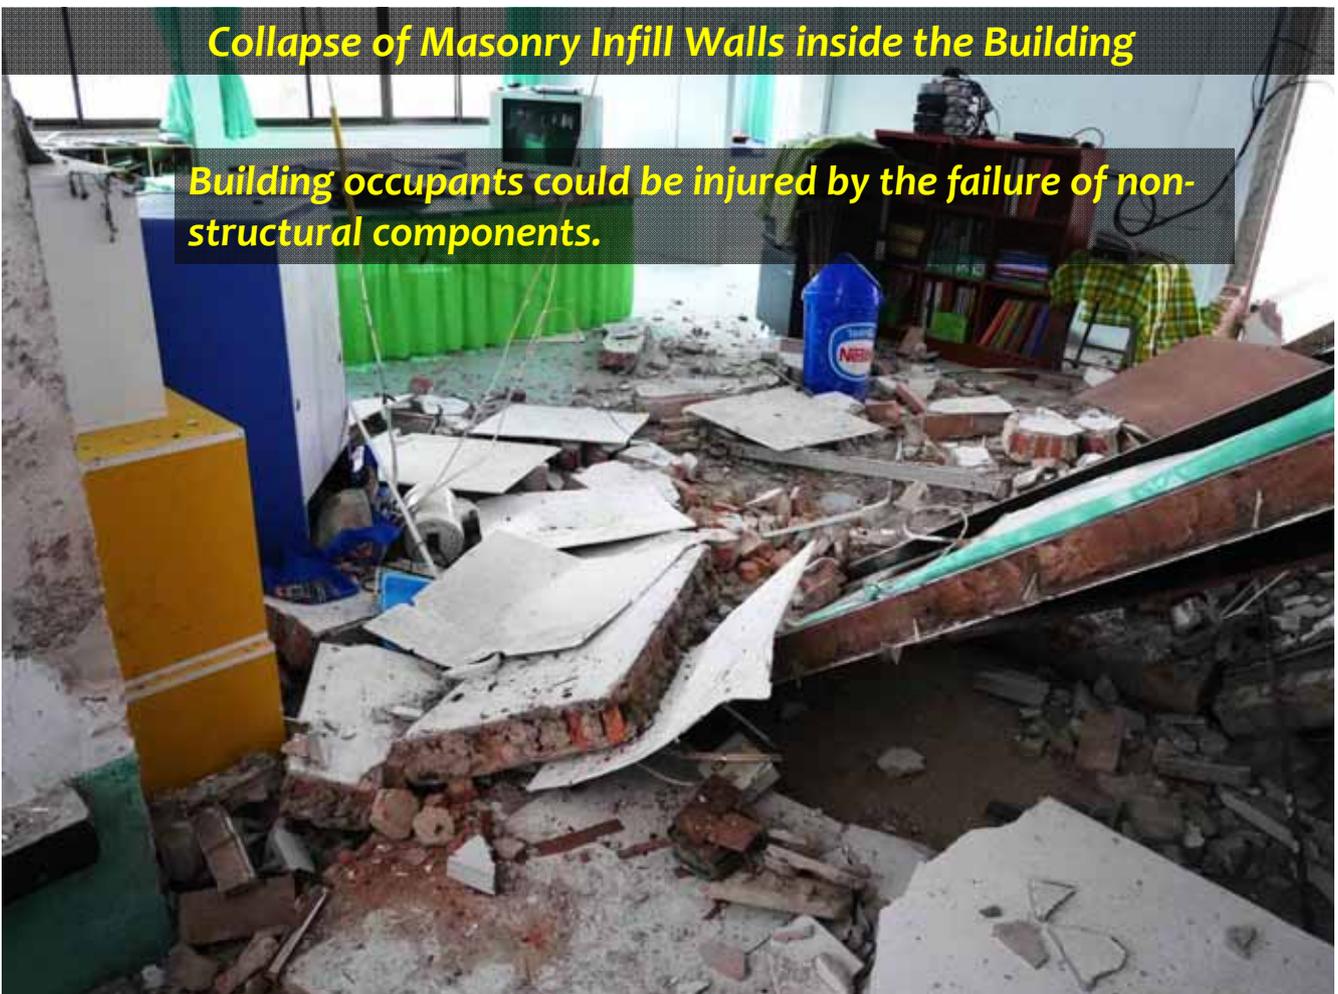
Collapse of Masonry Infill Walls inside the Building

Building occupants could be injured by the failure of non-structural components.

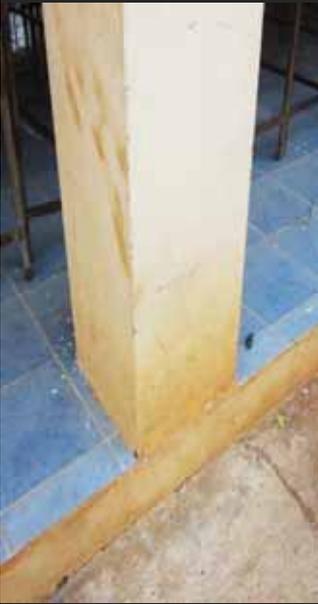
Failure Mode: Lap-splice Failure

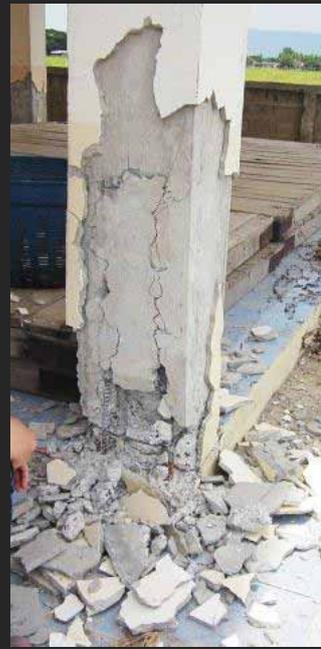
Column at center (moderately damage)

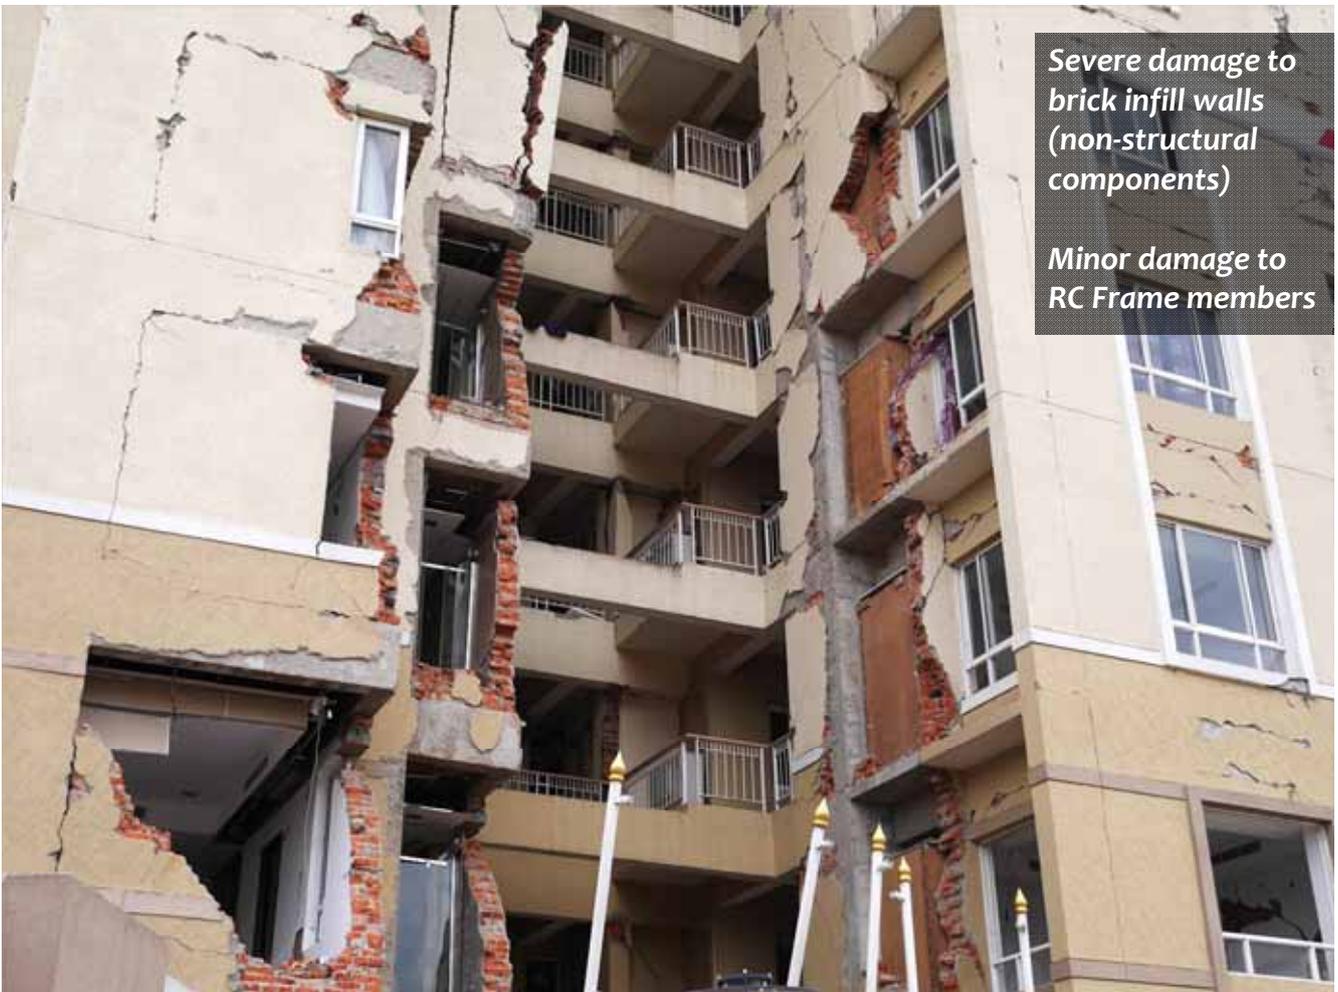
**Park View Horizon Apartment
Kathmandu, Nepal**

**Damaged by the long-period
ground motion**

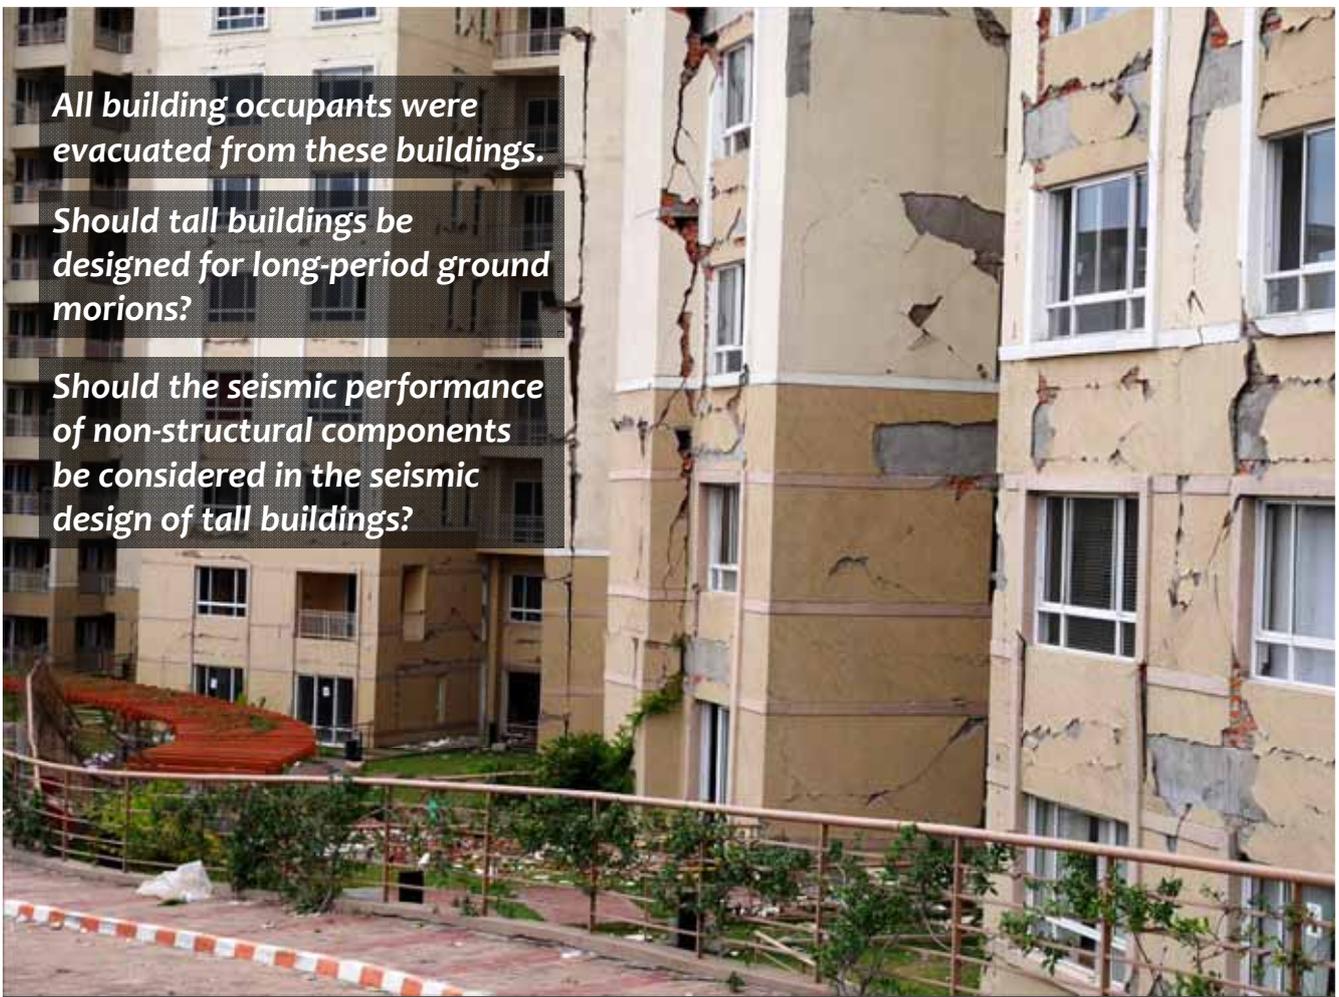
**Severe damage to
brick infill walls
(non-structural
components)**

**Minor damage to
RC Frame members**

Should tall buildings be designed for long-period ground motions?

Should the seismic performance of non-structural components be considered in the seismic design of tall buildings?

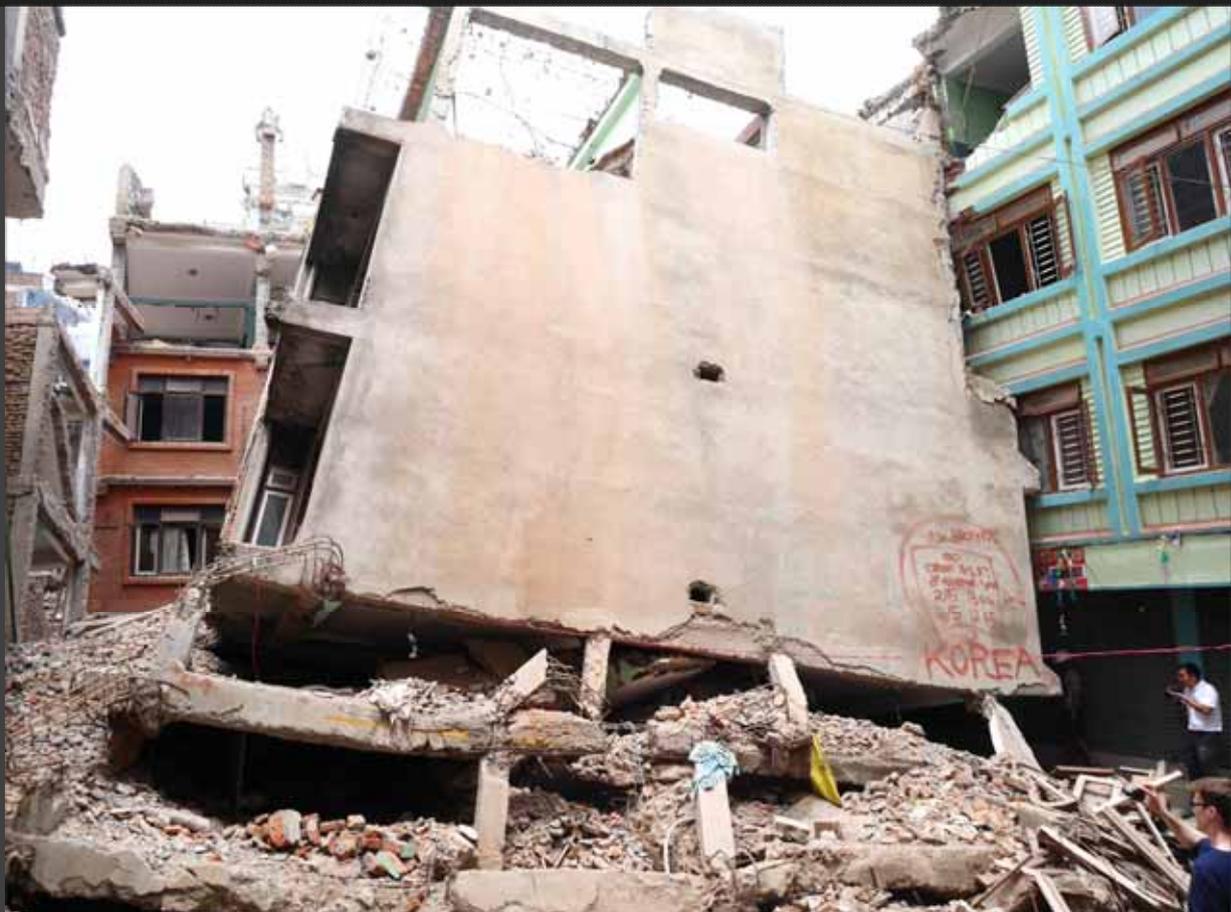
Collapsed RC Building in Gongabu, Kathmandu

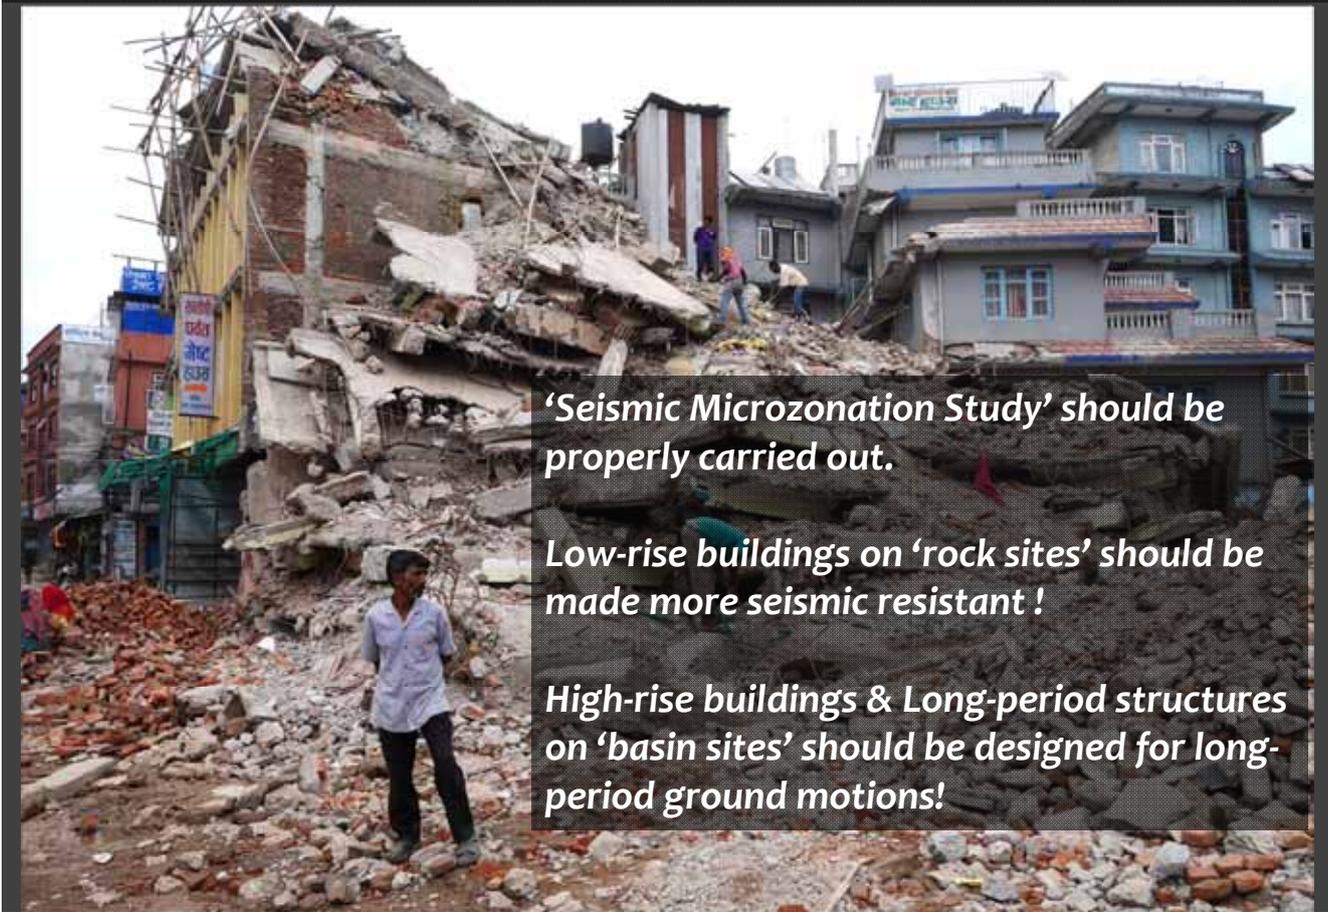
Pancake Collapse in Gongabu, Kathmandu

'Seismic Microzonation Study' should be properly carried out.

Low-rise buildings on 'rock sites' should be made more seismic resistant !

High-rise buildings & Long-period structures on 'basin sites' should be designed for long-period ground motions!

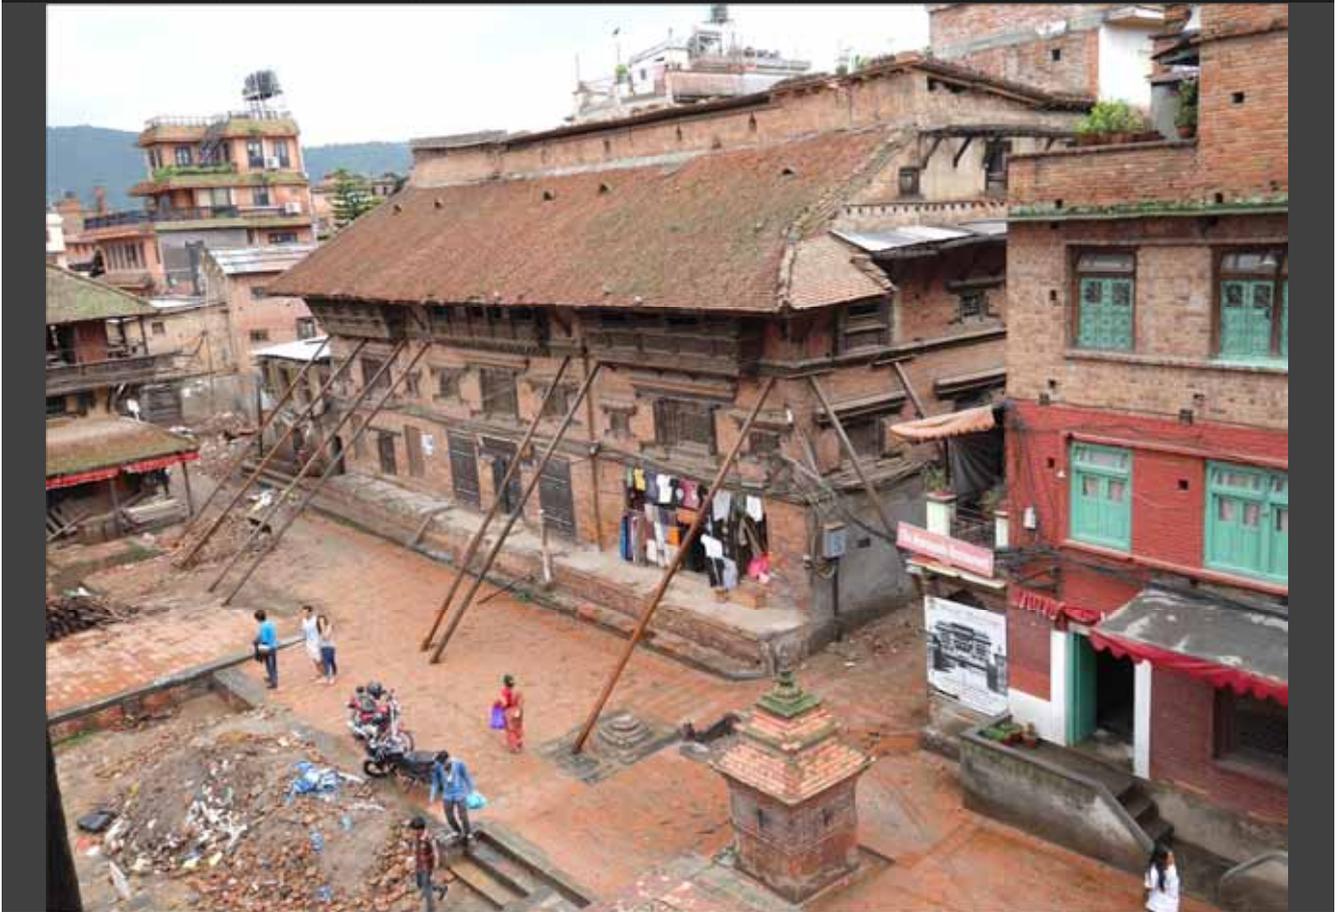
Damage to Cultural Heritage Buildings in Bhaktapur

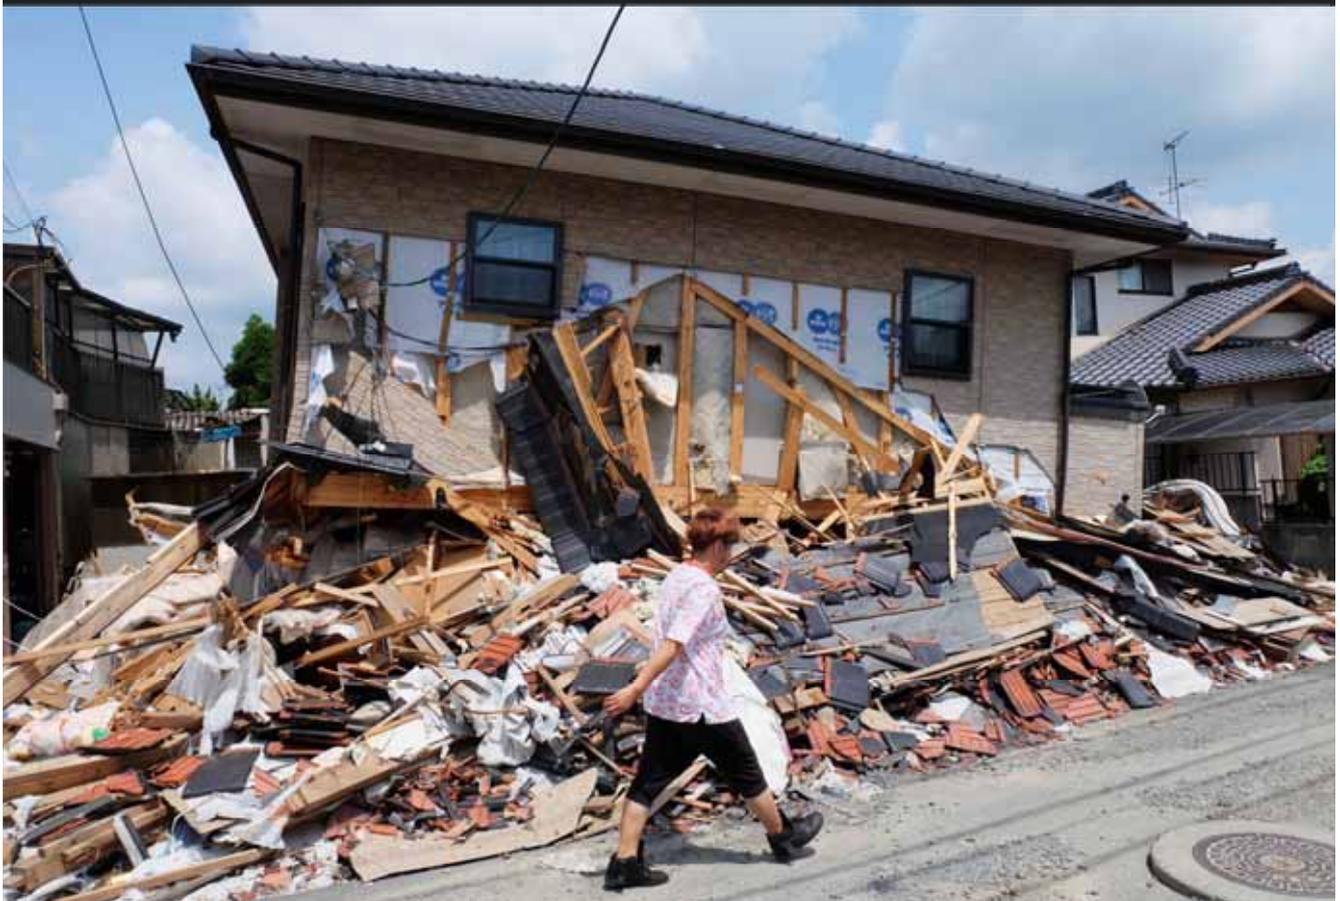
Collapse of Wooden Houses in Mashiki Town

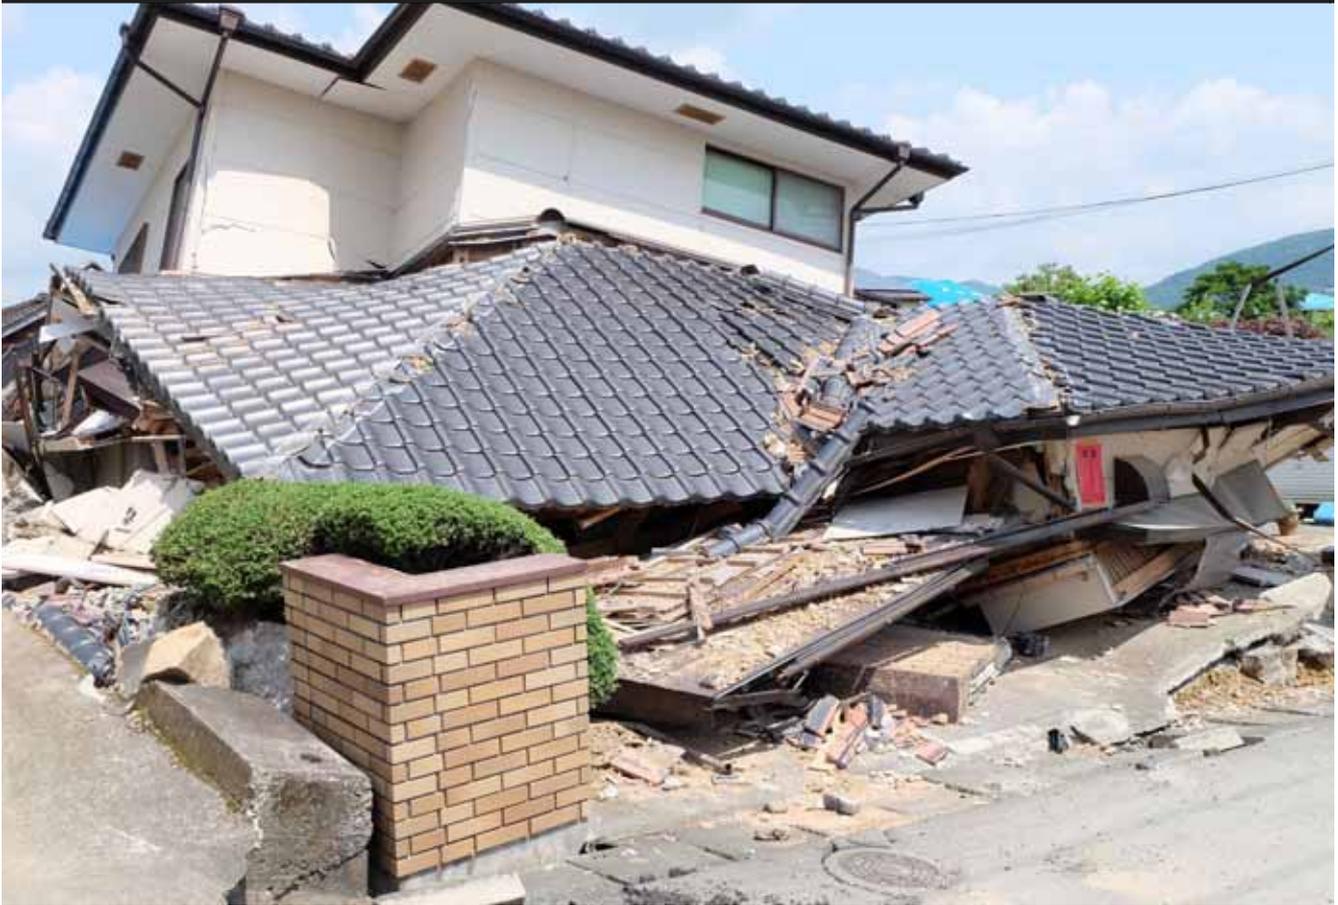
Collapse of Wooden Houses in Mashiki Town

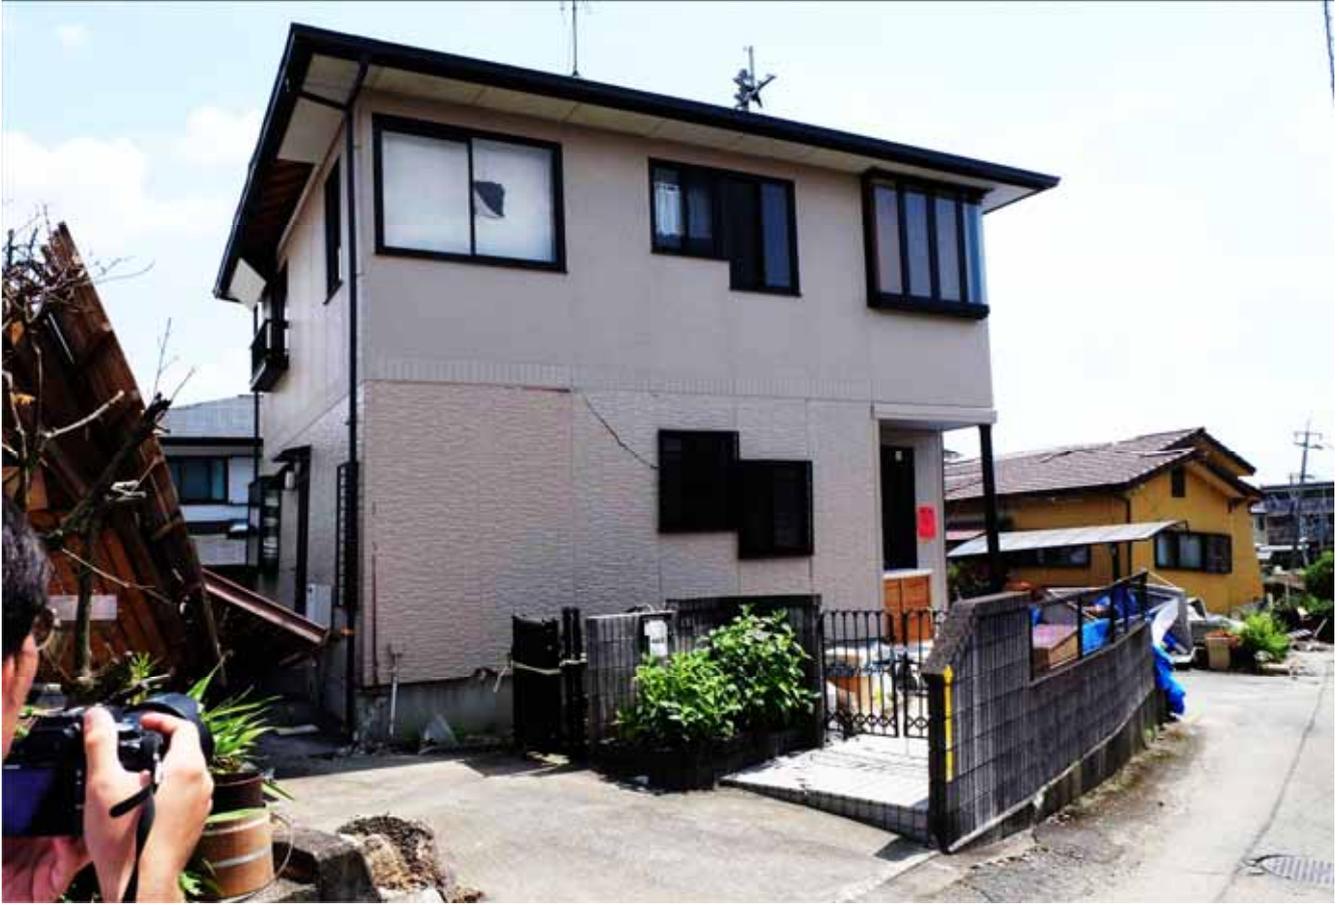
Minor Damage to Some Wooden Houses in Extremely Severe Shaking Areas
