Lake-catchment system and hydro-climatological fluctuations printed in lacustrine sediments

K. Kashiwaya

**Institute of Nature and Environmental Technology
Kanazawa University, Japan**

Monitoring for lake-catchment systems

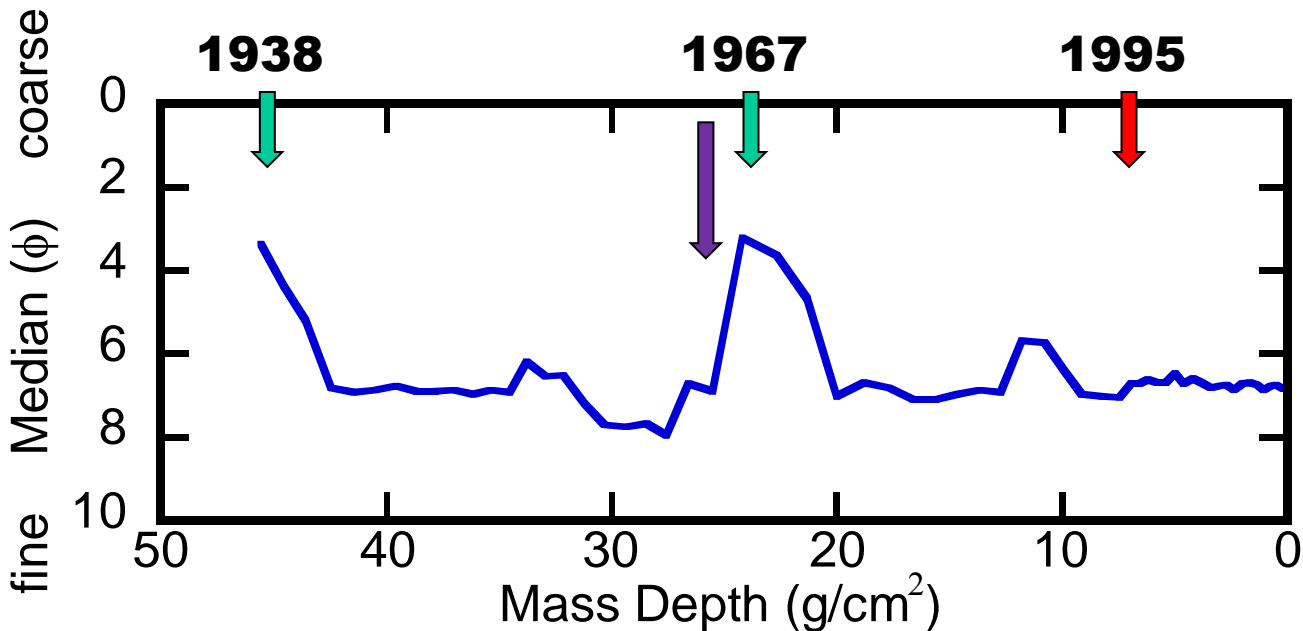
Grain Size Fluctuation in Core Sediments, Kobe
