- R&D Topics : Robotics Technologies
- R&D Theme : R&D of a multicopter-based inspection robotic system with visual observation and hammering test devices
- Principal Investigator : Hideki Wada (Shinnippon Nondestructive Inspection Co., Ltd.)
- Collaborative Research Groups : Nagoya University, Kyushu Institute of Technology, Fukuoka Industrial Technology Center

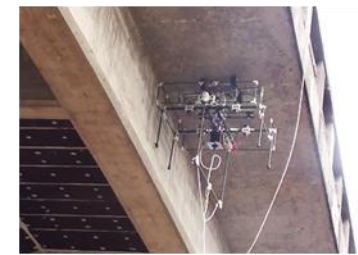
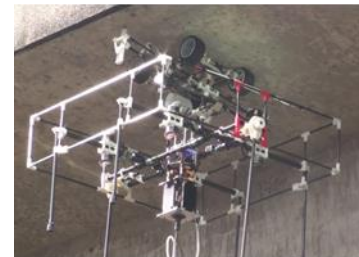
- **Mobility mechanism** with **drones** and **wheels**
- **Inspection** by **visual observation** and **hammering tests**
- **Image** and **sound**-based **abnormal detections**

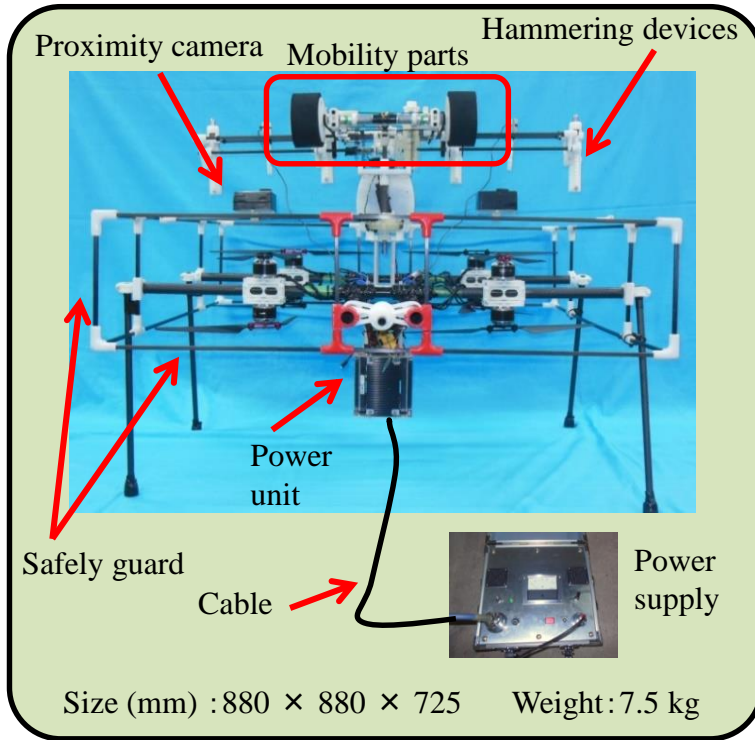
Inspection Robotic System

A multicopter with an inspection system running via independent wheels was developed to realize nonstop running inspections

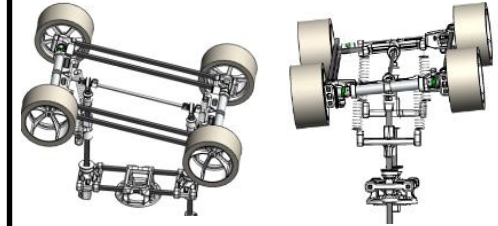
Mobility Mechanism

Adaptive for cants of the target
⇒ Flexible wheels

(Pitch : $\pm 15^\circ$) (Roll : $\pm 20^\circ$)

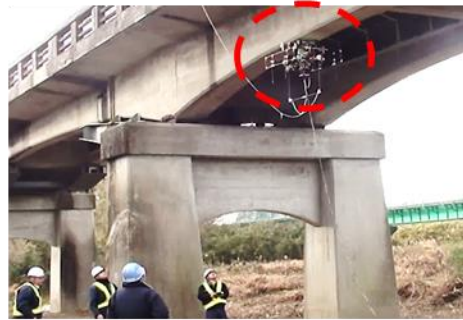
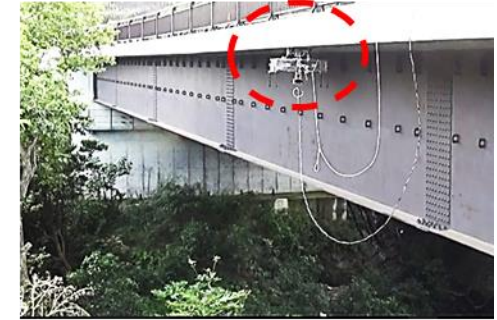
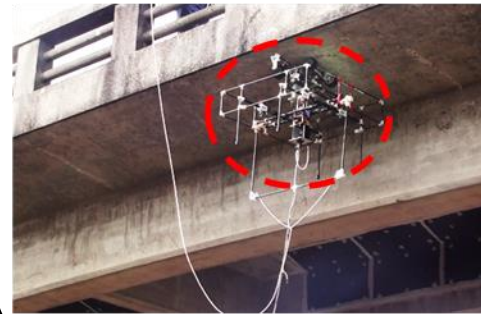
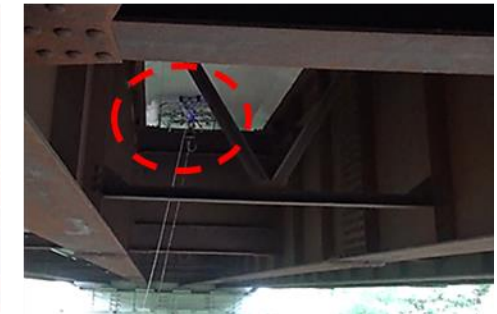
Field Inspection

Alternative inspection methods using robotics

- Contact danger areas easily
- Consecutive inspection as getting into touch with infrastructures

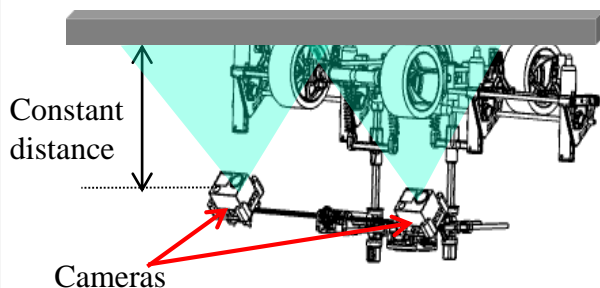
Visual Observation

Close distance video recording

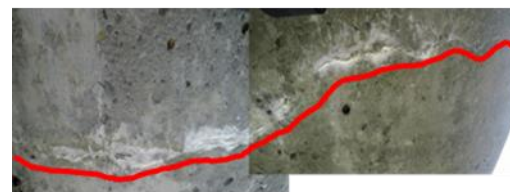
Image Inspection

- Automatic crack detection (0.2 mm width)
- Measurements (width, length and position)

(Free line)

(Cracks)

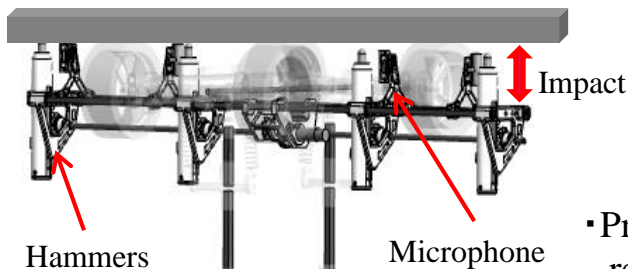
Hammering Tests

Detection of internal abnormality

Four piston alternative hammers

- Nonstop hammering tests
- Sound recording with microphones

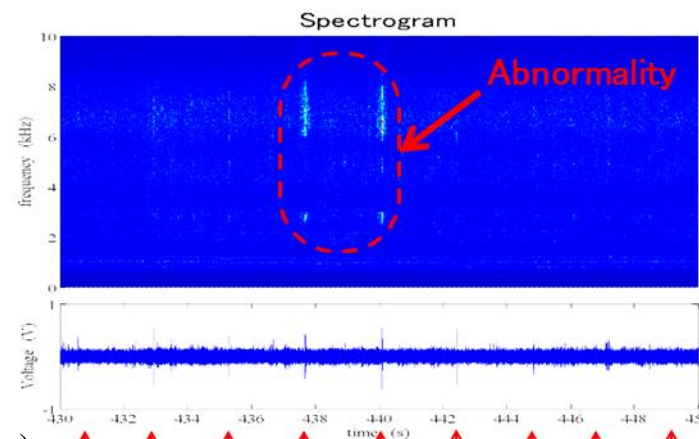
- Propeller-induced noise reduction
- Frequency analysis (hole detection at a depth of 60 mm)

Sound Analysis (↑: Impact points)
