Field investigation research to improve seismic capacity of new and existing Nepalese buildings

PI on Japan Side : Koichi Kusunoki, ERI, the Univ. of Tokyo

PI on Nepali Side: Krishna Kumar Bhetwal

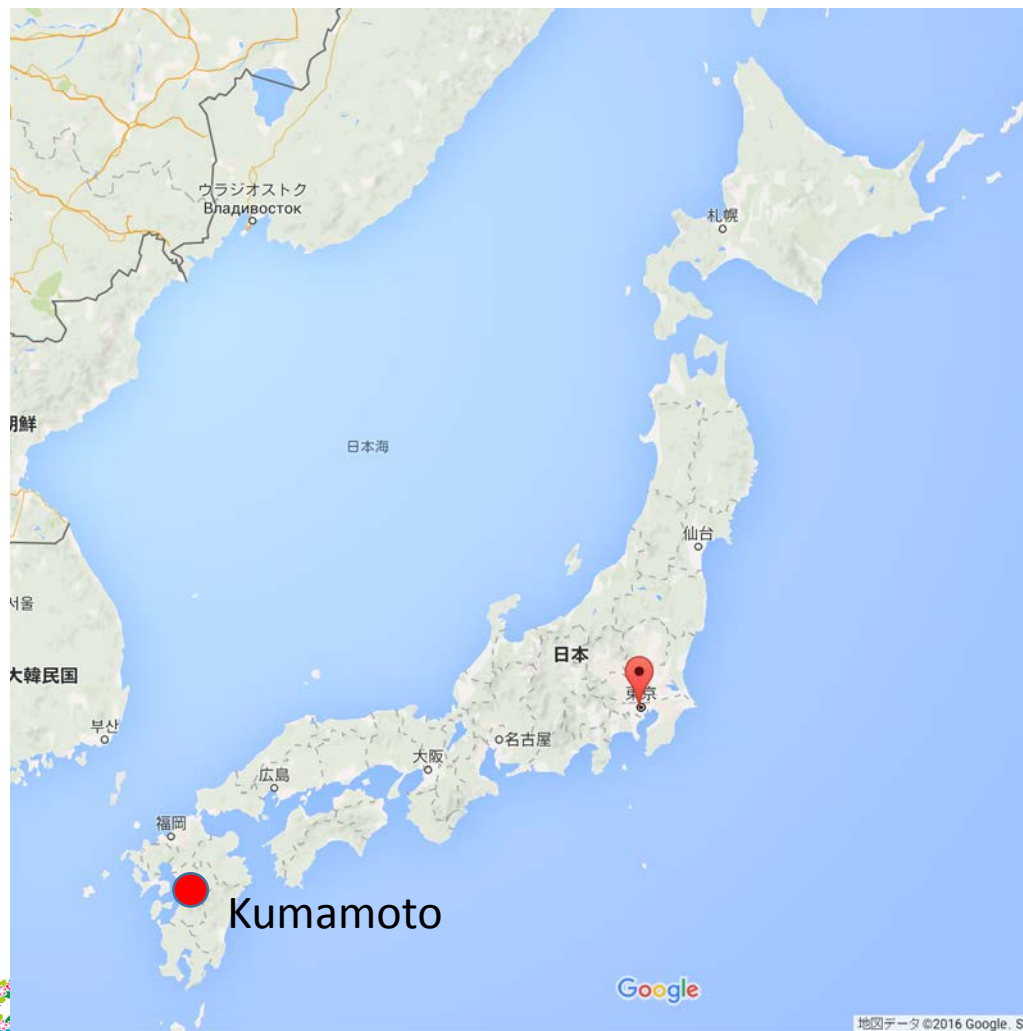
Kumamoto EQ

- April 14 Mw = 6.2
- April 16 Mw = 7.0
- Casualties 49

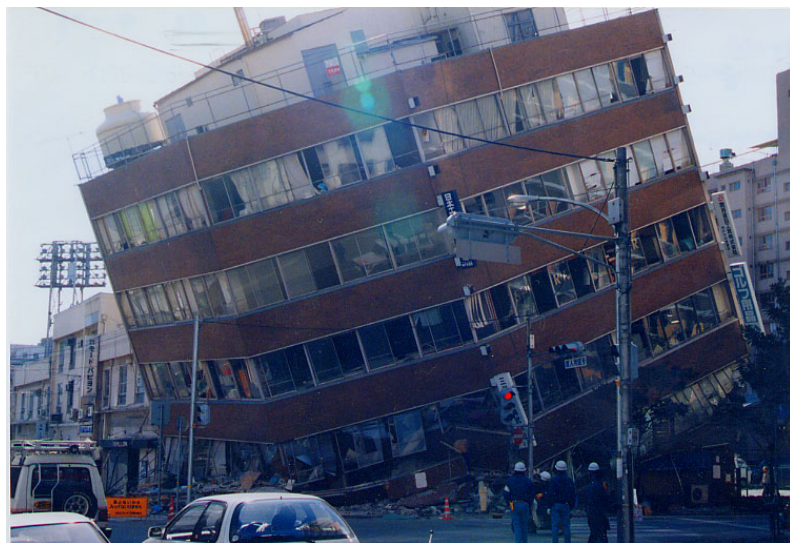
1995 Kobe EQ

Same damage in Japan

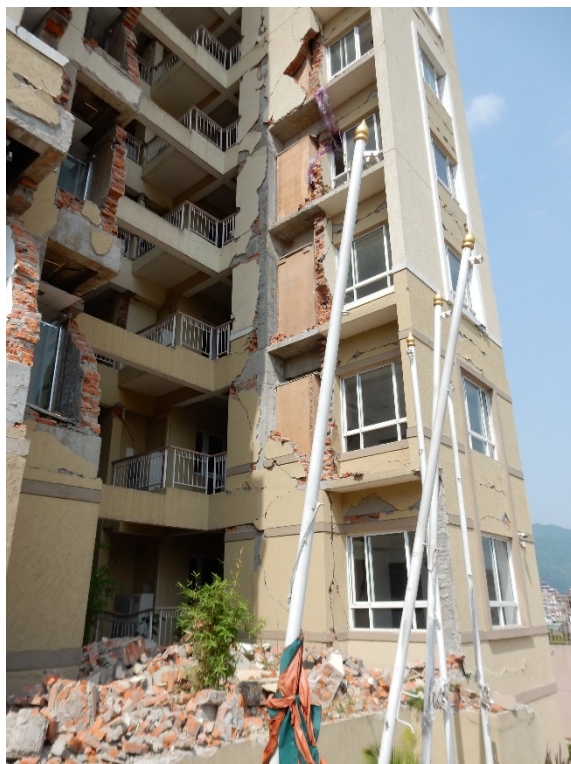
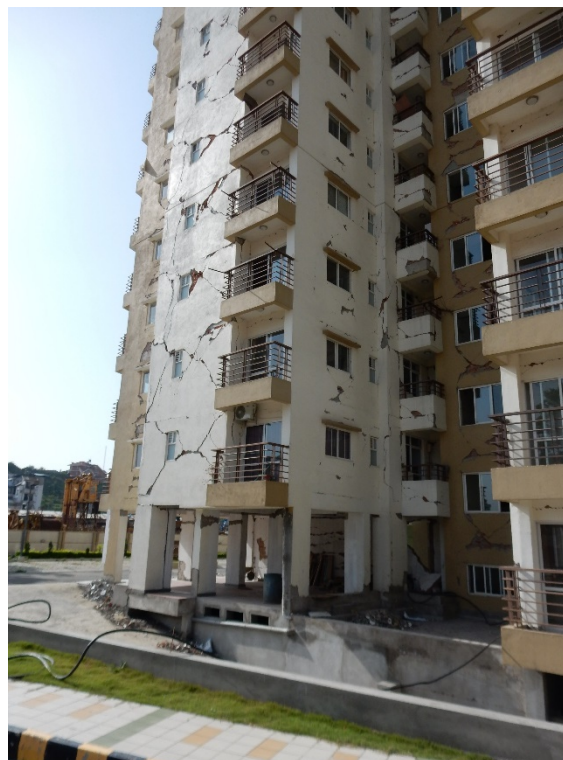
Damage of non-structural brick walls

Even structures are OK, non-structural walls were severely damaged
From AIJ reconnaissance

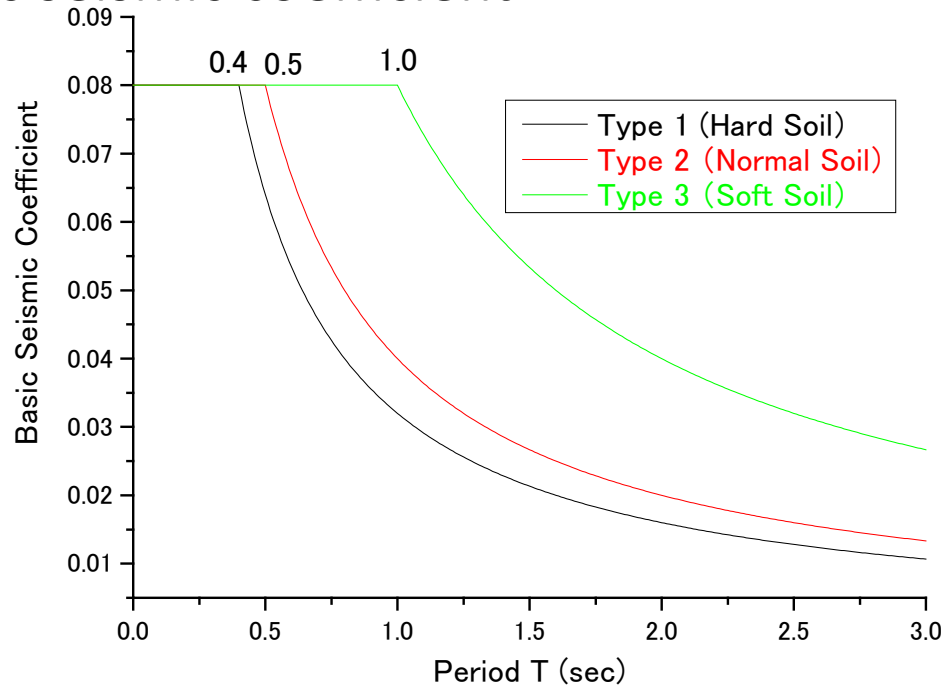
Code 105 Design lateral force coeff. C_d

- $C_d = C Z I K$
- C: Basic seismic coefficient

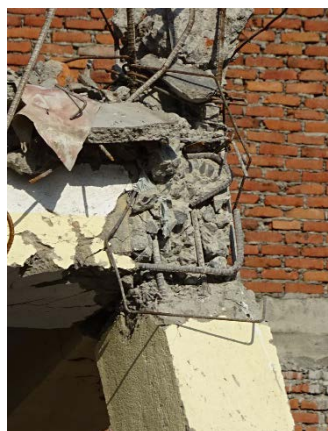
Nepalese Building Code Beam-column joint

- Bar anchorage length is defined in the code
- As for the reinforcement in the joint, **the special confining reinforcement** as required at the end of the column shall be provided through the joint as well, unless the joint confined as specified as follows.

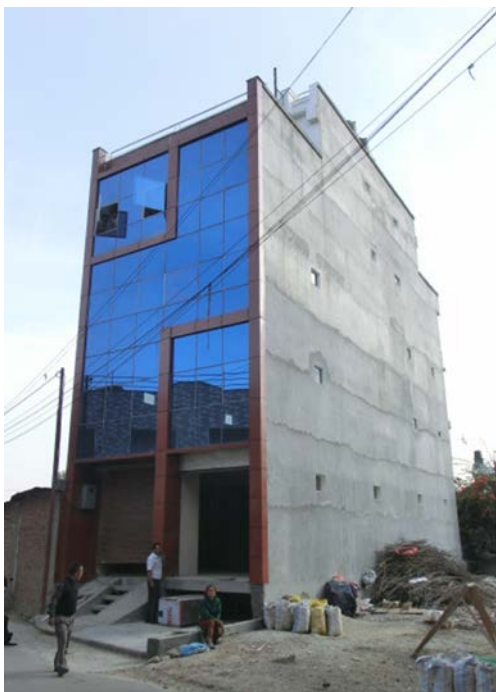
Investigated building at Kathmandu

Built after Nepal Earthquake
R/C residence with brick walls

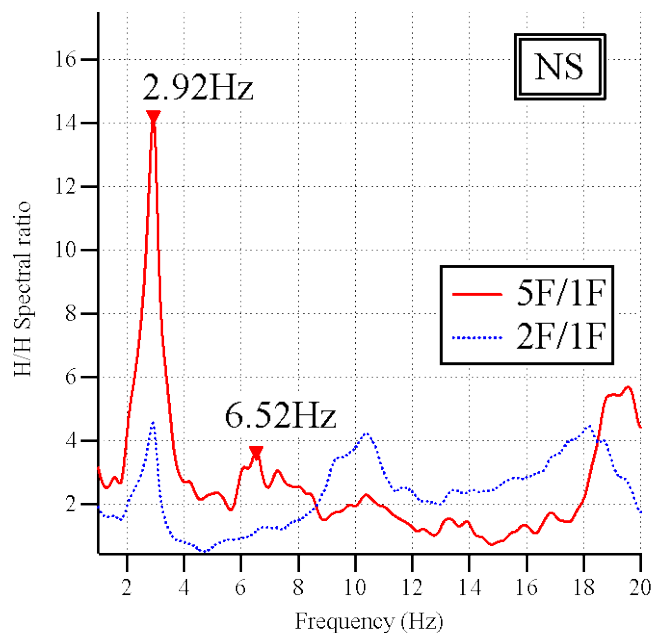
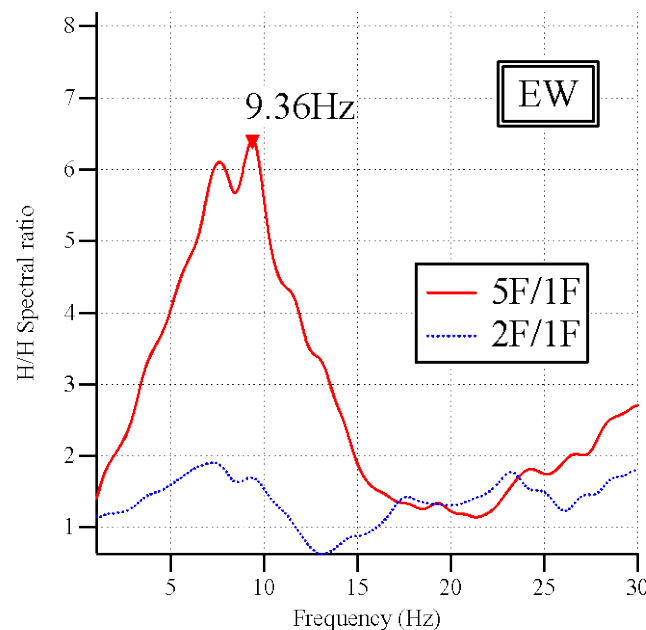
Microtremor measurements

Higher frequency was observed in the EW direction
due to existence of more brick walls

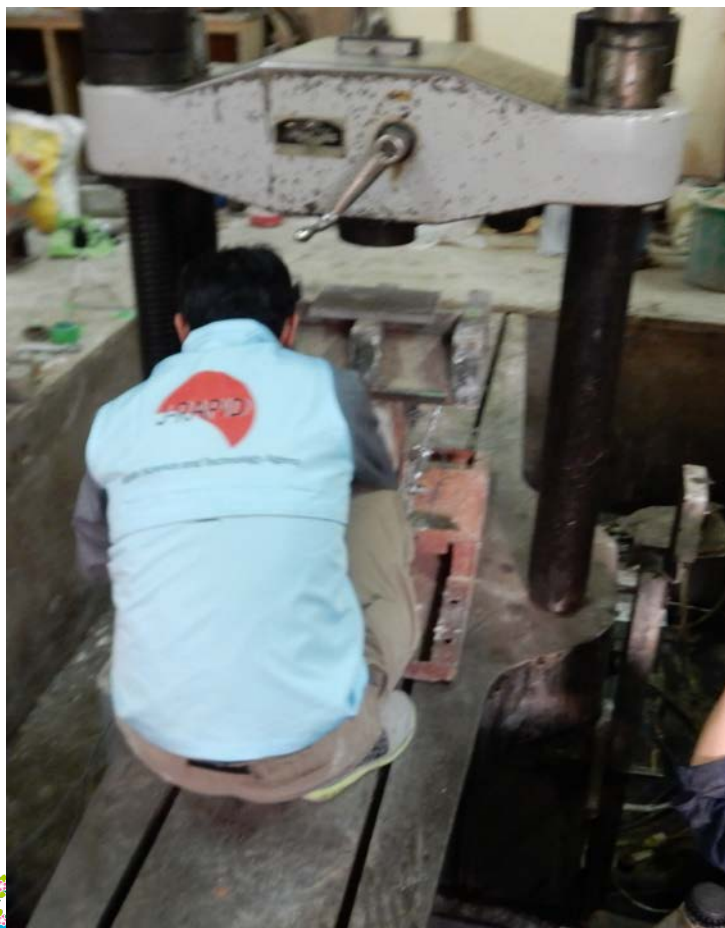
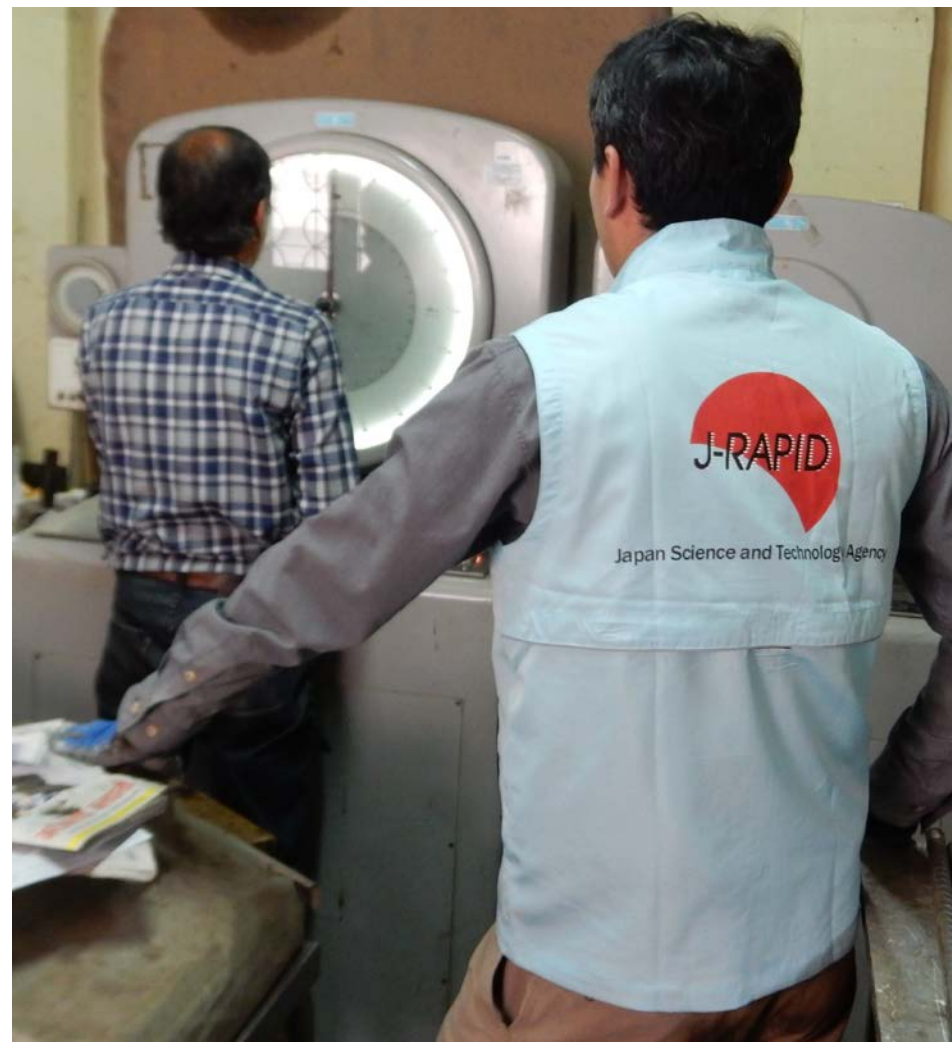
Experimental test

Compression test set-up

Strength is very low compared with R/C. But they have strength!

Area (mm ²)	Maximum load (N)	Compression strength (N/mm ²)
Non-mortar finishing	24613	107013	4.4
Mortar finishing on one side	28428	109512	3.9
Mortar finishing on both sides	30552	185537	6.1

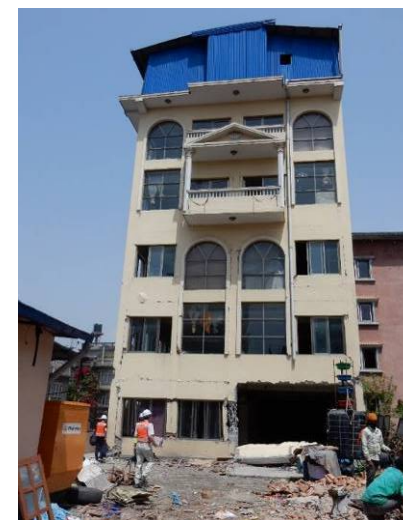
Case study of seismic screening method for 5-story building with non-structural brick walls in Nepal

C1	C2	C3
column dimensions (mm)	305×305	305×305	355×355
column longitudinal rebar	8-T25	8-T20	8-T25
column hoop	T10@100-2legs	T10@150-2legs	T10@150-2legs

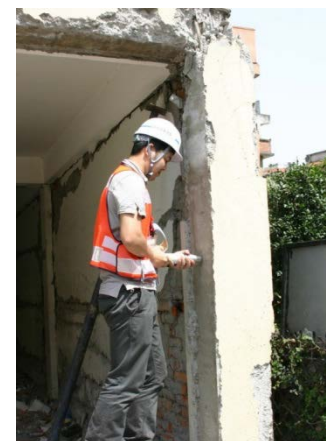
- Assumptions

- Mass ratio of each floor: **12 kN/m²**.
- Compressive strength of concrete: **40N/mm²**.
- Average shear stress of brick walls: **0.15N/mm²**.
- Thickness of brick wall is **220mm**.

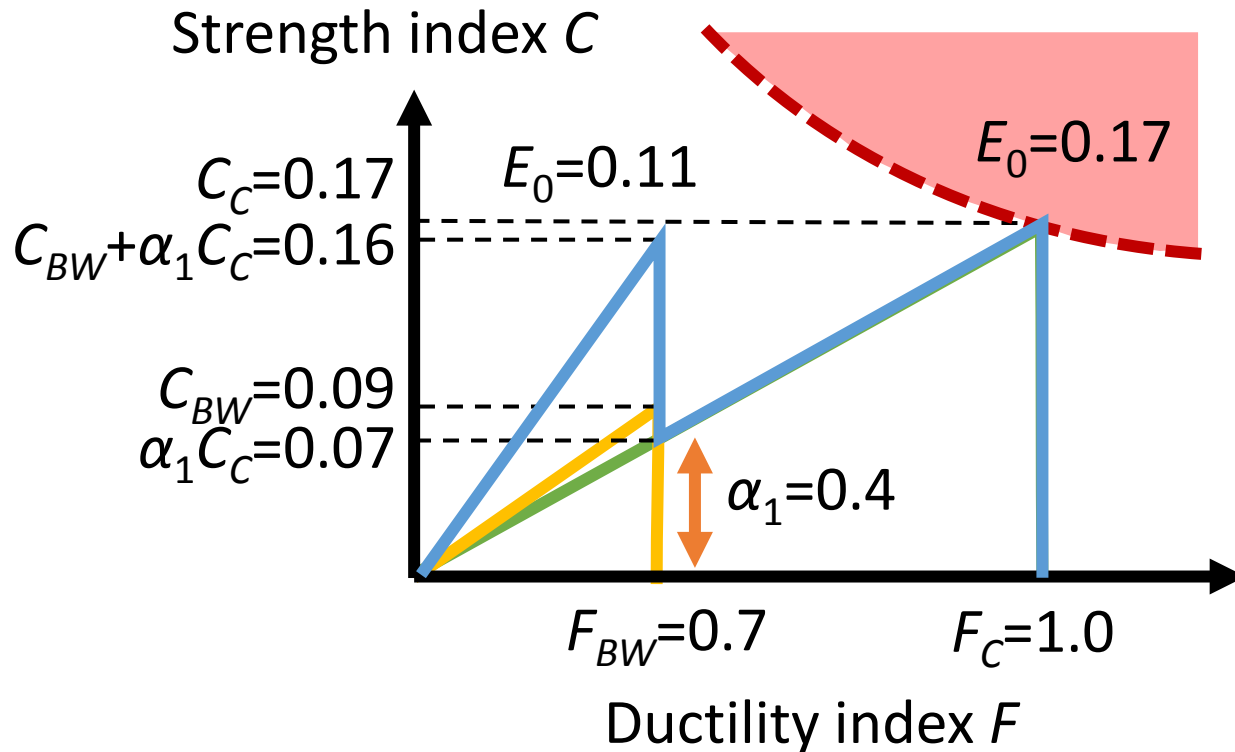
Seismic capacity E_0 considering non-structural brick walls

If shear strength contribution of brick walls becomes large, the seismic capacity is determined at when brick walls fail.

$C_C, \alpha_1 C_C$	C_{BW}	F_C, F_{BW}	E_0
when brick walls fail	0.07	0.09	0.7	0.11
when columns fail	0.17	0	1.0	0.17

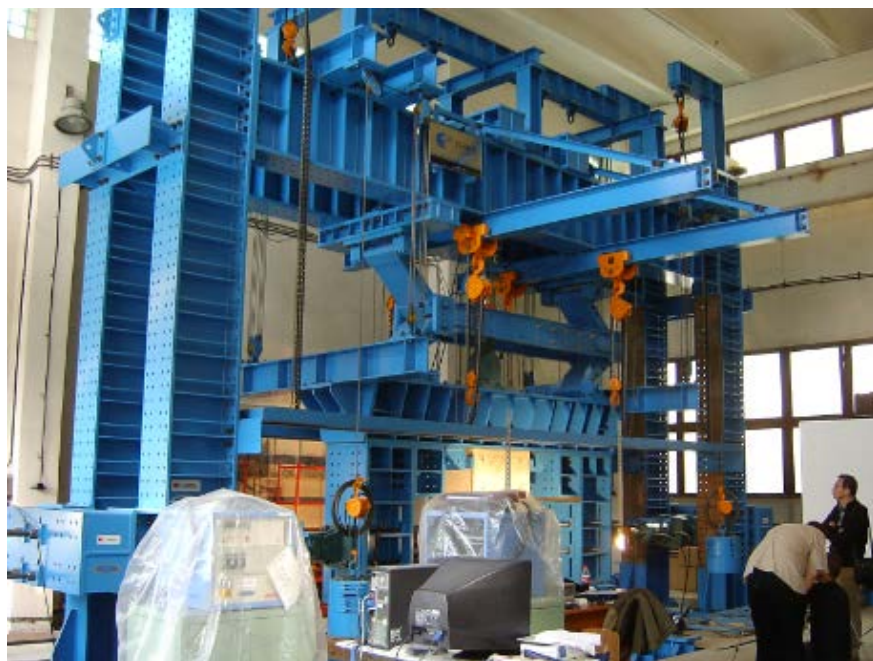
Loading system in Romania donated from Japan

Bi-directional lateral loading system

- Hydraulic oil jacks
- Hydraulic pump
- Pantograph system to prevent out-of-plane deformation
- Transducers
- Data logger
- Switch boxes
- Strain gauges
- Data acquisition software
- Notebook computer for data acquisition

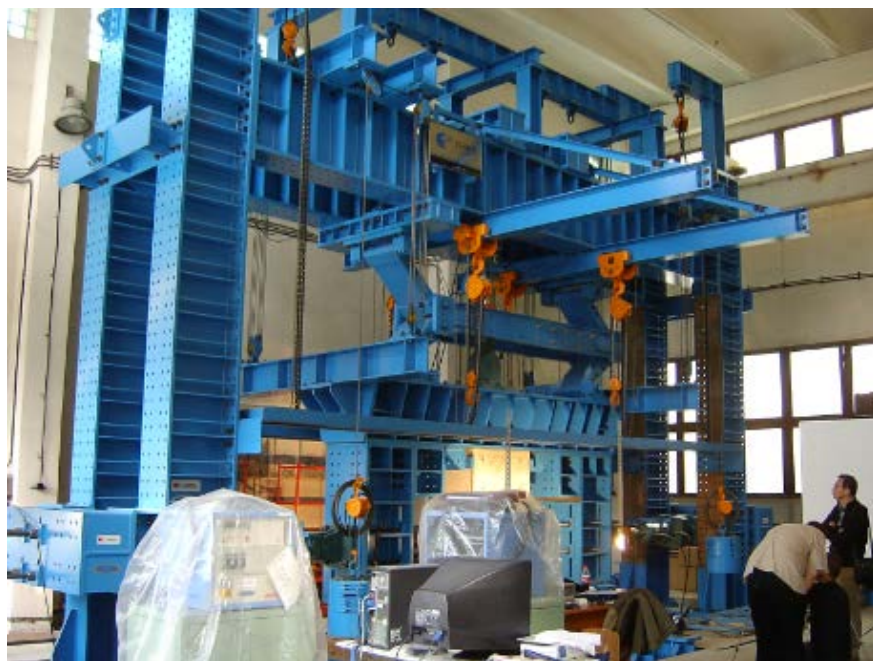
Loading system in Romania donated from Japan

Bi-directional lateral loading system

- Hydraulic oil jacks
- Hydraulic pump
- Pantograph system to prevent out-of-plane deformation
- Transducers
- Data logger
- Switch boxes
- Strain gauges
- Data acquisition software
- Notebook computer for data acquisition
