Urgent environmental survey on groundwater pollution by sewer leakage after the 2016 Kumamoto Earthquake

Haruhiko NAKATA¹⁾ Eri ISHII¹⁾, Takahiro HOSONO¹⁾, Tetsuro AGUSA²⁾,
Daisuke UENO³⁾ and Kurunthachalam KANNAN⁴⁾

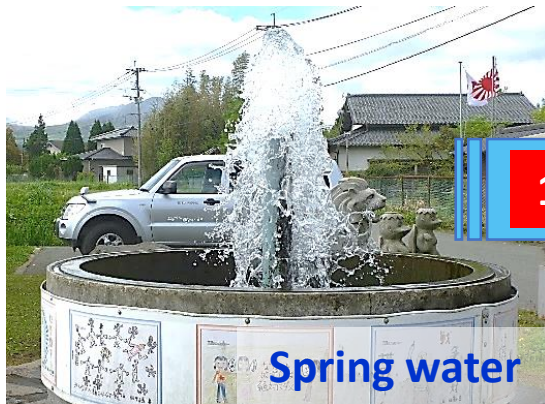
Groundwater flow in Kumamoto area¹⁾²⁾

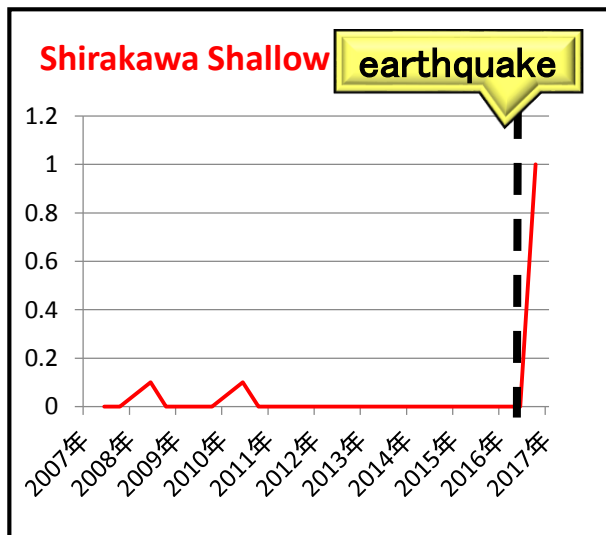
To begin, we checked long term monitoring data

Significant change in NO_3^- and $\text{NO}_2^- \Rightarrow$ 2 sites

Increasing in NH_4^+

Leaking of sewage

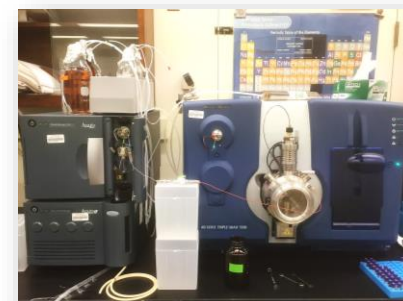
PFOA target analysis

Standards solution of perfluorinated compounds

HPLC-MS/MS
