Emergency survey of the great earthquake impacting on water security in Kathmandu, Nepal

Objectives of J-RAPID project

- To investigate impacts of the great earthquake on domestic water for local people, as well as natural water resources and water supply and treatment systems.
- To assess and propose emergency actions, such as securing sanitary condition related to water use, quick and efficient water treatment methods, possible alternative water sources, in Kathmandu and surrounding areas.

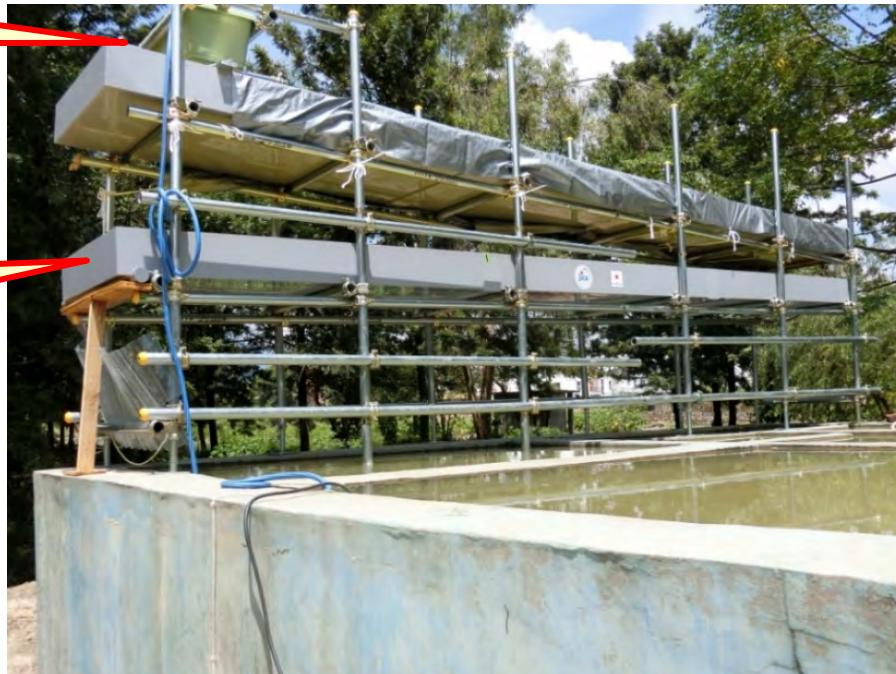
Locally-fitted, compact and distributed (LCD) water treatment system

- **Sponge tray water treatment system** installed at Jwagal showed the mean removal ratio of **78.9% ($0.68 \log_{10}$)** for total **coliforms**, indicating a potential use of this system for domestic water production.

Removal ratio of total coliforms

63.5% ($0.44 \log_{10}$)

87.7% ($0.91 \log_{10}$)

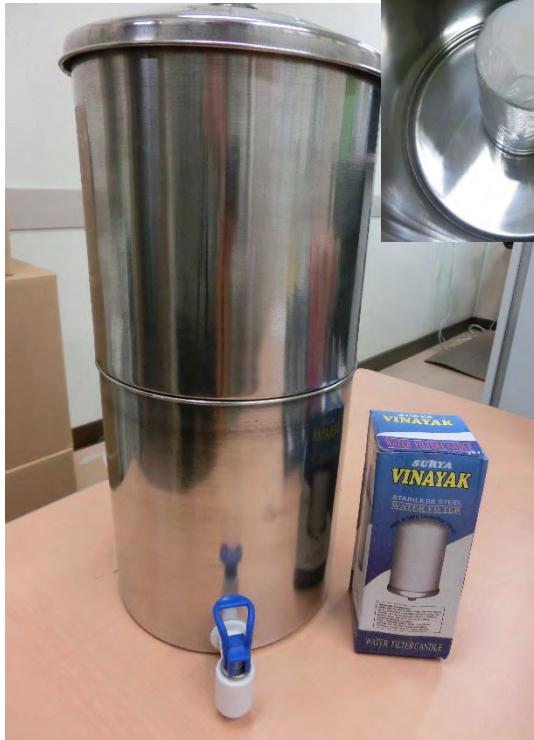
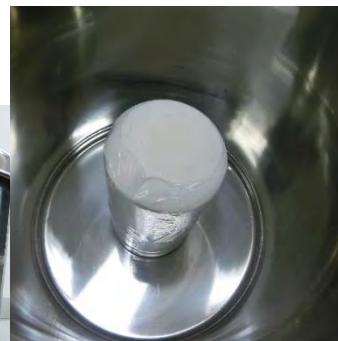
Household water filter

- Commercially available water filter worked well to remove *E. coli*, but not for coliphages.

Volume filtered (L)	Removal of <i>E. coli</i>
0	99.98% (3.73 log)
50	99.98% (3.62 log)
100	99.53% (2.33 log)

Volume filtered (L)	Removal of coliphage MS2
100	0–18.9% (<0.09 log)

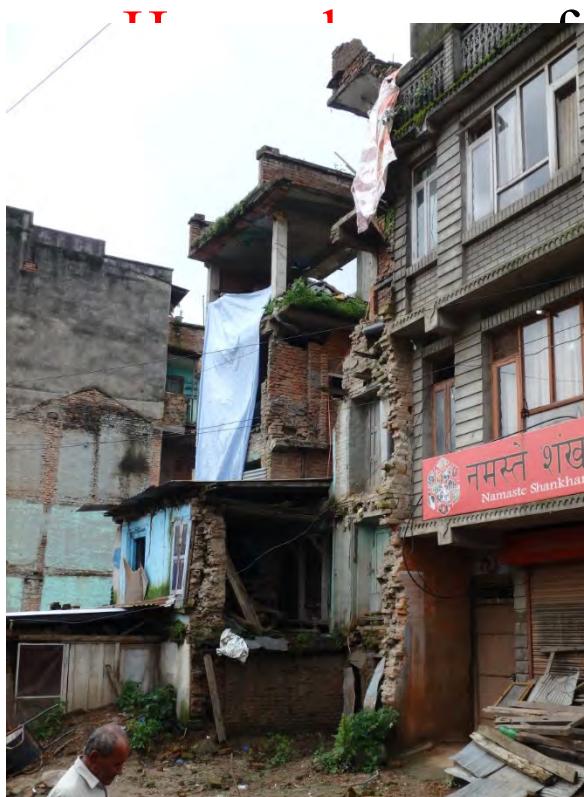
Collapse of masonry buildings

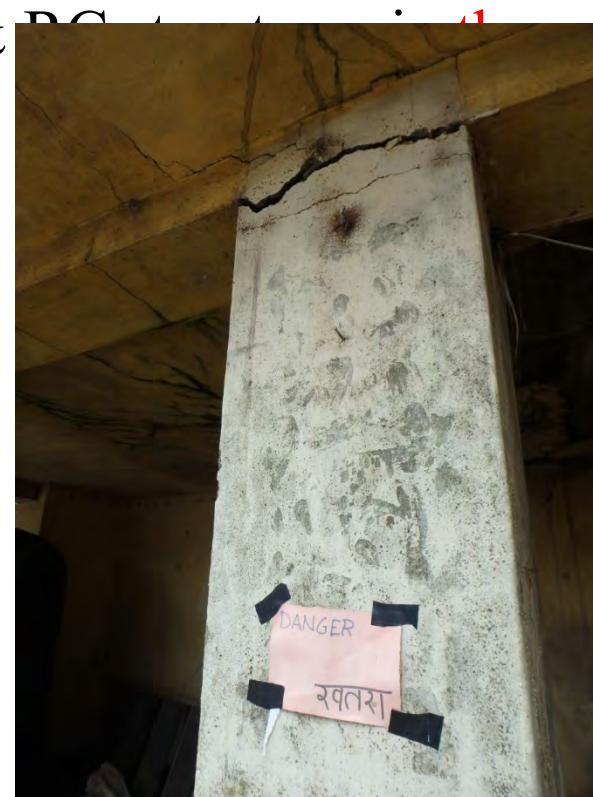
Damage of a concrete pillar
