Kamisaigo river restoration project

Design directions

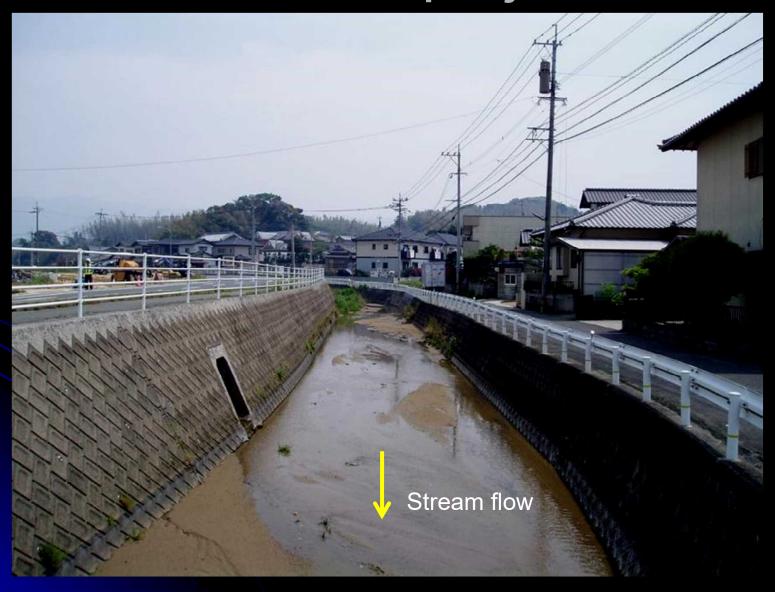
Issues of the project site

- Residents were suffering from floods.
- No vegetation, no fishes, no insects...

- The environment of the project site was not good for residents and aquatic organisms.
- Relationship between residents and river had been disappeared.

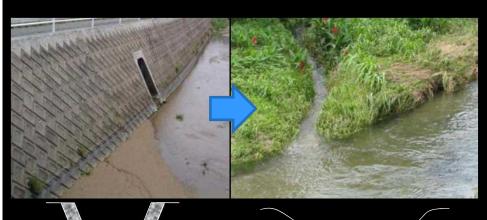
Remove concrete revetments

Dam removal to restore longitudinal connectivity

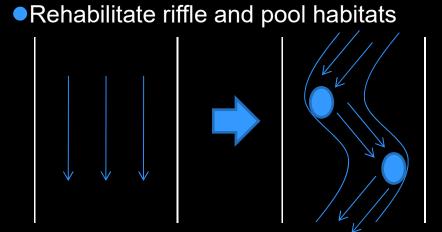
Installed techniques to restore riffle and pool habitat

Log structure

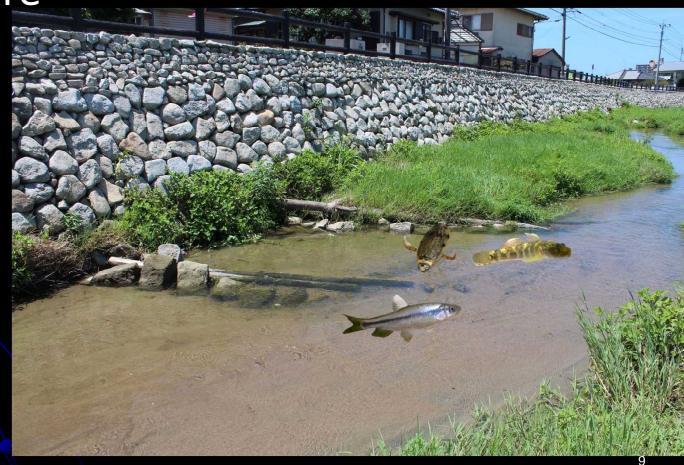
Installed techniques to restore longitudinal connectivity
