# INVESTIGATION ON THE PERFORMANCE OF BUILDINGS WITH STRUCTURAL WALLS IN THE TOHOKU, JAPAN, EARTHQUAKE OF 2011

# Overview of the project

- Severe damage of RC buildings with structural walls were observed.
- Three retrofitted RC buildings are picked up and the damage are investigated.
- The reason of the damage and what happened during the earthquake are discussed.

# Effect of Longitudinal Web Reinforcement Discontinuities on the Drift Capacity of Structural Walls

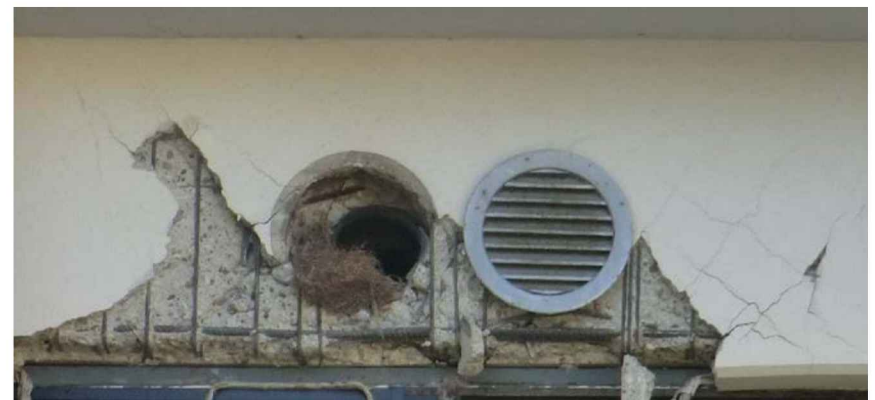
Observed damage in transverse direction

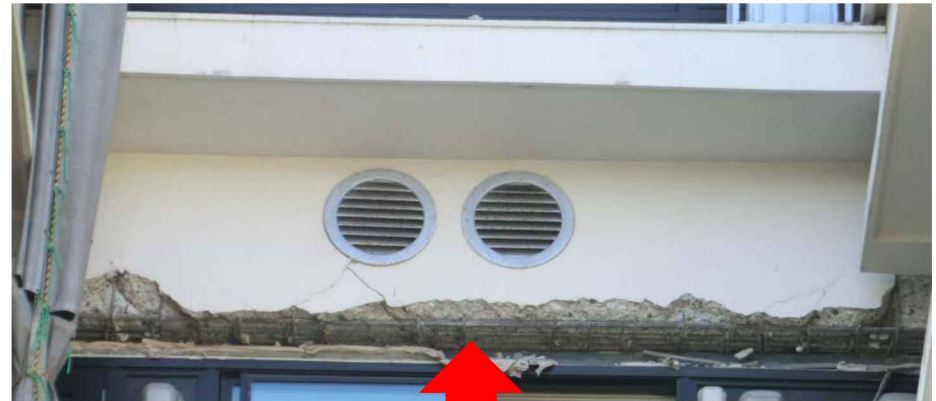
Observed damage in transverse direction

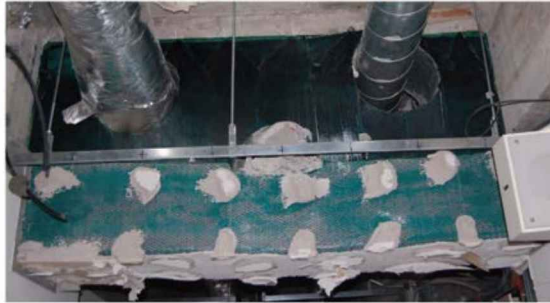
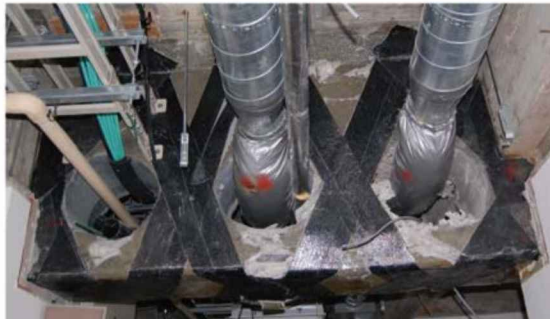
Reinforcement with carbon fiber
