Site characterization for geotechnical hazards associated with soil liquefaction prevailing in Kanto region based on geotechnical field investigations

(1) Objectives

To carry out field investigations & to disclose geotechnical soil profiles responsible for widely spread damages to infrastructures and private houses in Kanto region.

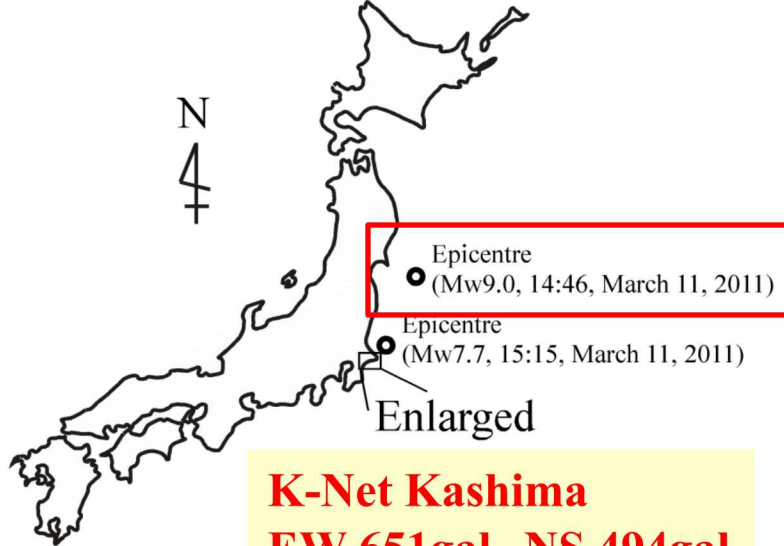
K-Net Kashima
EW 651gal, NS 494gal

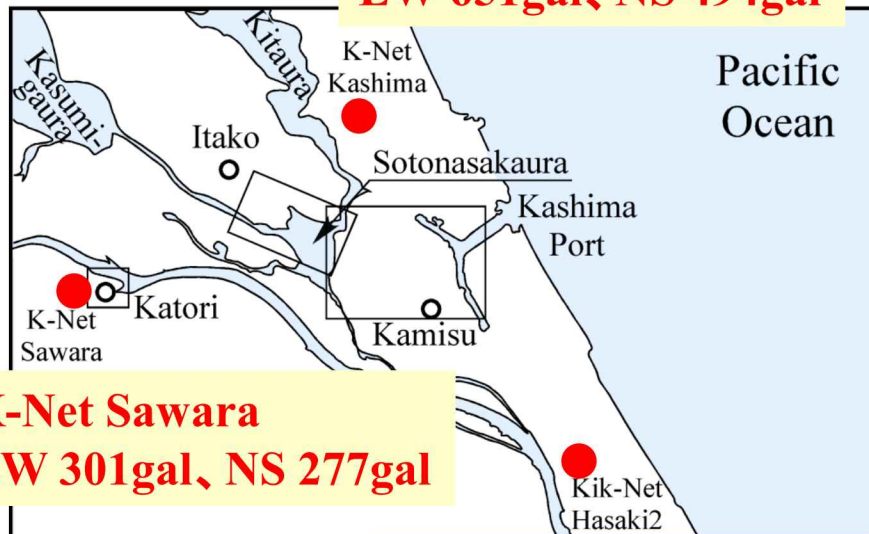
K-Net Sawara
EW 301gal, NS 277gal

K-Net Hasaki2
EW 188gal, NS 216gal

Main shock
14:46, March 11, 2011
Focal depth: 24 km
Mw=9.0

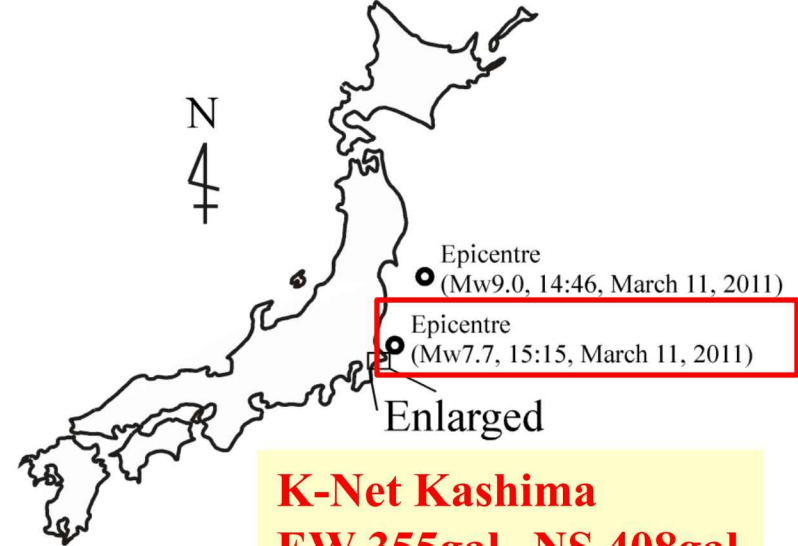
K-Net Kashima
EW 355gal, NS 408gal

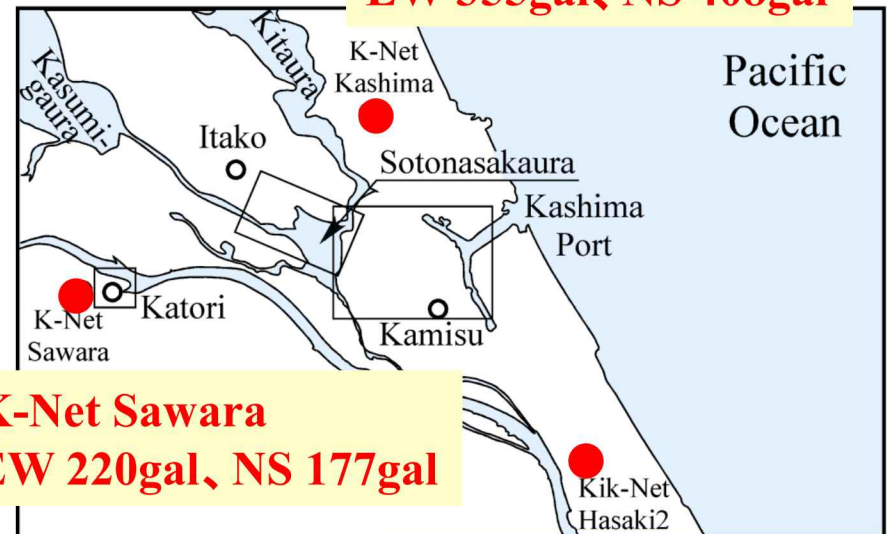
K-Net Sawara
EW 220gal, NS 177gal

K-Net Hasaki2
EW 228gal, NS 168gal

Aftershock
15:15, March 11, 2011
Focal depth: 43km
Mw=7.7

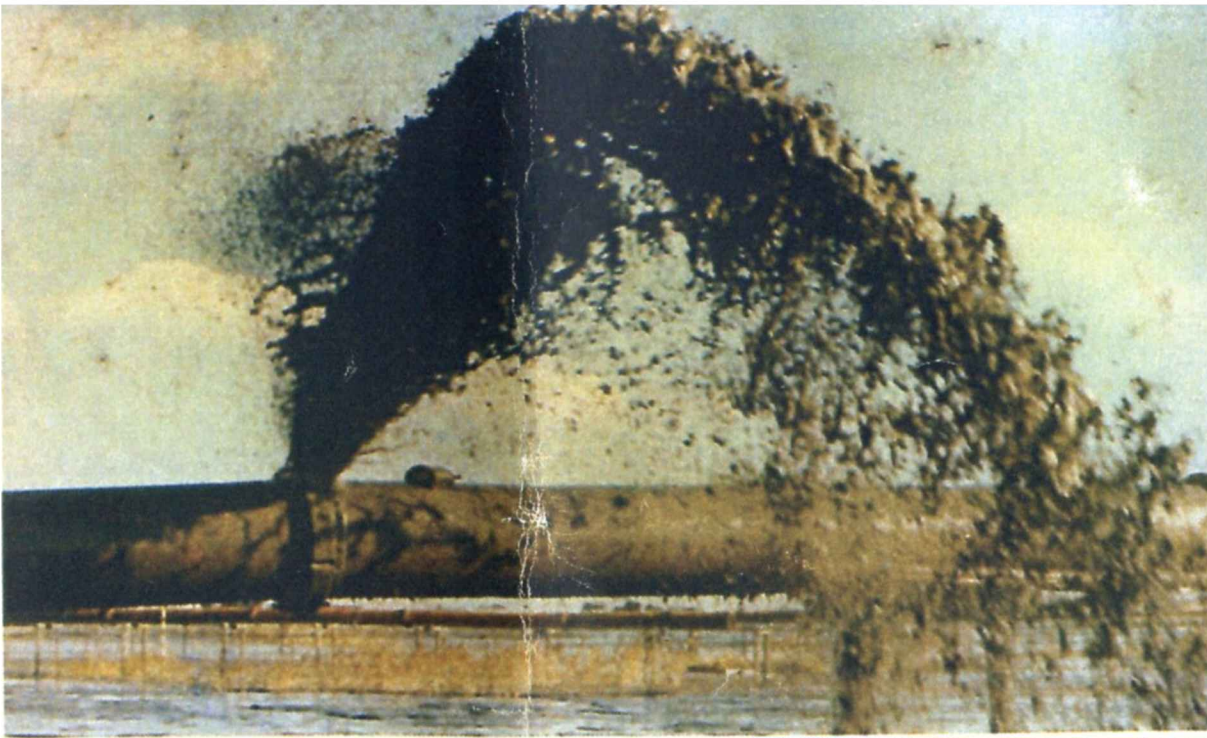
Reclamation by
pumping up sea floor
sludge

{ 1970 **Reclamation by pumping up sea floor sludge** started
