Damage assessment and vulnerability modeling of structures in the 2016 Kumamoto earthquake based on the data acquired from field investigation and remote sensing

March 4, 2017

Symposium on J-Rapid-Kumamoto

Recent Earthquakes in Nepal, Thailand, and Japan *My impression about building vulnerability and ground motion*

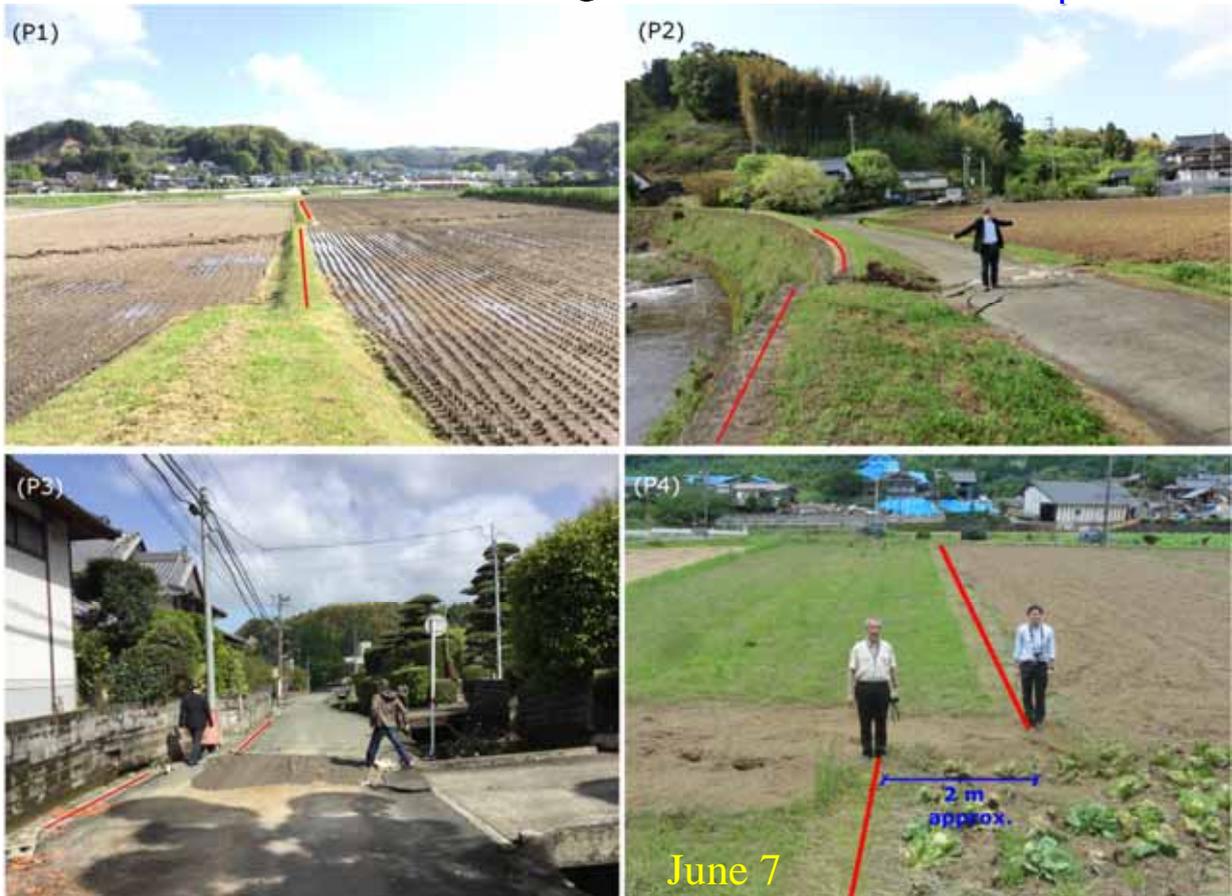
Surface faulting in Mashiki town April 17

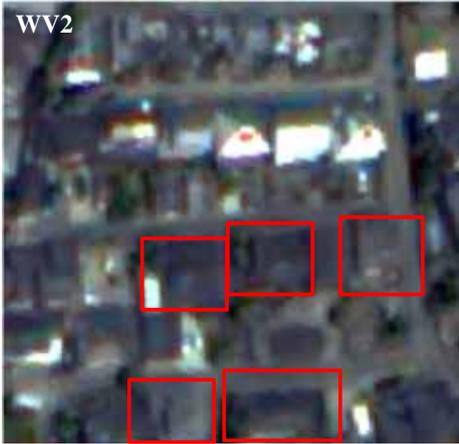
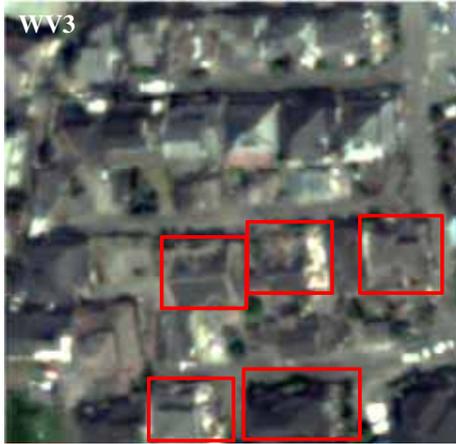
area A

Building Damage in Mashiki Town on April 15, 2016

Damaged buildings

Damaged buildings by visual interpretation from the pan-sharpened pre- and post-event optical images.

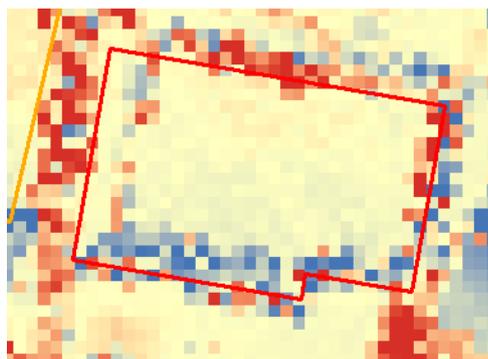
Estimation of collapsed buildings from the height change in the footprint

$\Delta h = -0.17\text{m}$ $\sigma = 0.77\text{m}$ $r = 0.857$

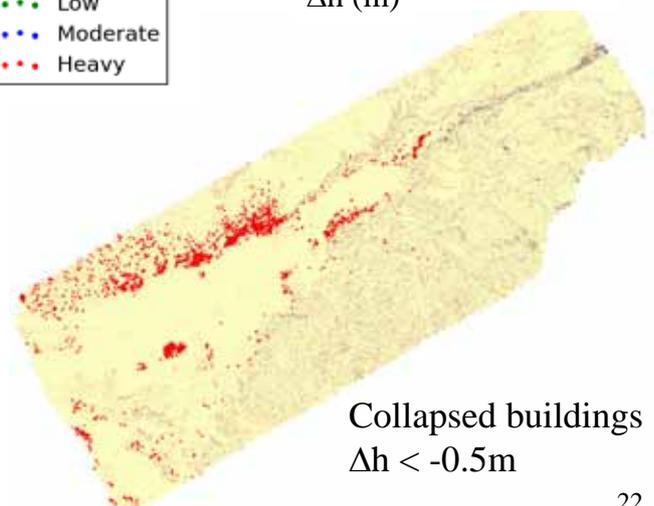
Collapsed buildings
 $\Delta h < -0.5\text{m}$

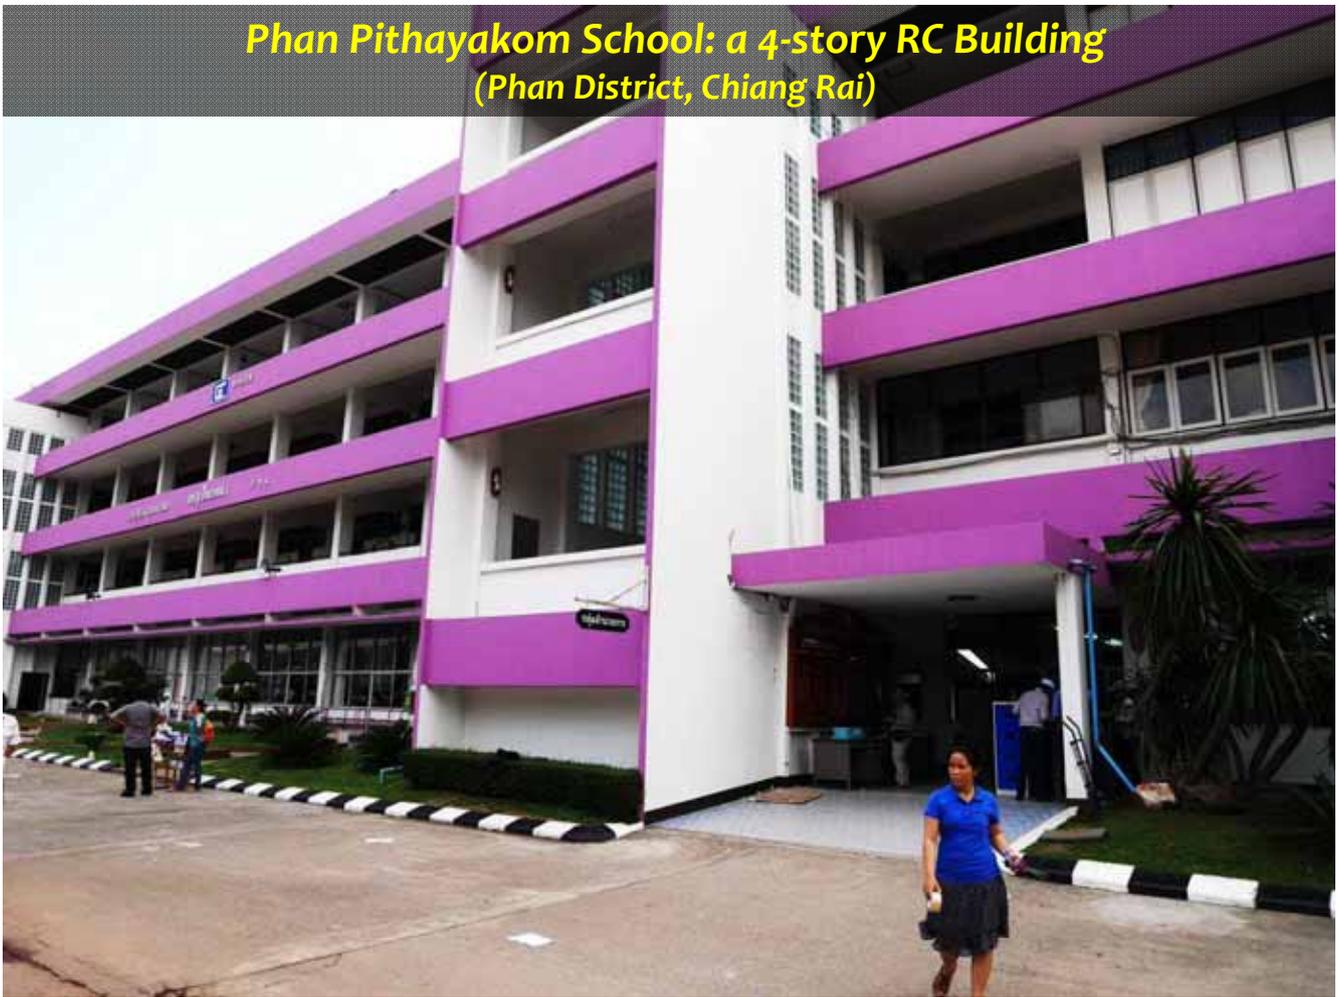
**Phan Pithayakom School: a 4-story RC Building
(Phan District, Chiang Rai)**

Extensive shear failure in the first-story columns
No seismic detailing—low amount of transverse reinforcement & wide spacing
Failure location is just above the infill walls

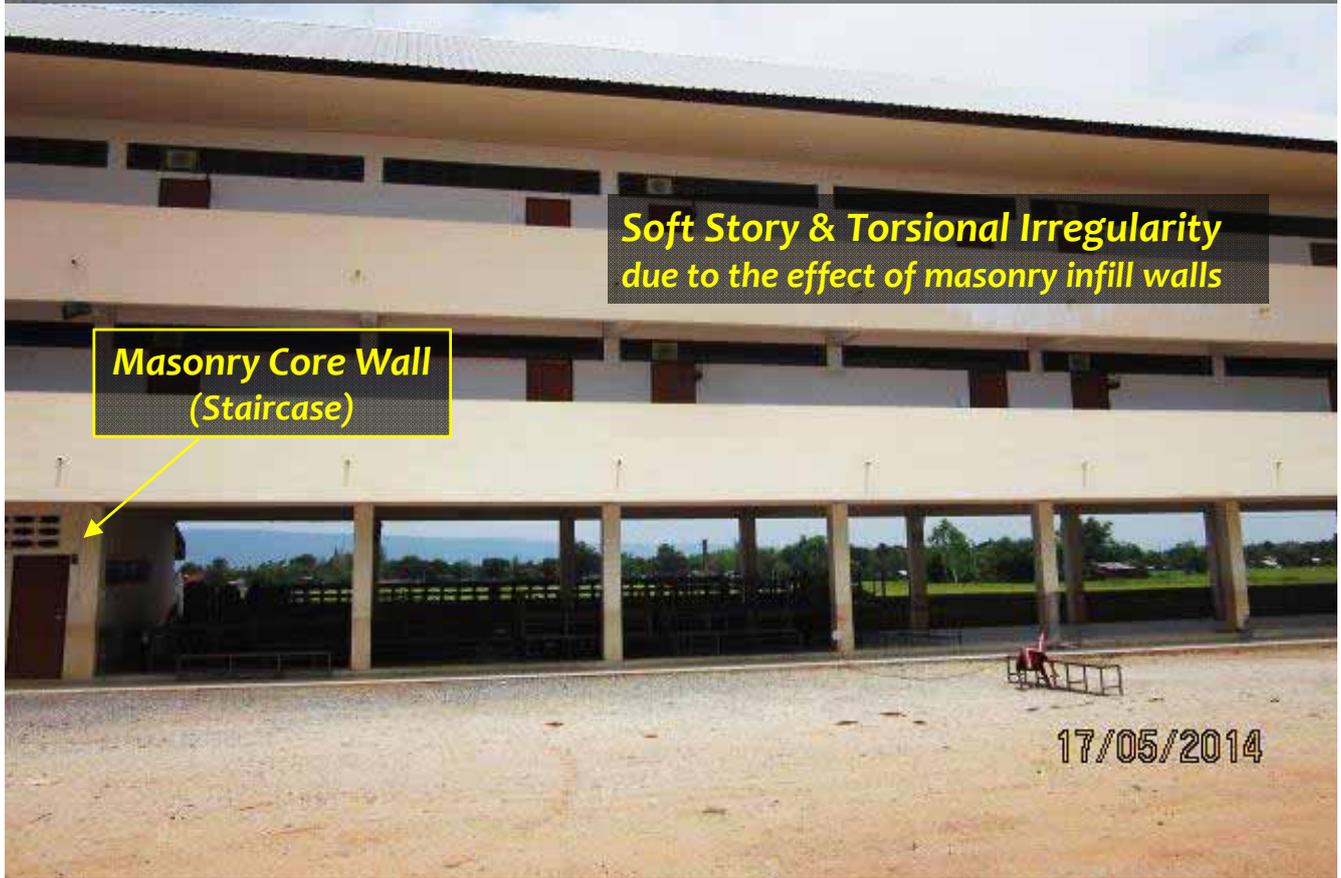
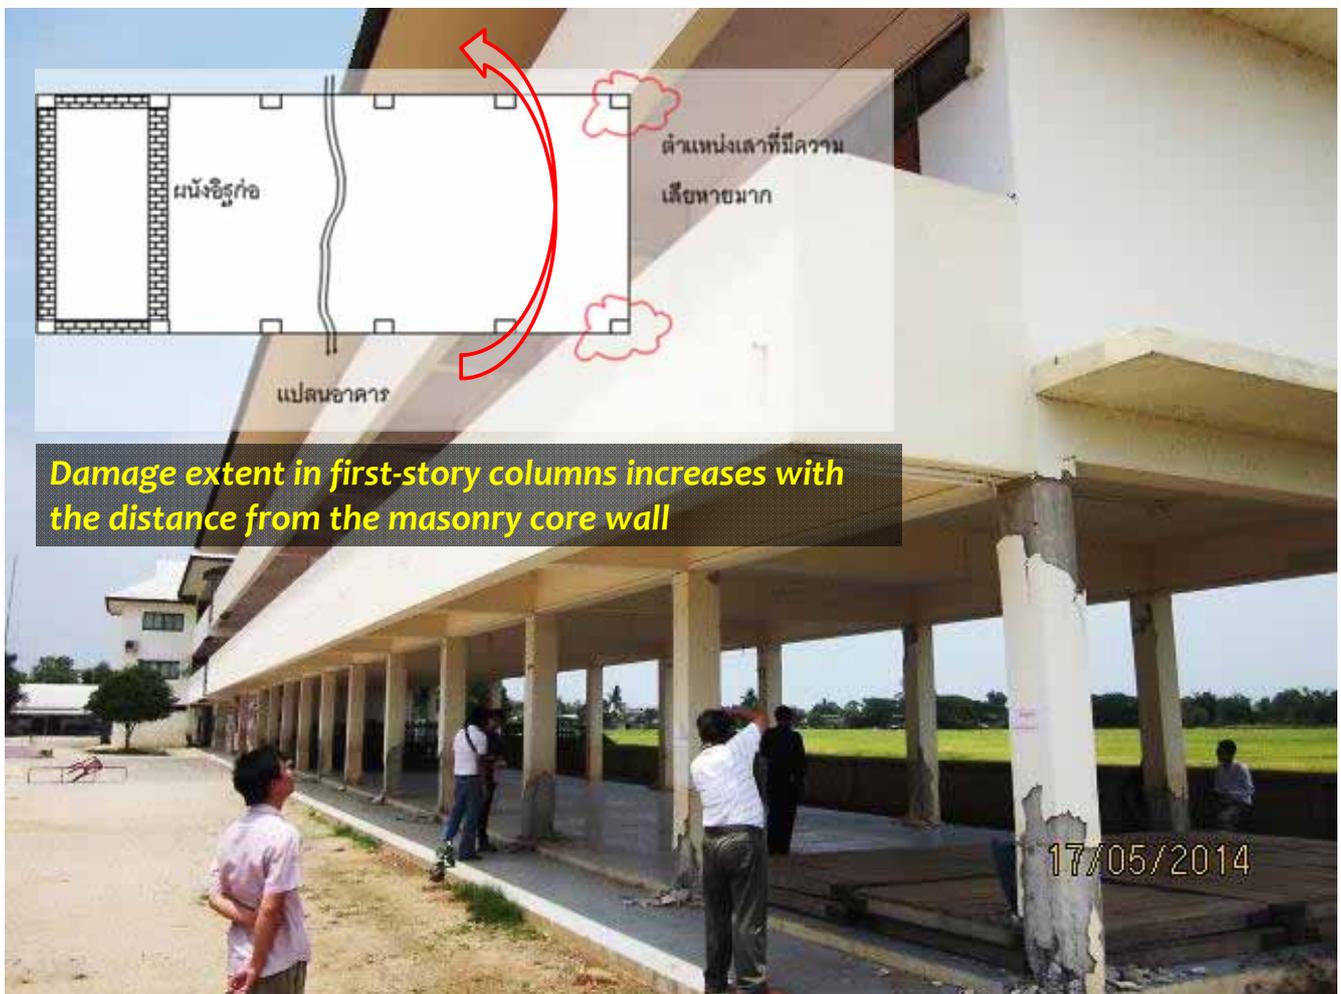
**Wat Muang Nga School: a 3-story RC Building
(Phan District, Chiang Rai)**

Failure Mode: Lap-splice Failure

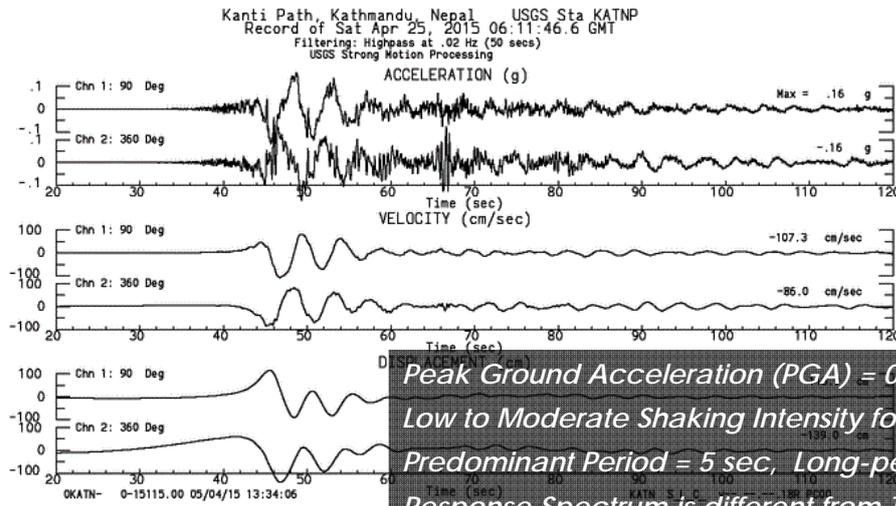
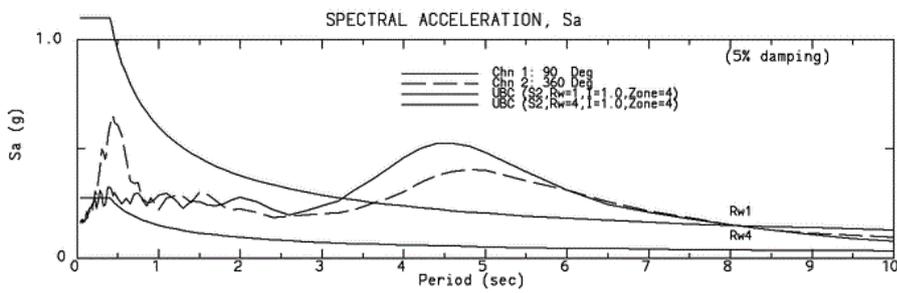
Ground Motion Records in Kathmandu: The 25th April 2015 Earthquake (M_w 7.8)

Peak Ground Acceleration (PGA) = 0.16 g
Low to Moderate Shaking Intensity for Low-rise Buildings
Predominant Period = 5 sec, Long-period Ground Motion!
Response Spectrum is different from Typical Design Spectrum
More Damaging Effect to Tall Buildings (Long-period Structures)

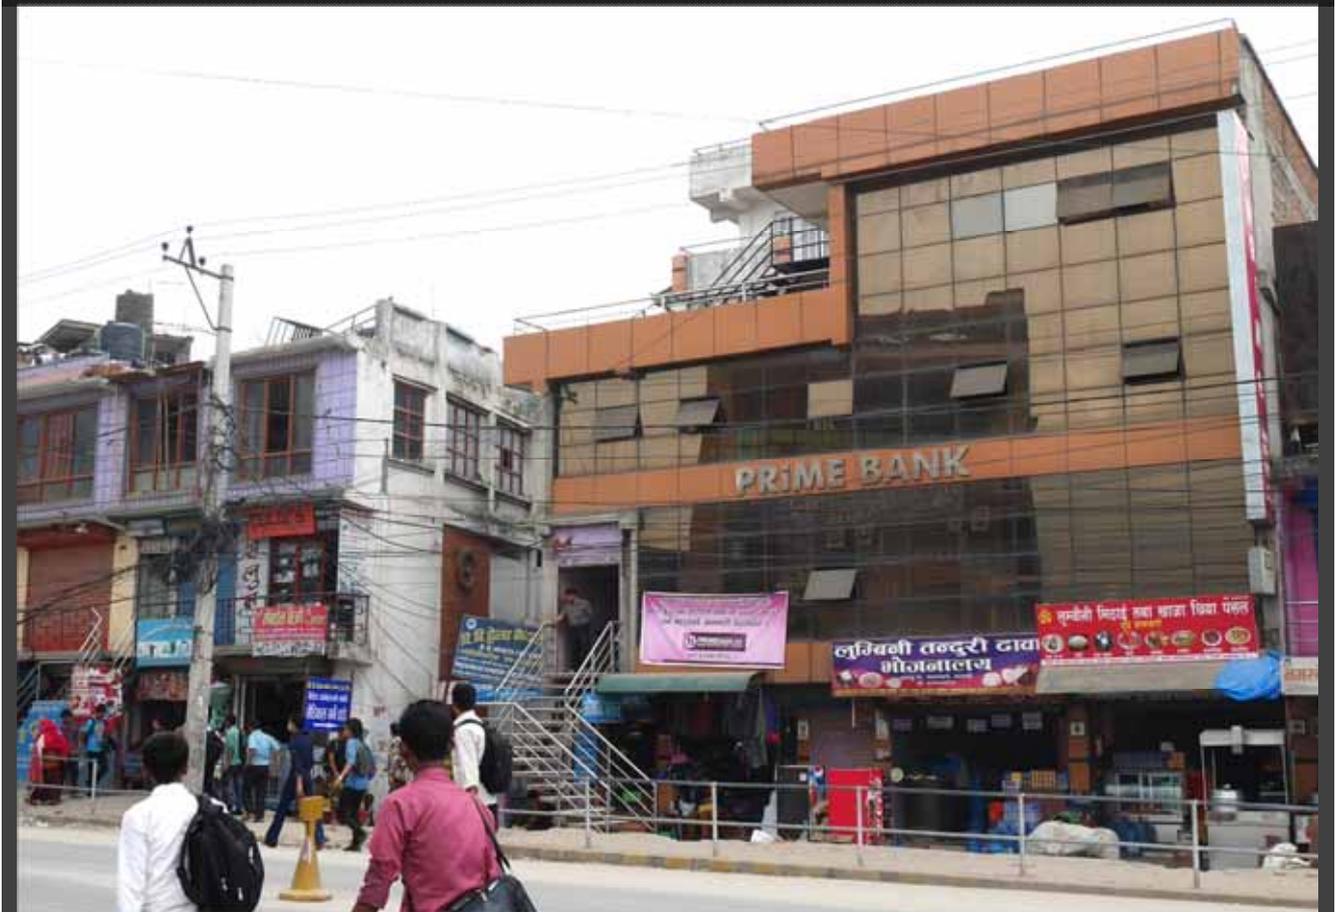
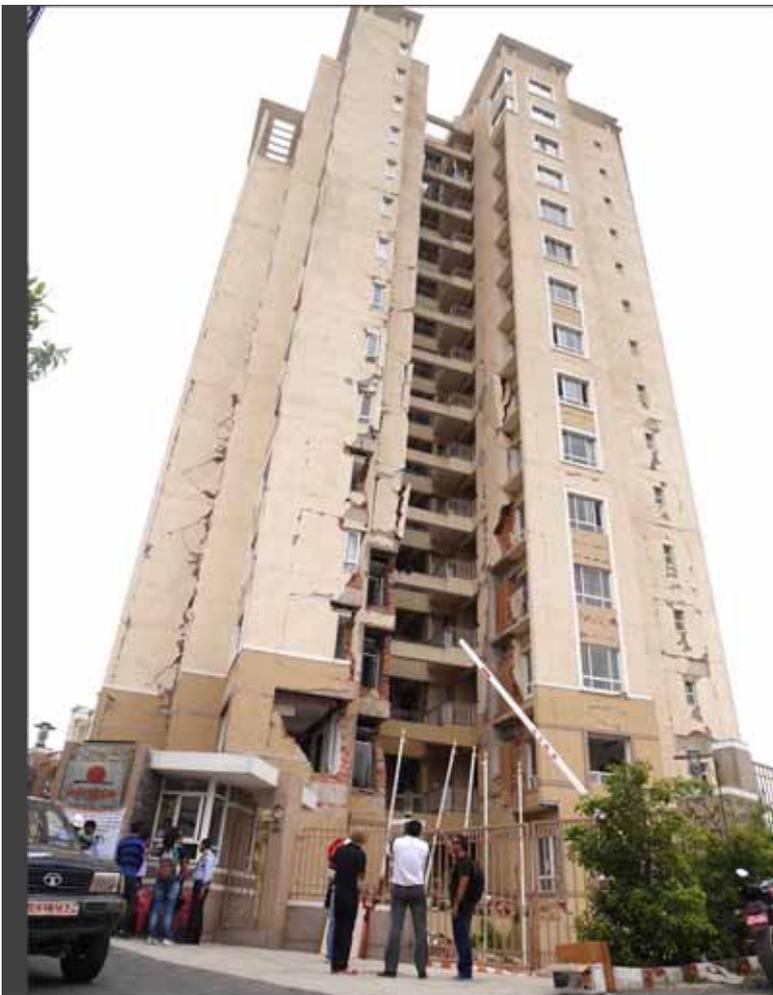
Minor or No Damage to Modern RC Buildings in Kathmandu City

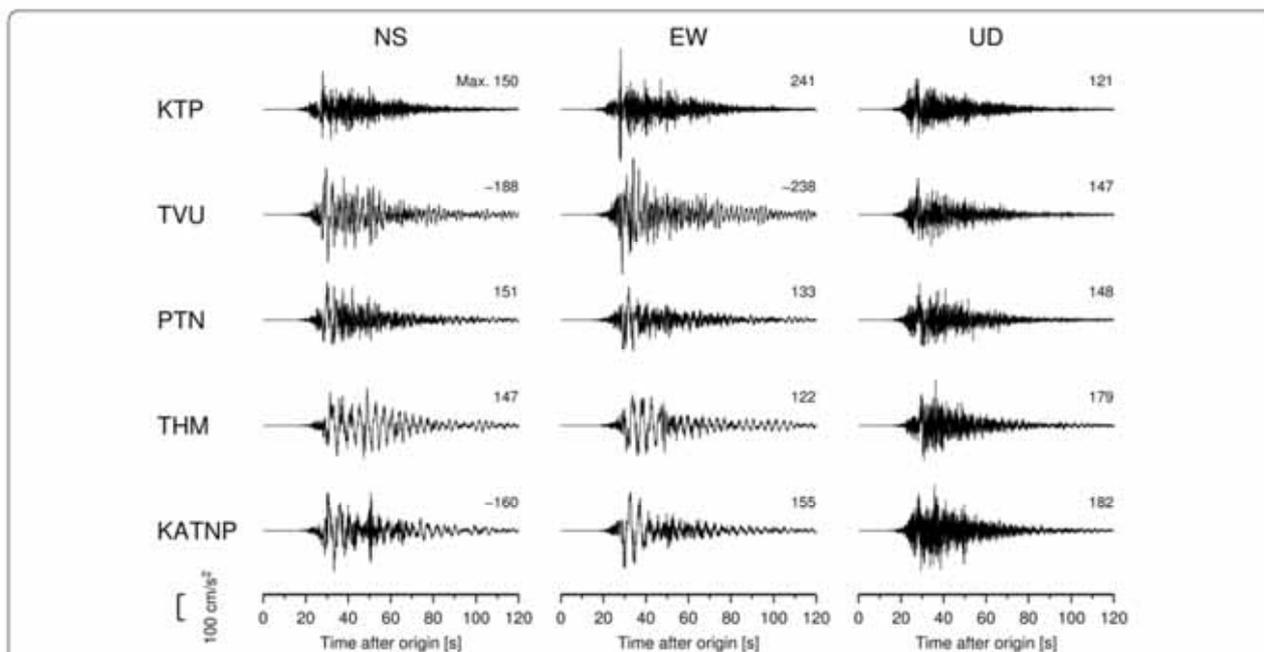
Observed Ground Accelerations in Kathmandu

Fig. 2 Observed ground accelerations at various sites. The station at KATNP is a rock site and the others are soft sedimentary sites. The waveform shows the acceleration in cm/s² over time (0 to 120 seconds).

PGA is low—about 0.12g to 0.24g

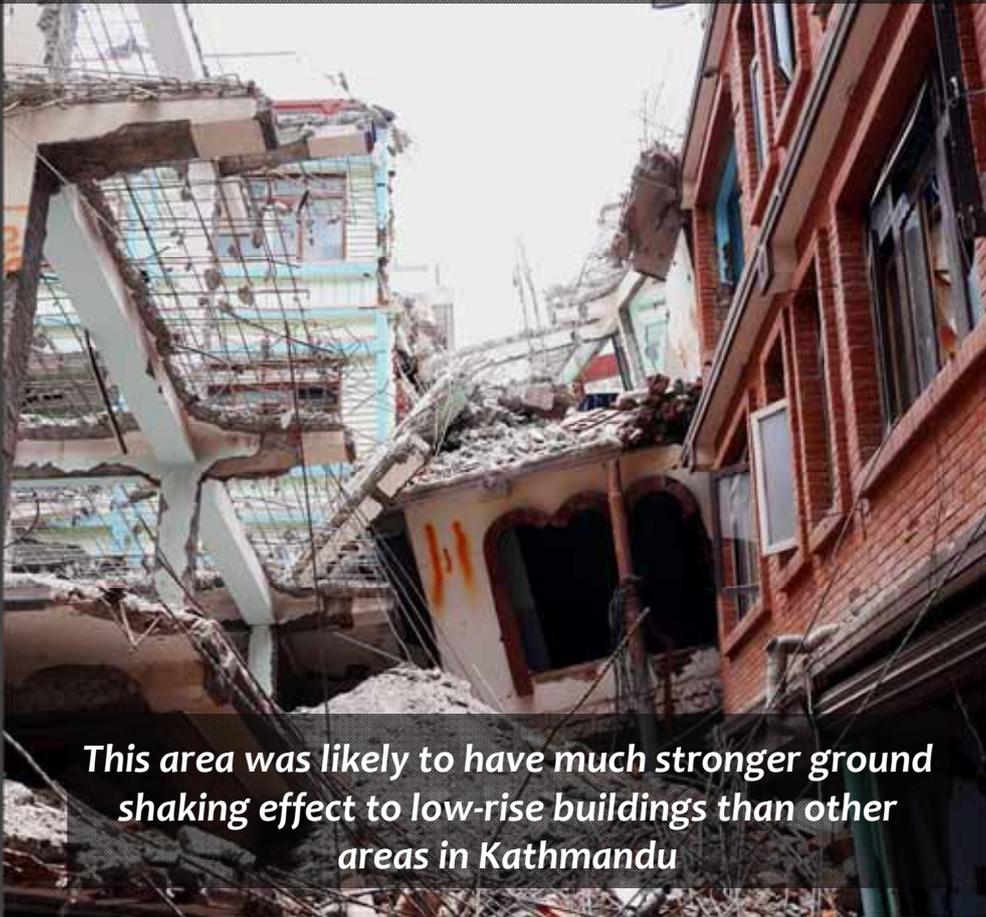
The Concentrated Damage Area in Gongabu, Kathmandu

This area was likely to have much stronger ground shaking effect to low-rise buildings than other areas in Kathmandu

'Seismic Microzonation Study' should be properly carried out.

Low-rise buildings on 'rock sites' should be made more seismic resistant !

High-rise buildings & Long-period structures on 'basin sites' should be designed for long-period ground motions!

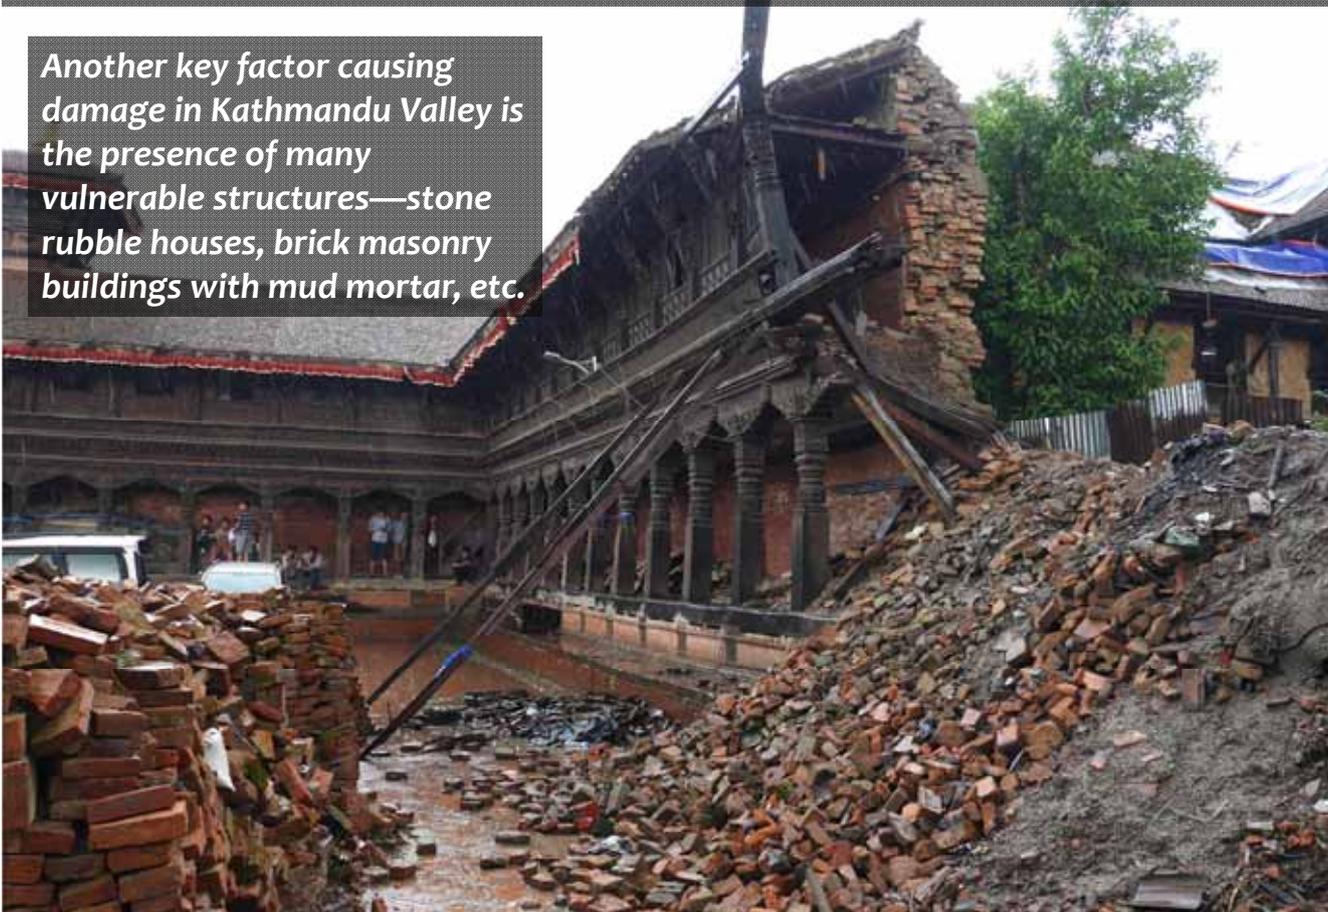
Bhaktapur—An Ancient City in Kathmandu Valley

Another key factor causing damage in Kathmandu Valley is the presence of many vulnerable structures—stone rubble houses, brick masonry buildings with mud mortar, etc.

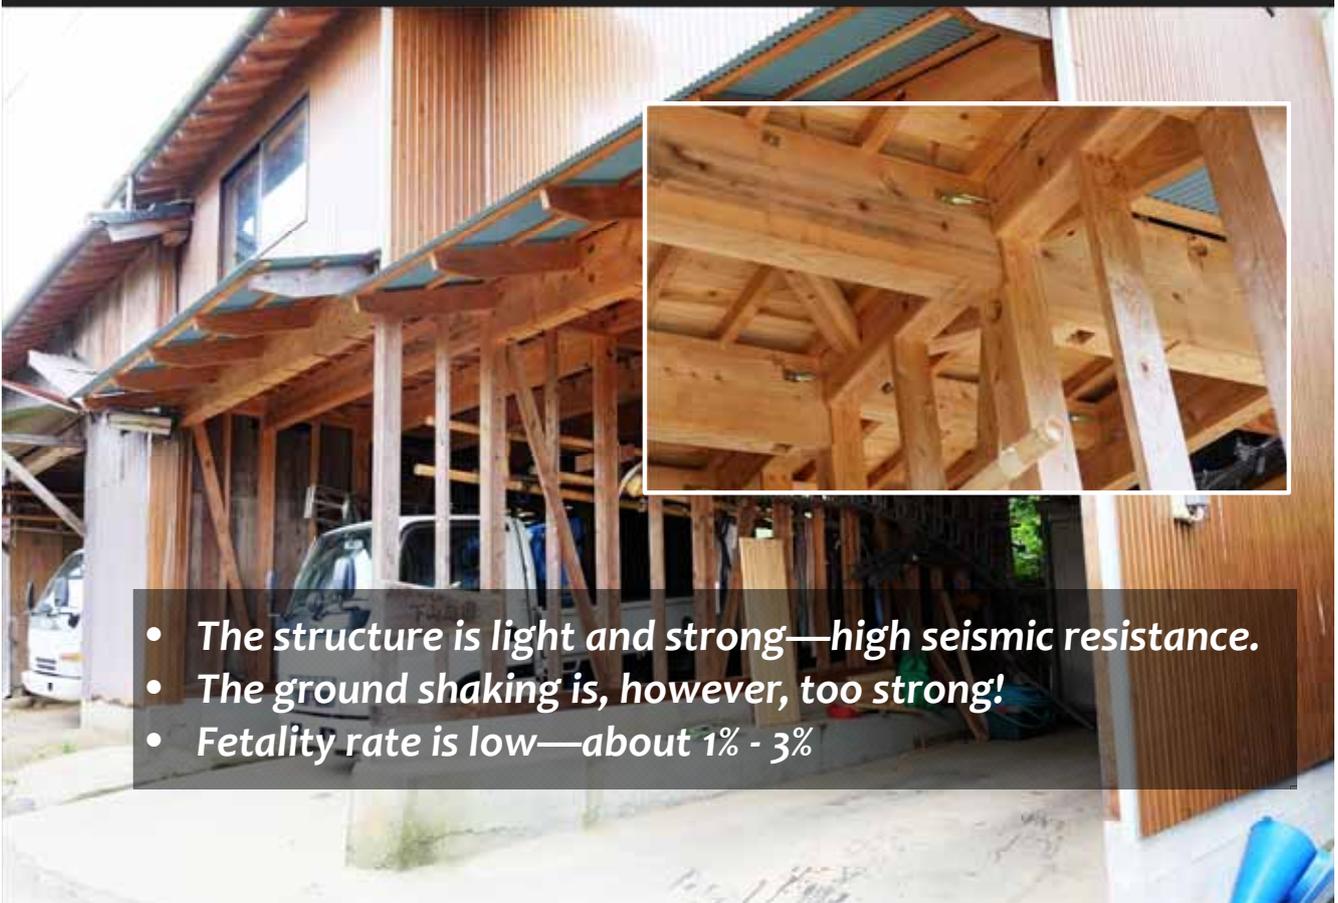
Typical Timber Frame & Wooden Panel of Modern Wooden Houses

- *The structure is light and strong—high seismic resistance.*
- *The ground shaking is, however, too strong!*
- *Fetality rate is low—about 1% - 3%*
