R&D of a multicopter-based inspection robotic system with visual observation and hammering test devices

Principal Investigator Hideki Wada (Shinnippon Nondestructive Inspection Co., Ltd.)

Collaborative Research Groups Nagoya University, Kyushu Institute of Technology, Fukuoka Industrial Technology Center, National Institute of Technology, Kitakyushu College

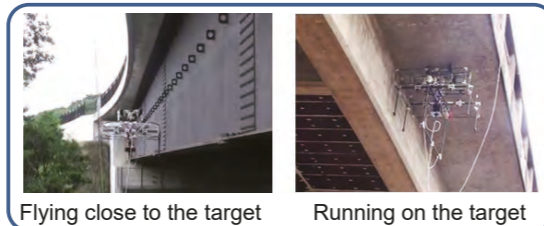
- **Mobility mechanism** with **drones** and **wheels**
- **Inspection** by **visual observation** and **hammering tests**
- **Image** and **sound**-based **abnormal detections**
