J-RAPID Report Symposium for Anak Krakatau volcano eruption and Sunda Strait tsunami

# Field Survey of Anak Krakatau on August 2019

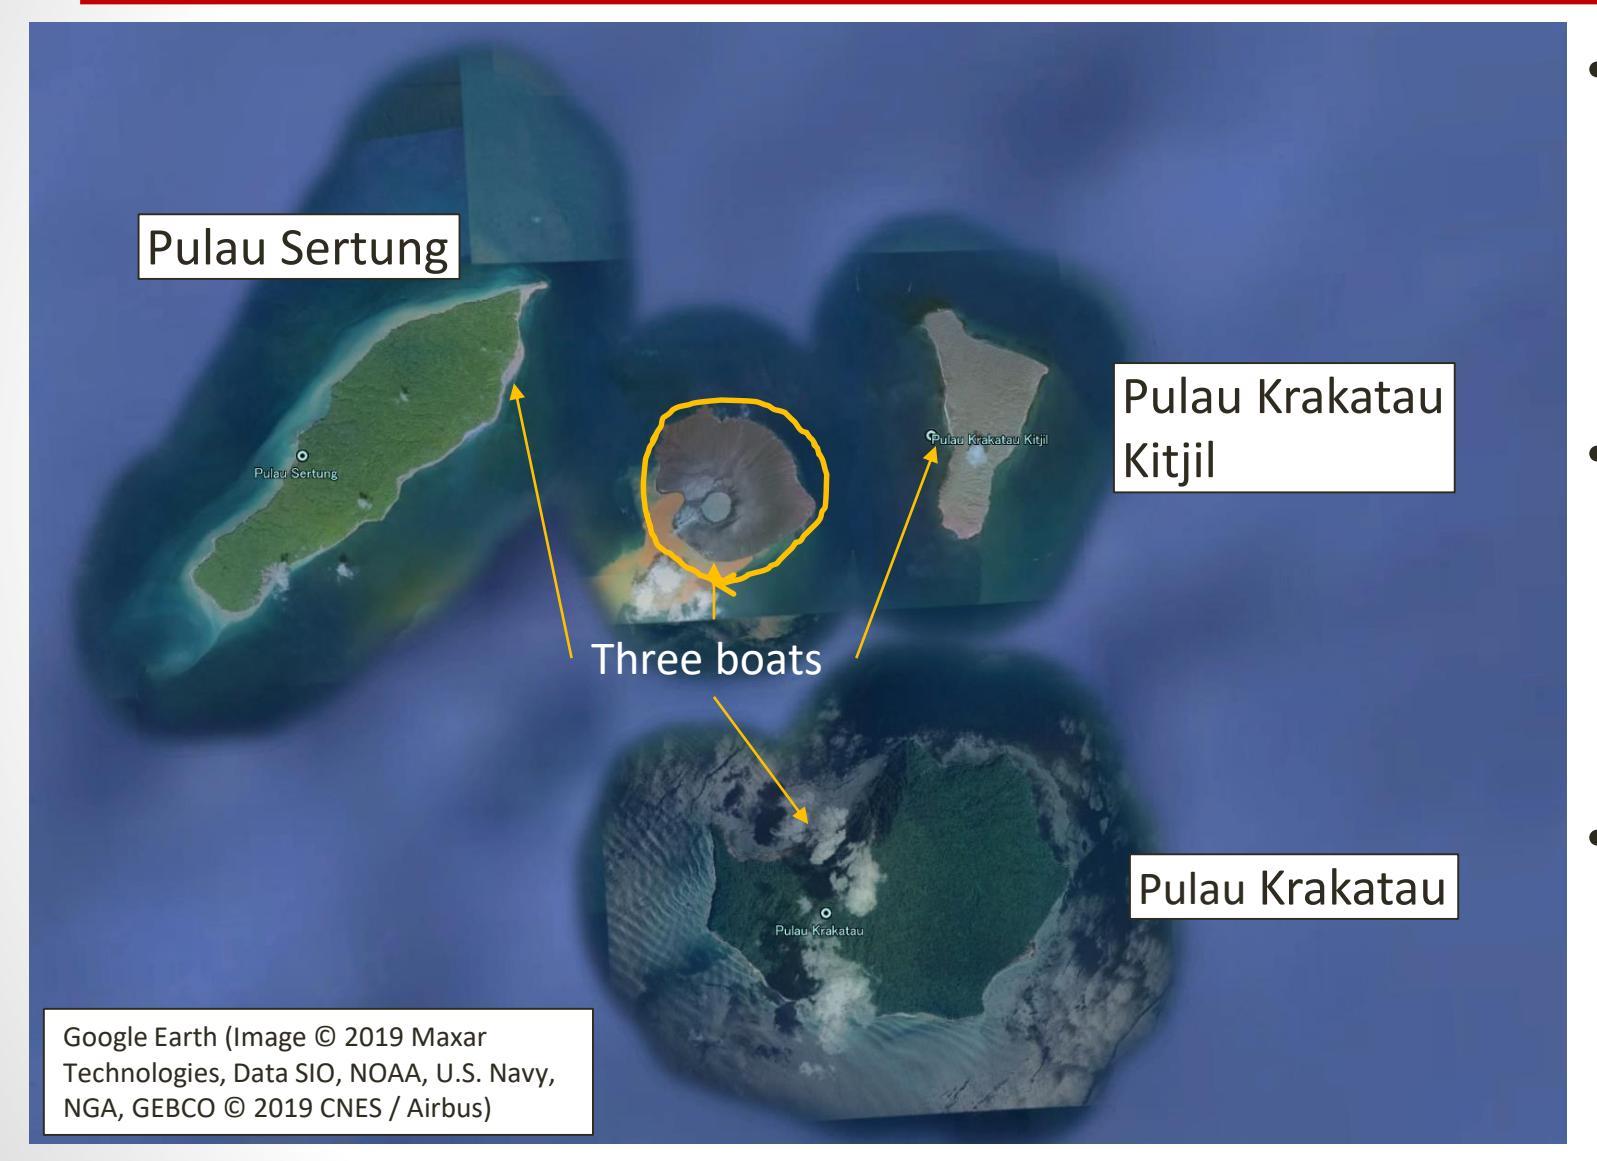
The field survey was conducted
to measure a possible tsunami
height at three Islands which
we landed on from small boat.

- Sonar equipped in main and
  small boat, which went around
  Anak Krakatau many times,
  measured oceanic bathymetry.
- UAV took many pictures of Anak Krakatau to construct digital elevation map by using photogrammetry on Photoscan.

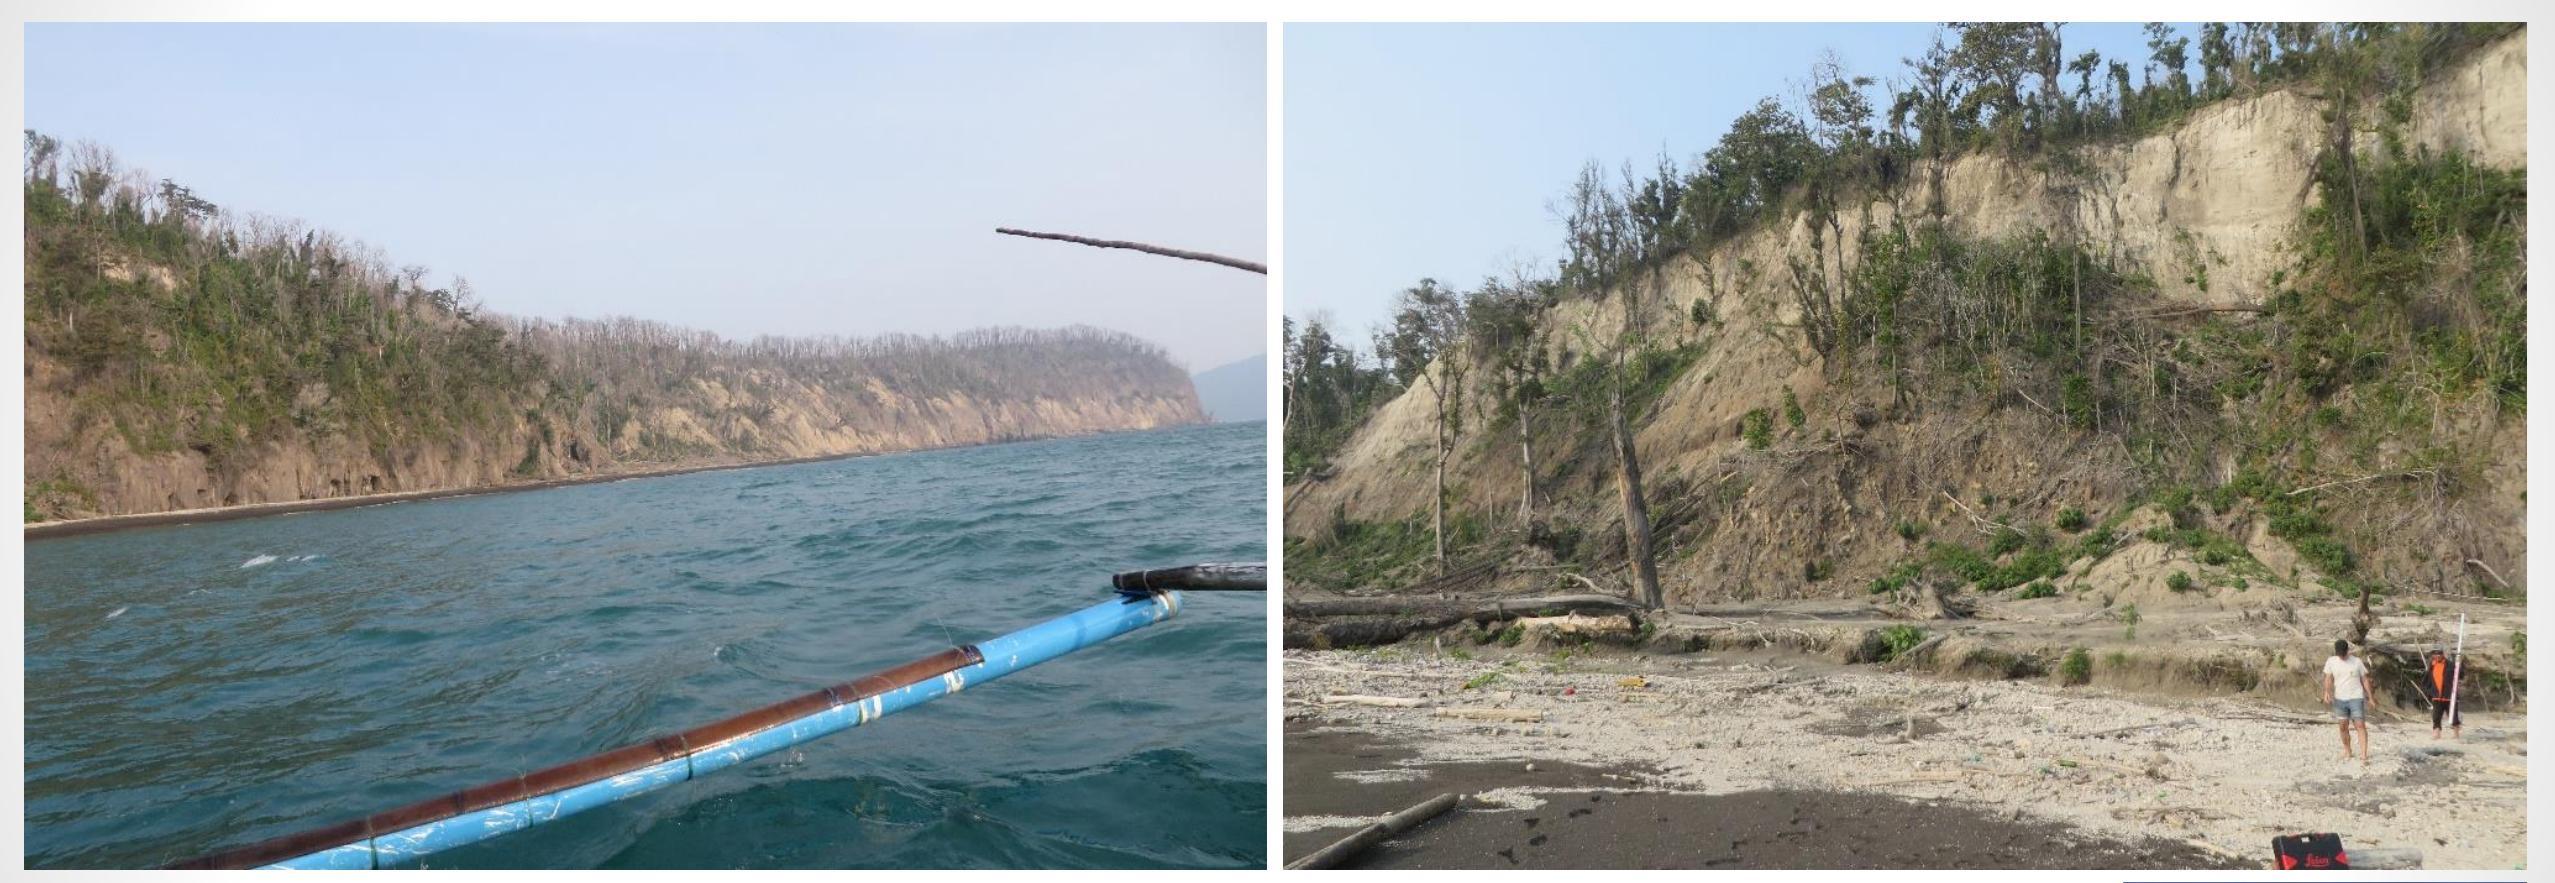
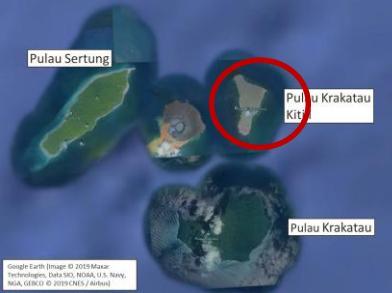
#### Pulau Krakatau Kitjil

- A lot of trees on Pulau Krakatau Kitjil were withered and ground was largely eroded, meaning that generated tsunami apparently attacked this Island.
- We measured a height of tsunami from water level after we landed on some area of this Island.

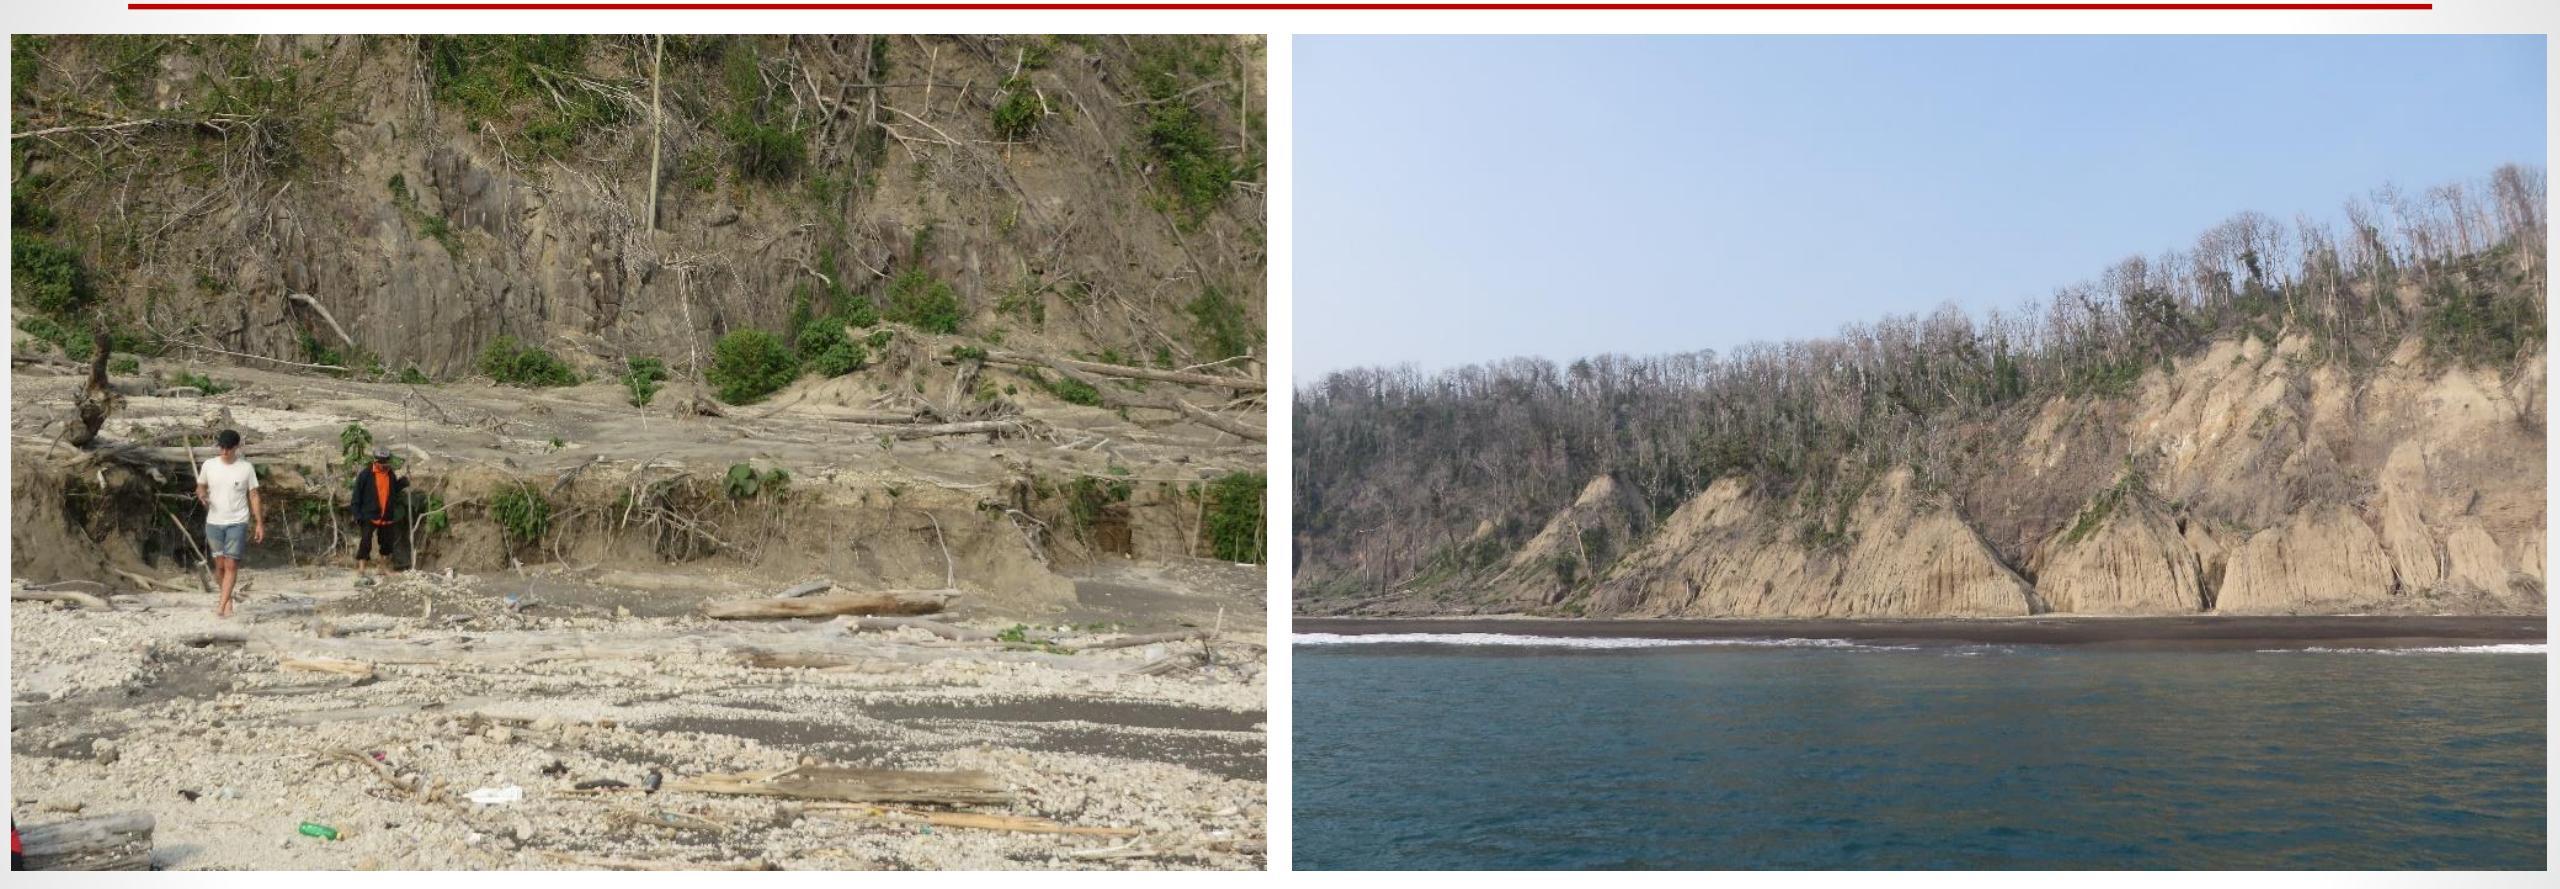
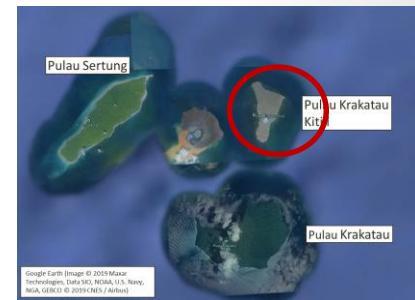
#### Pulau Krakatau Kitjil

- In other parts, a lot of trees on Pulau Krakatau Kitjil were withered and ground was largely eroded as well.
- There is a still controversial, however, tsunami was probably run-upped and overtopped this Island. If so, possible tsunami height was over 80 m.

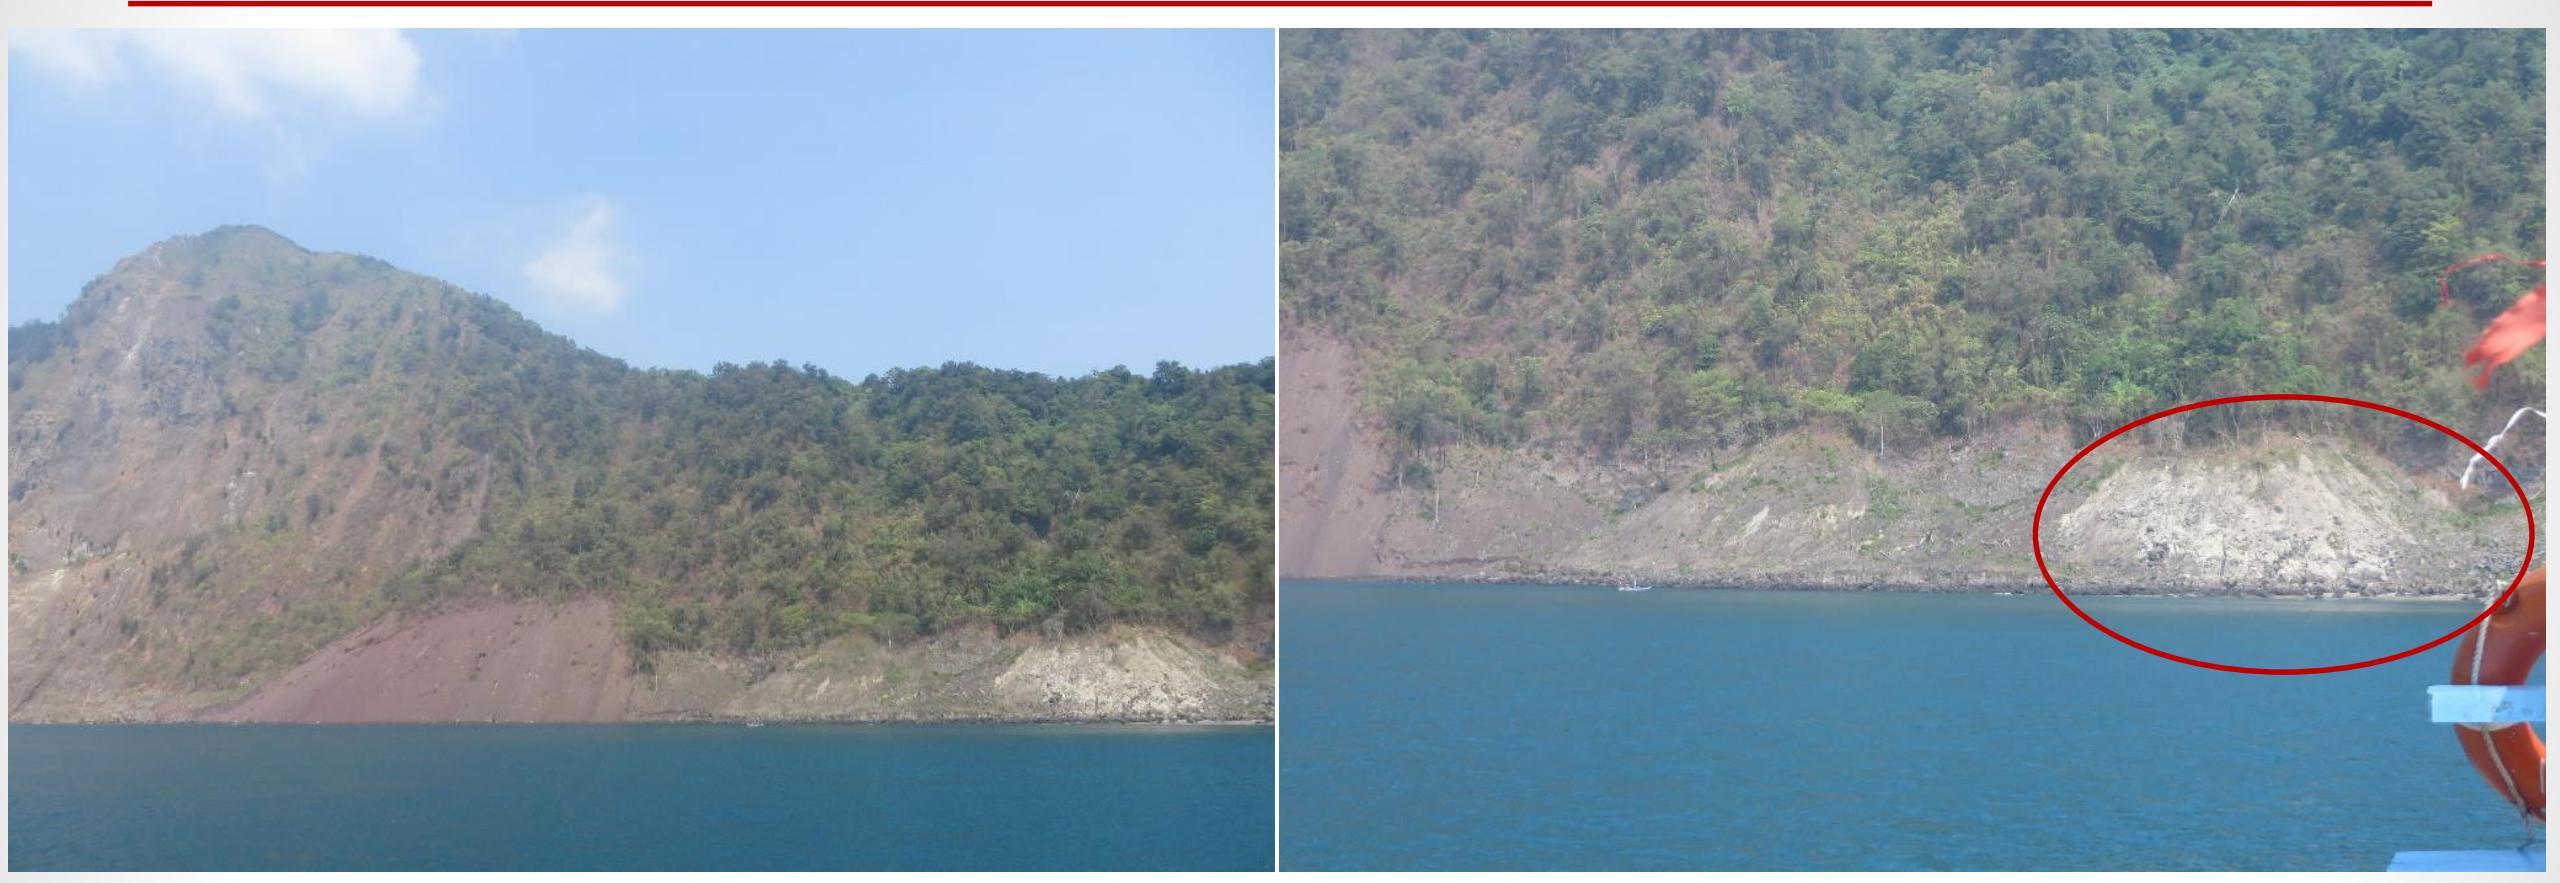
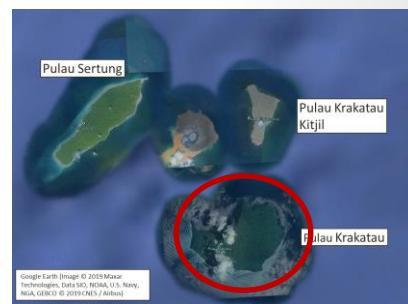
#### Pulau Krakatau

- Severe erosion was observed at Pulau Krakatau as well. In addition, trees were withered in low ground elevation area.
- Tsunami probably reached a boundary between bare ground and trees planted area. Its height was approximately 50 m.

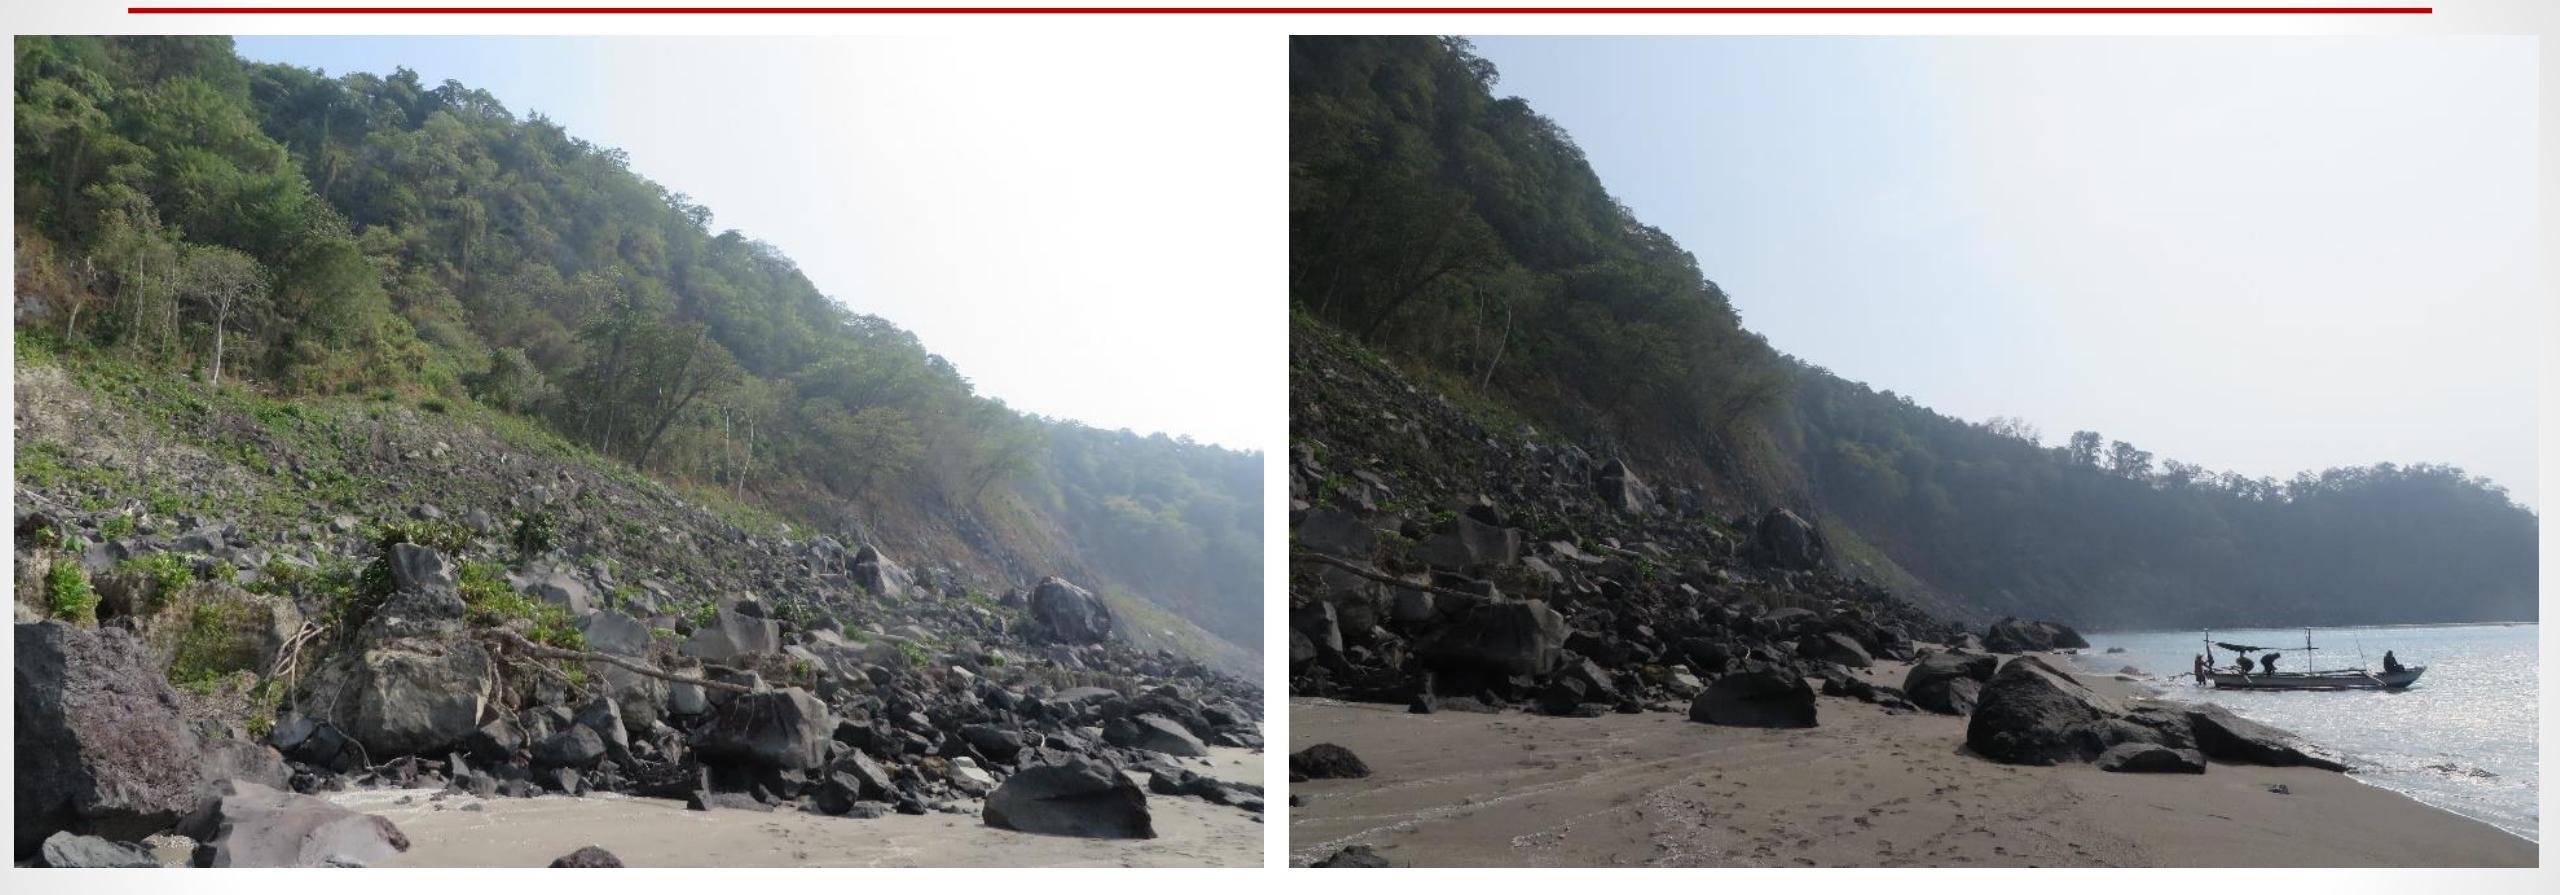
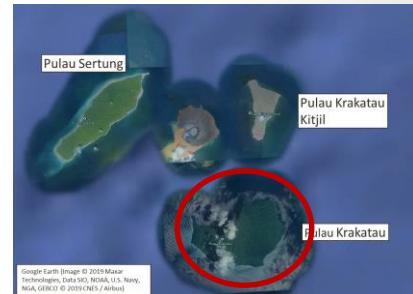
#### Pulau Krakatau (from side angle)

- From side angle, it can be observed that a lot of gravel were scattered near coastal area, but were concentrated in some part.
- We can recognize a clear boundary between with and without trees.

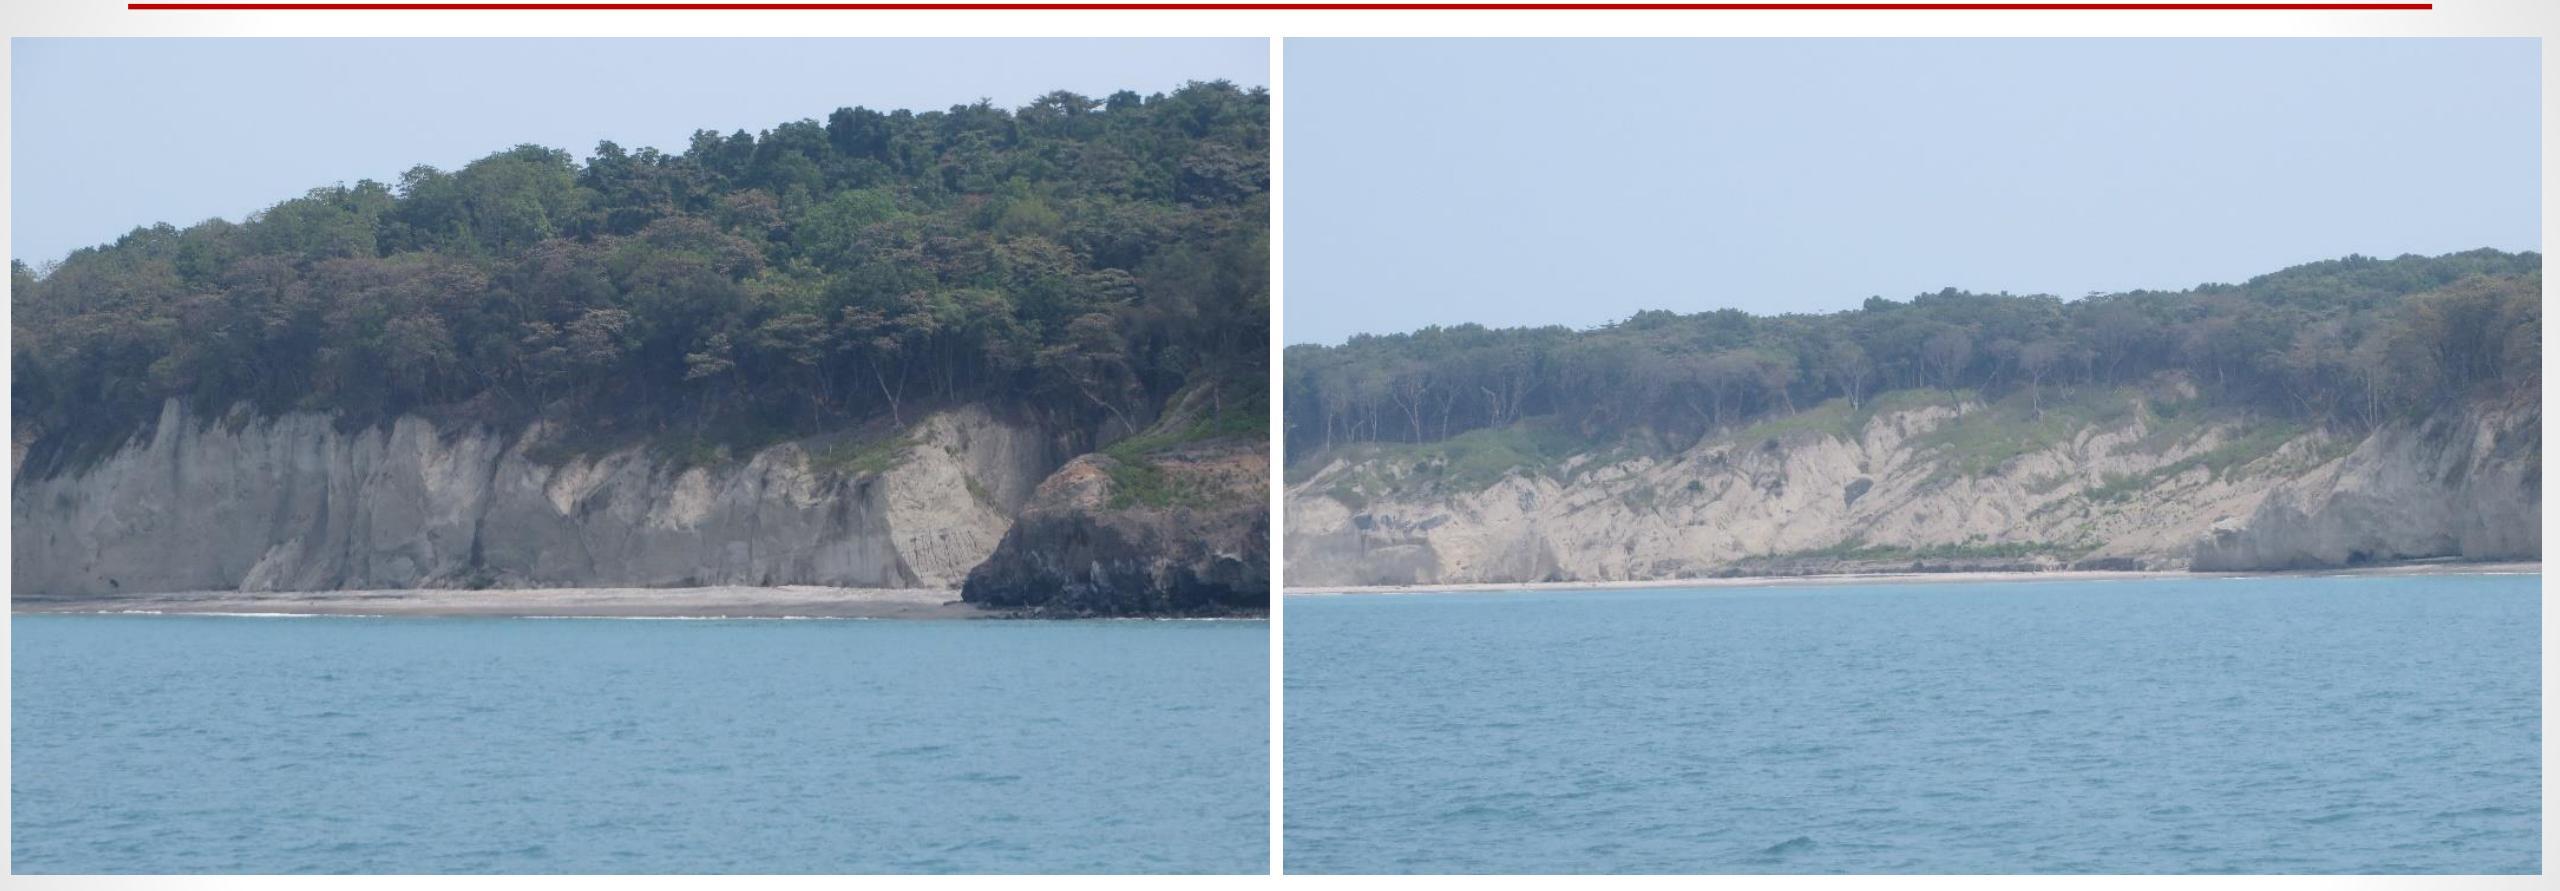
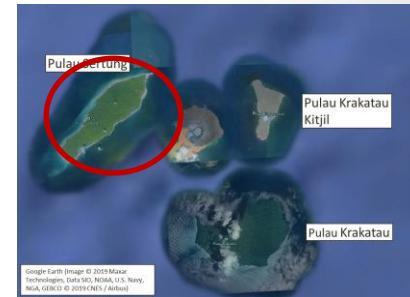
#### Pulau Sertung

- The severe erosion was observed at Pulau Sertung as well. The trees probably disappeared in the front area meeting Anak Krakatau.
- A possible tsunami height was nearly 40 m, if the tsunami height was equal to the boundary.

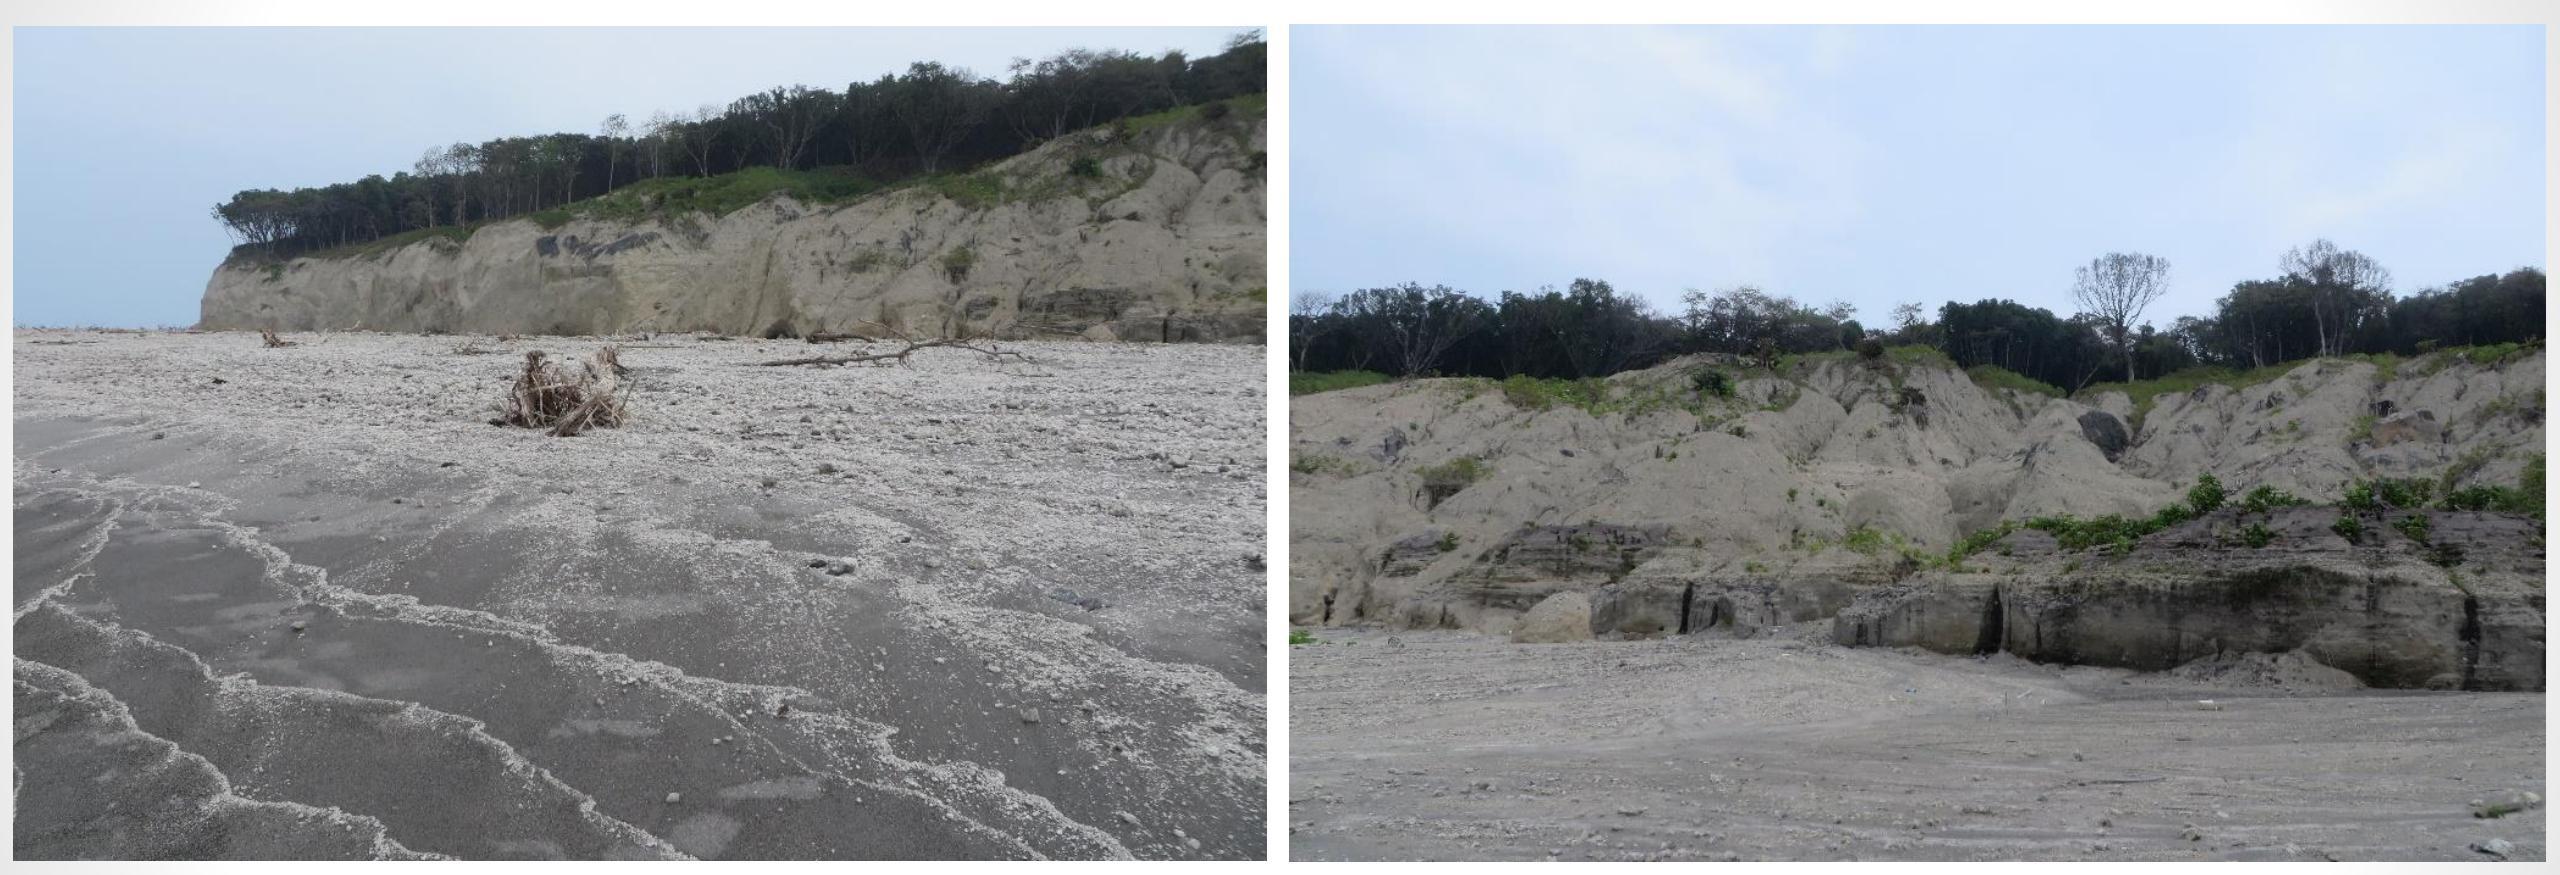
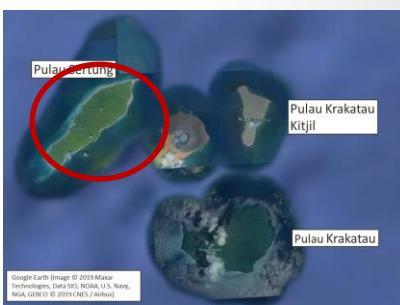
#### Pulau Sertung

- The severe erosion could be observed in other area of Pulau Sertung.
- The cliff was also existed in the front area of Pulau Sertung, meeting Anak Krakatau.

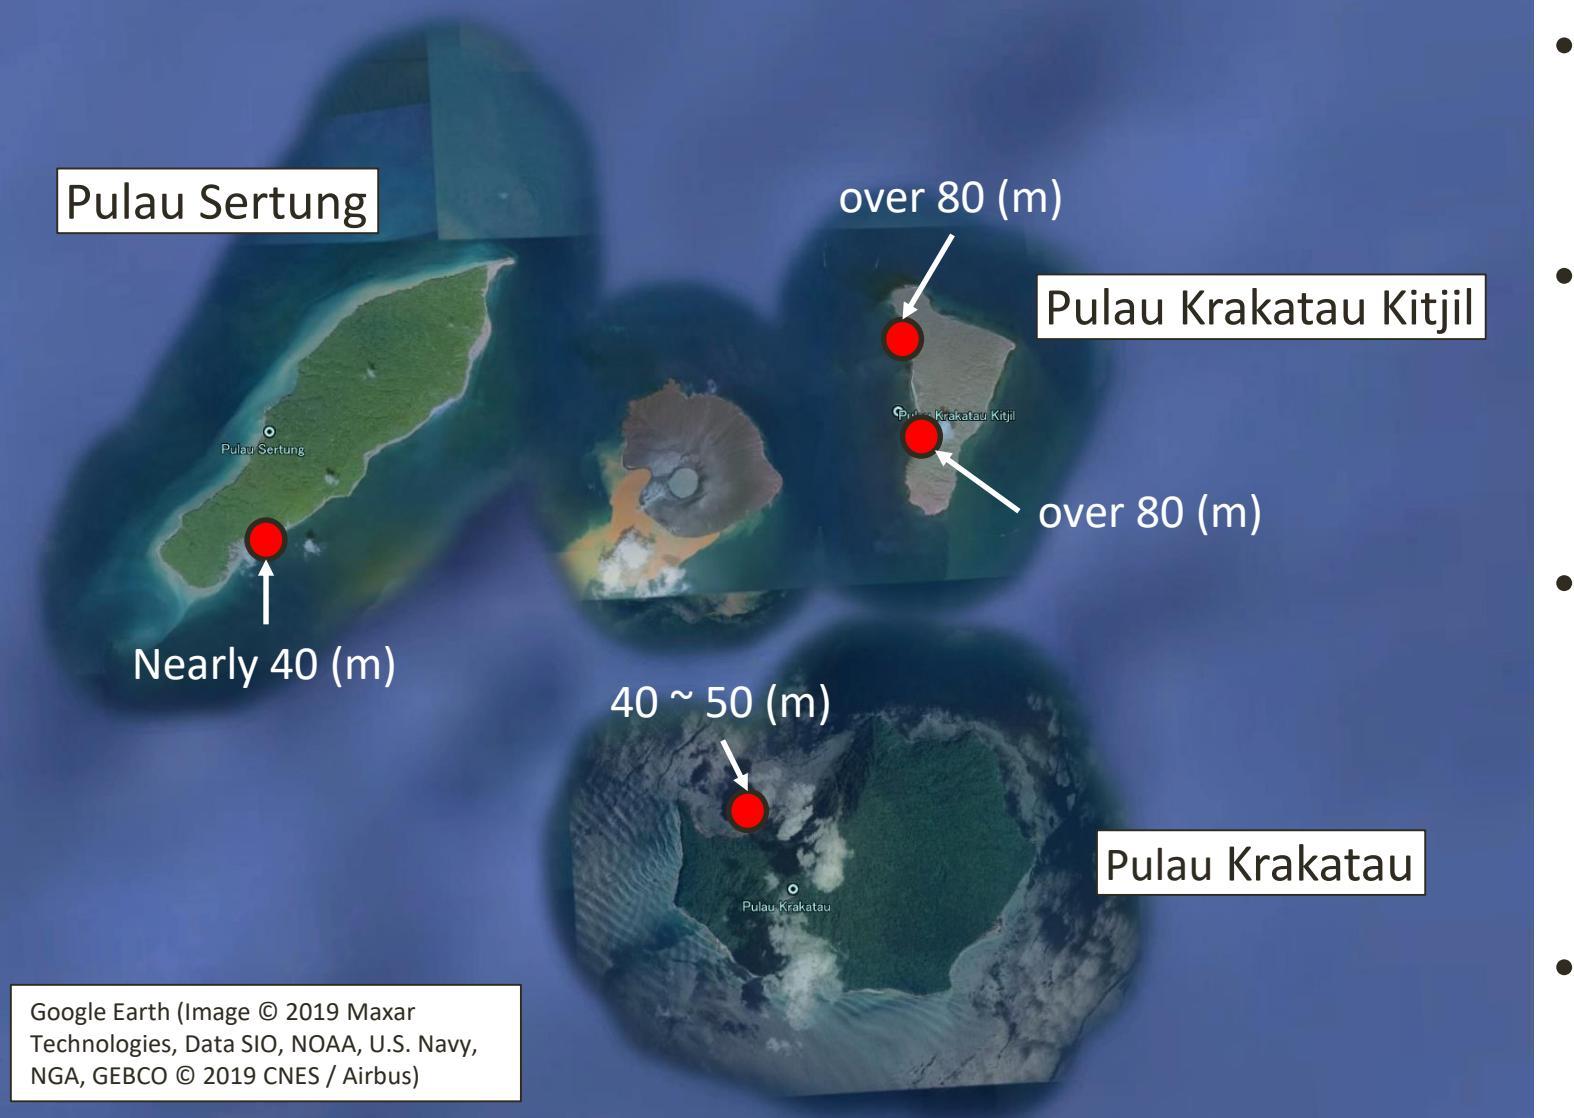
### Tsunami Height at Three Islands

- It should be noted that tsunami height was roughly measured.
- The possible tsunami height at Pulau Sertung and Pulau Krakatau ranges from 40 ~ 50 m.
- At Pulau Krakatau Kitjil, where tsunami was expected to be overtopped, a possible tsunami height was nearly 80 m.
- There can be still discussions regarding the tsunami heights.

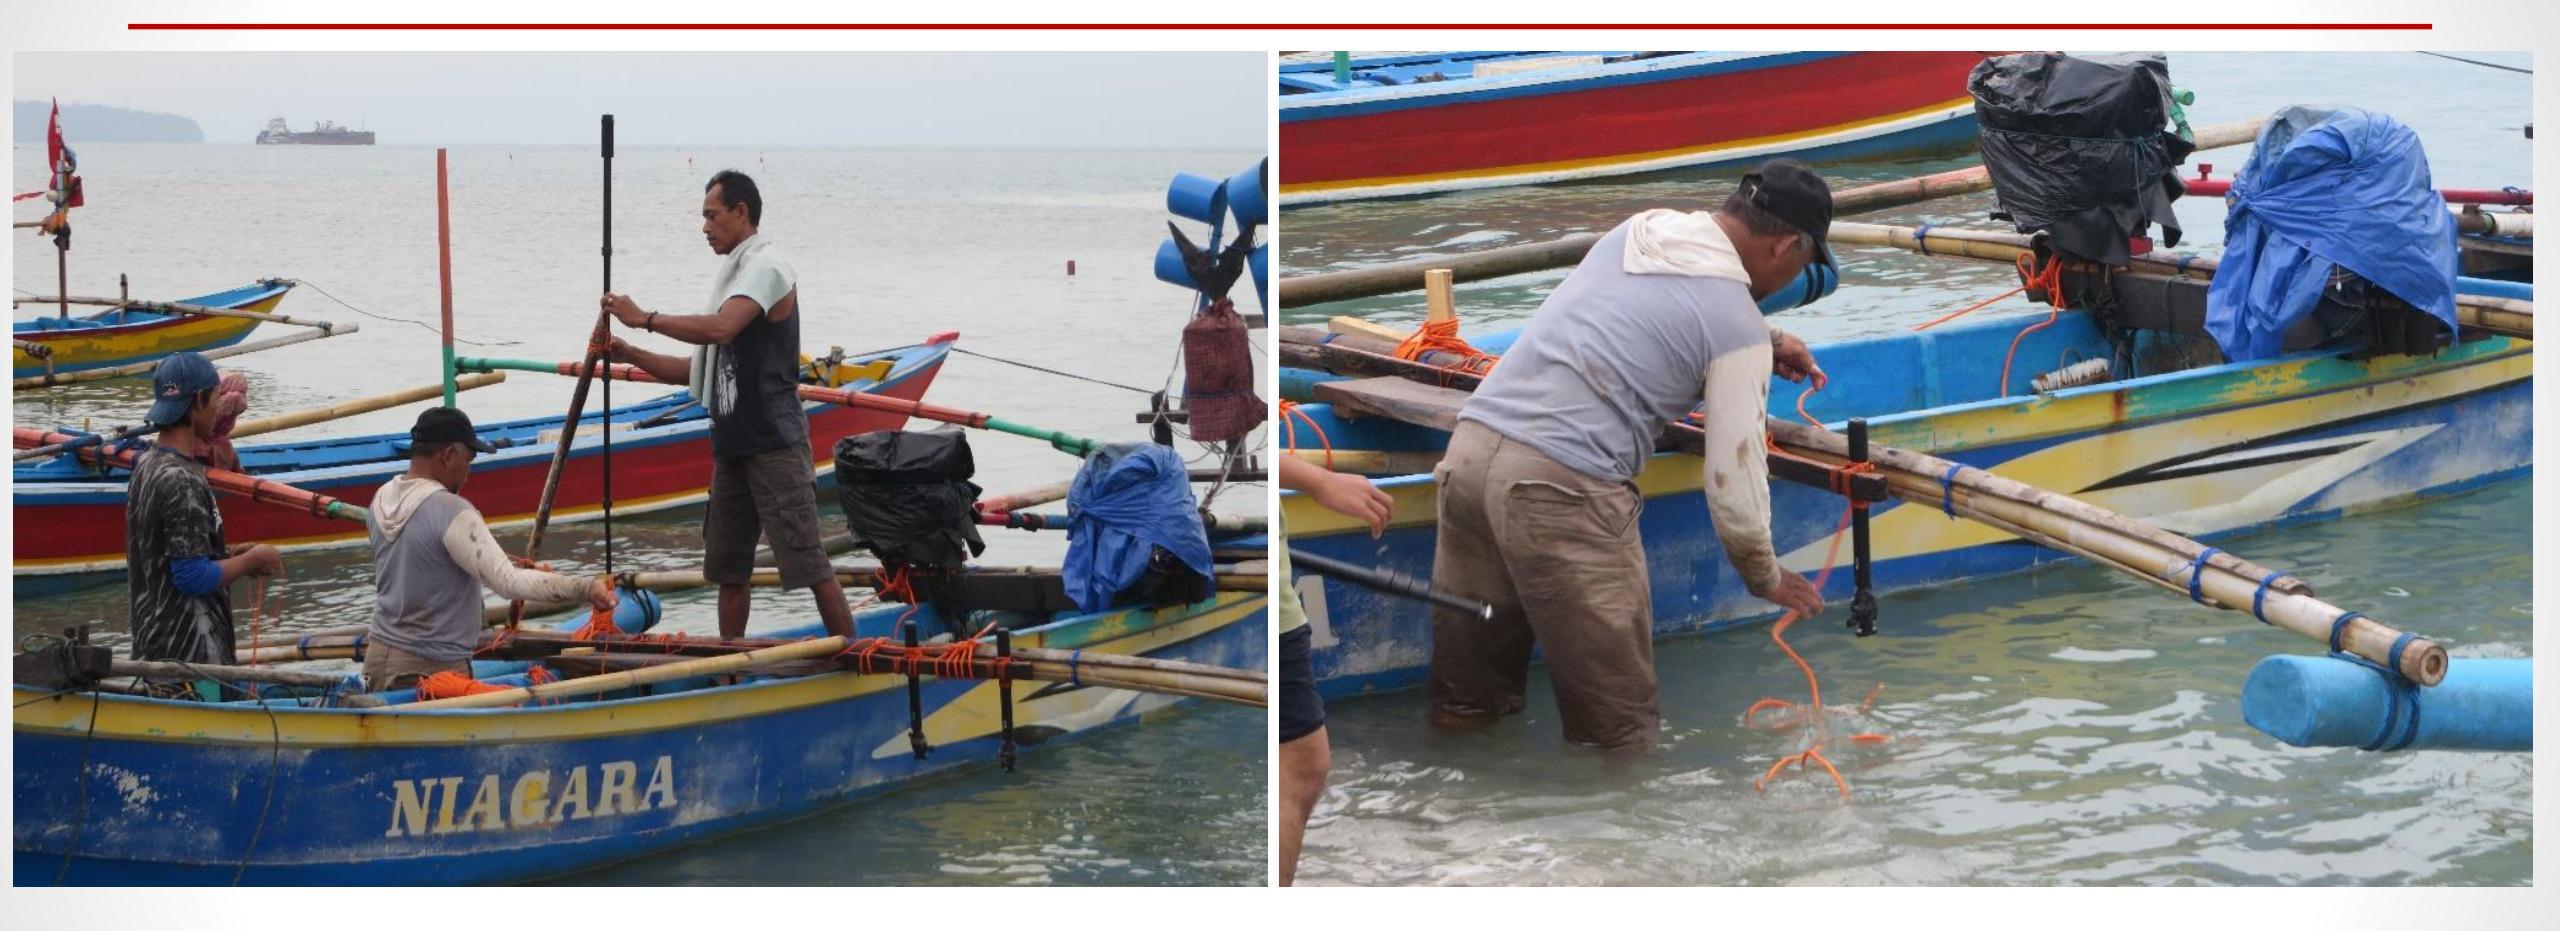
#### **Bathymetric Survey**

- The pictures show a scene when we attached Garmin's sonar to small boat.
- The bathymetric survey was conducted by using a small boat and the main boat to measure bathymetry and estimate its changes due to eruption of Anak Krakatau.

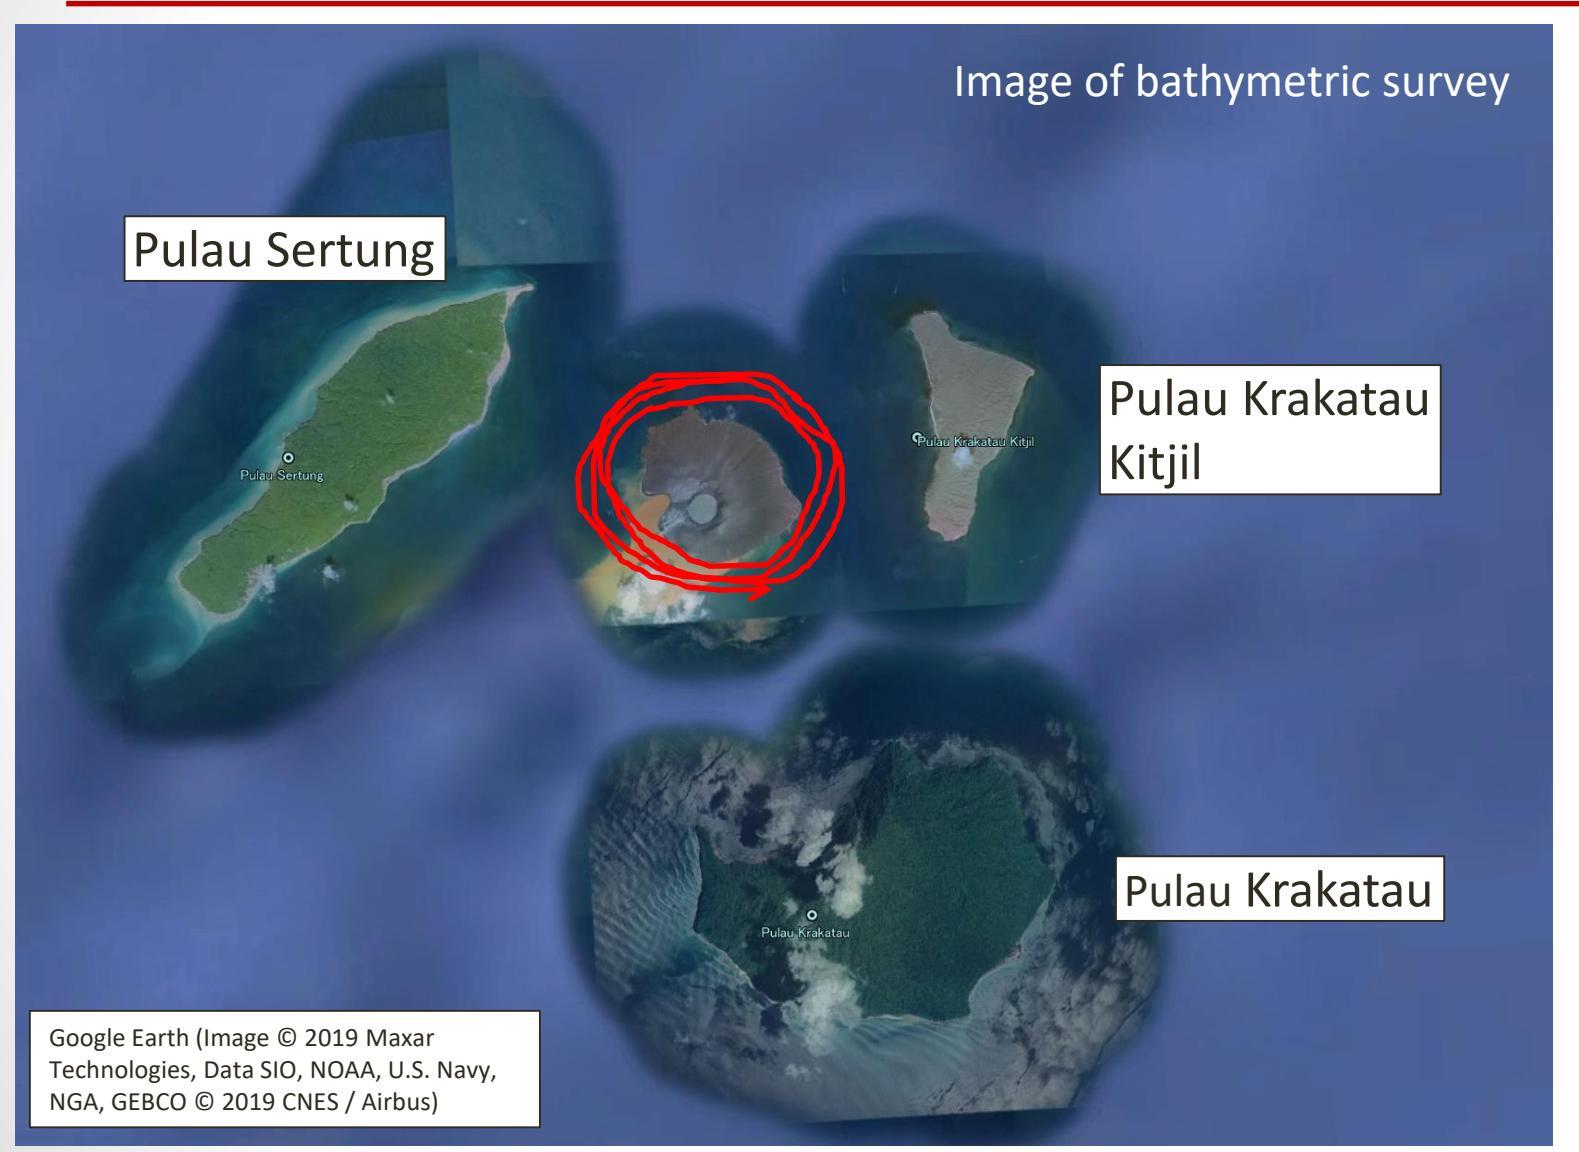
### **Bathymetric Survey**

- The bathymetric survey was conducted around the Anak Krakatau.
- We went around Anak Krakatau many times in order to obtain dense bathymetric map and to find out the bathymetric changes associated with volcanic eruption.
- The results of bathymetric survey have been now under analysis.
