J-RAPID Report Symposium for Anak Krakatau volcano eruption and Sunda Strait tsunami

# Field Survey of Anak Krakatau on August 2019

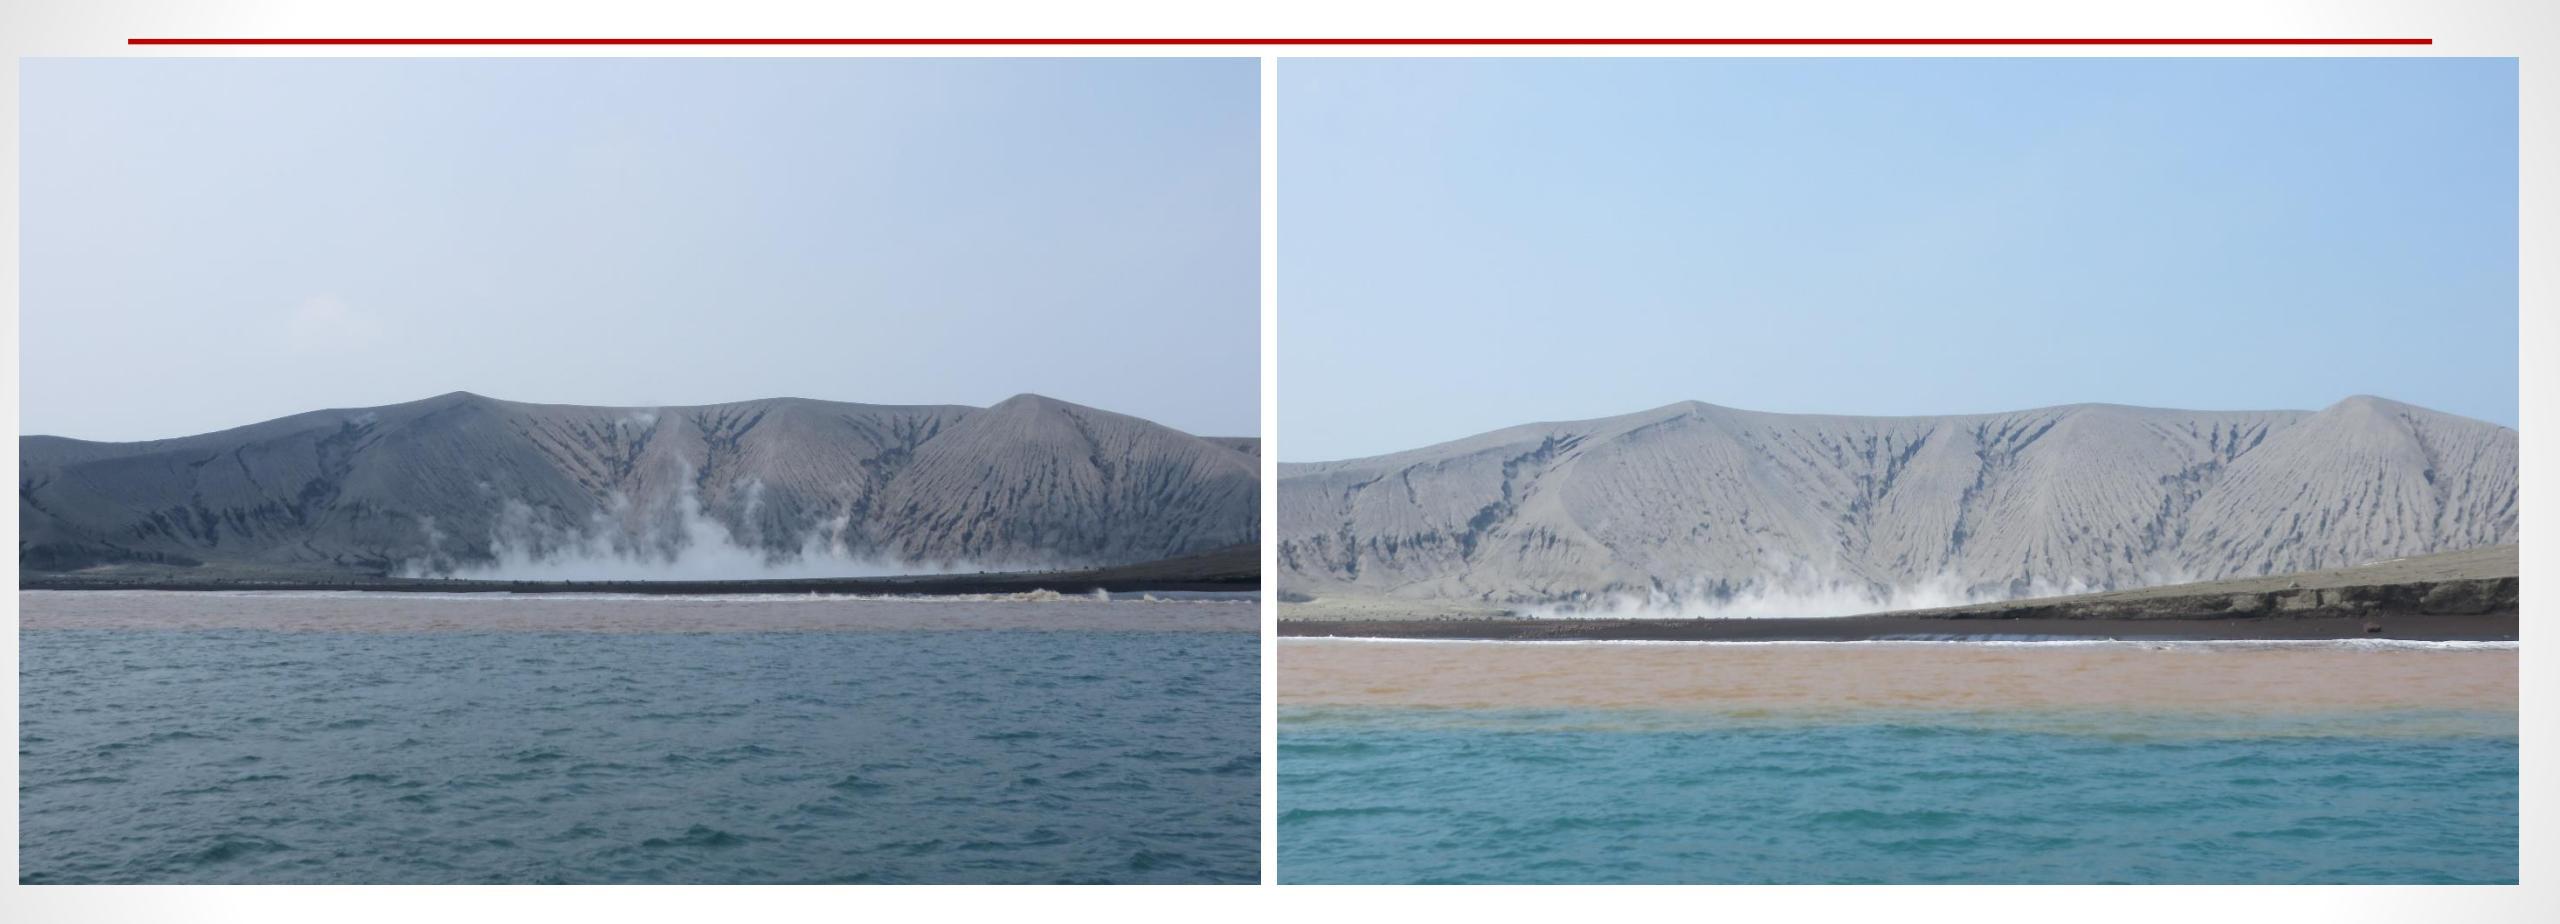
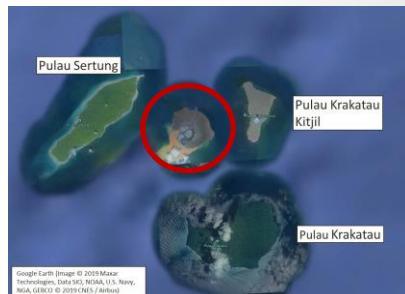
#### Anak Krakatau

- Caldera of Anak Krakatau was still active and release gas (there was a smell of sulfur compounds).
- Cloudy sea water (including sediments flowed from Anak Kratatau) was observed near Anak Krakatau. This can be also recognized from Google Earth.

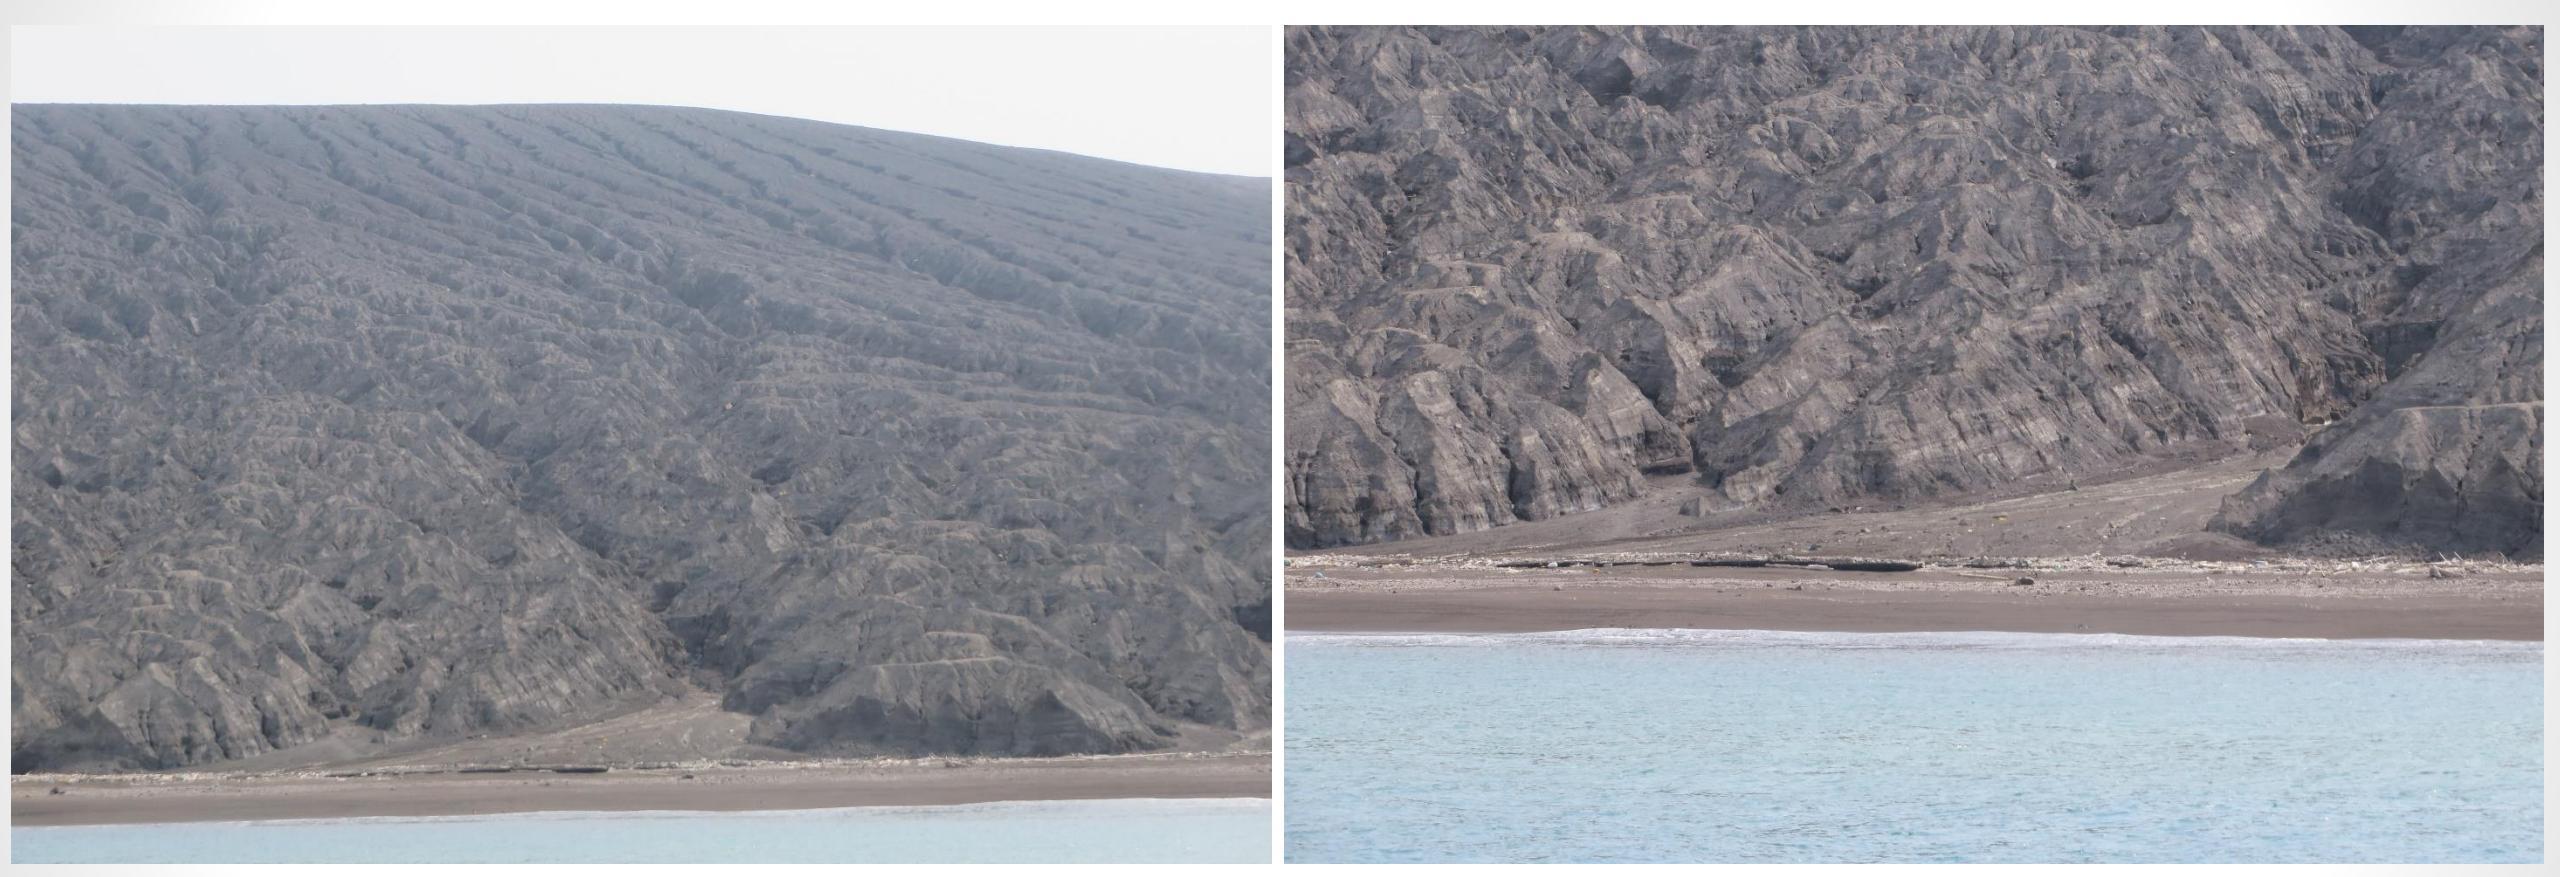
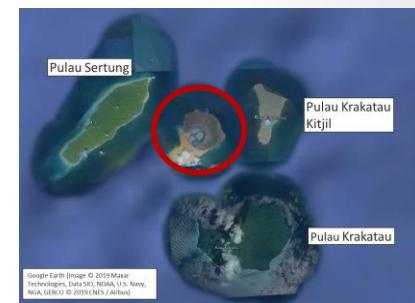
#### Anak Krakatau

- Surface feature of the Anak Krakatau was rough and solid probably as a result of lava flow and collapse of mountain.
- There were a lot of small cliffs and hill which height were roughly below 5-10 m, which could be found when we climbed up Anak Kratatau.

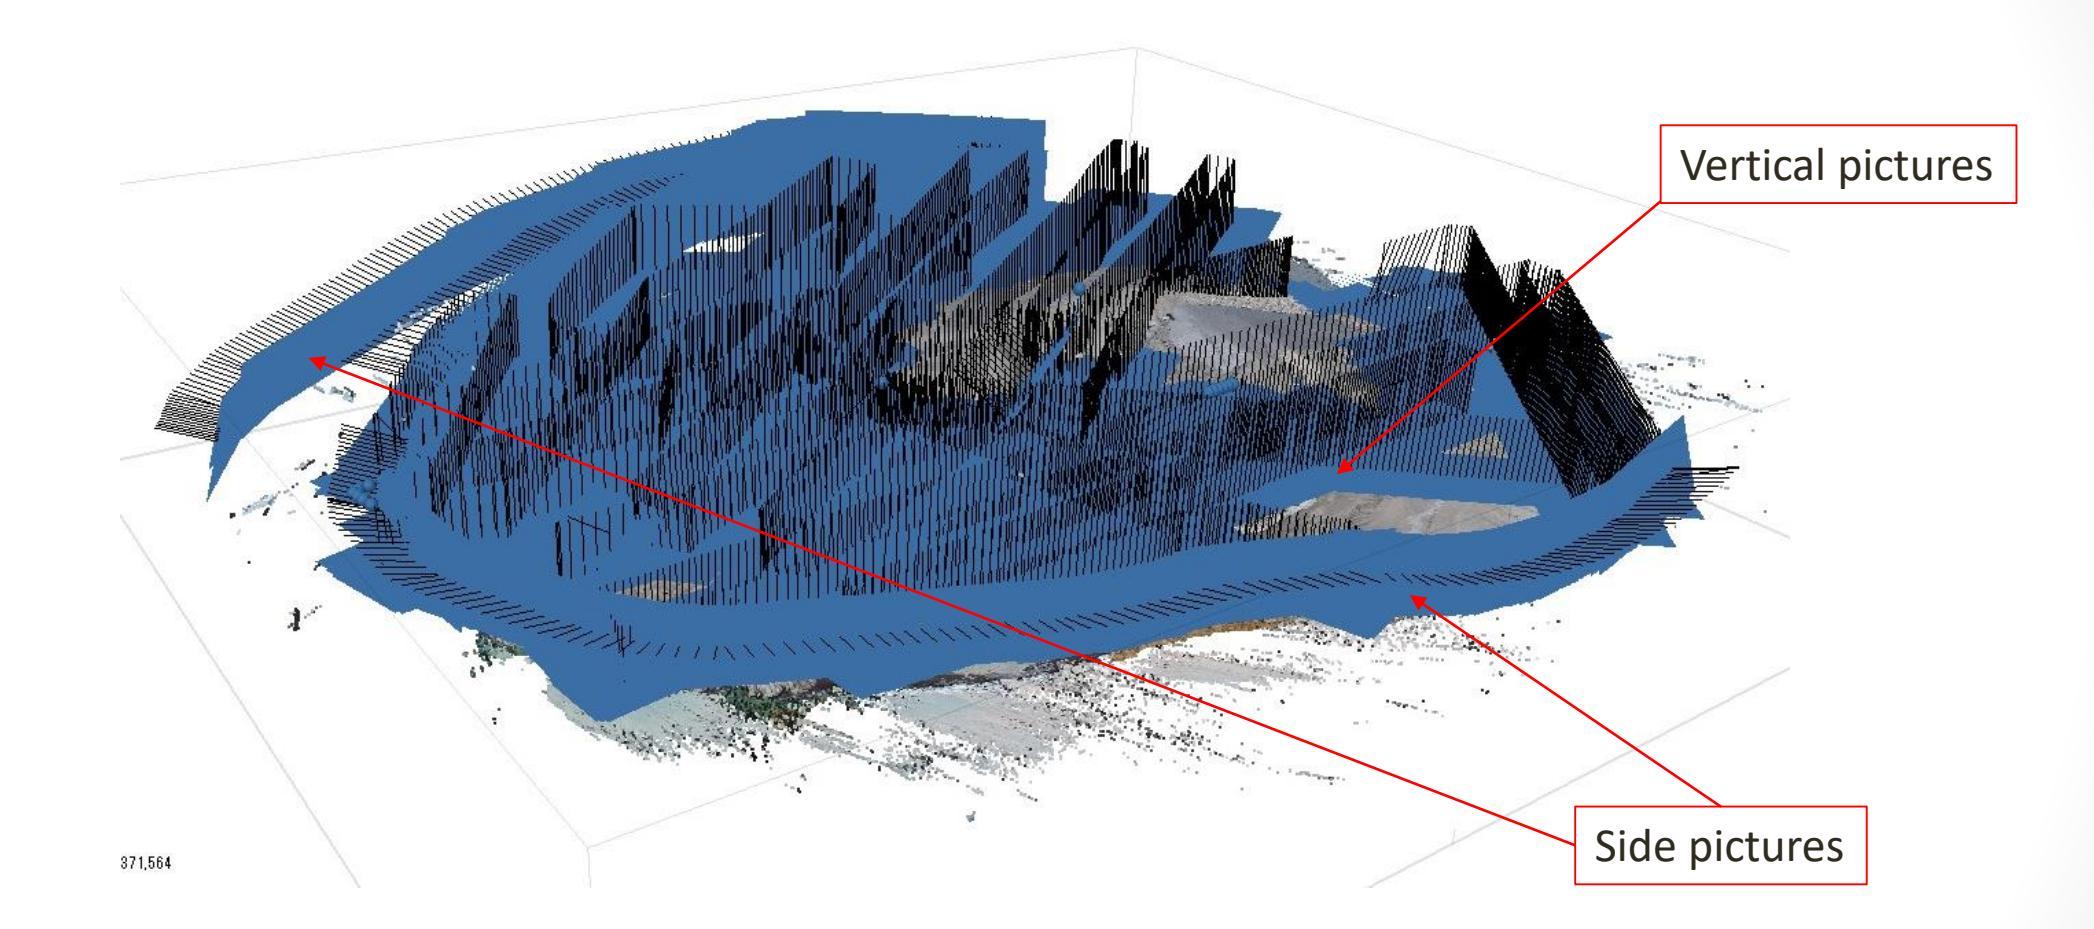
#### Process on photogrammetry

- Flight covers almost all area of Anak Krakatau. The slide view pictures of Anak Krakatau were included in order to construct DEM with high precision.
- Photoscan was used to create the DEM.

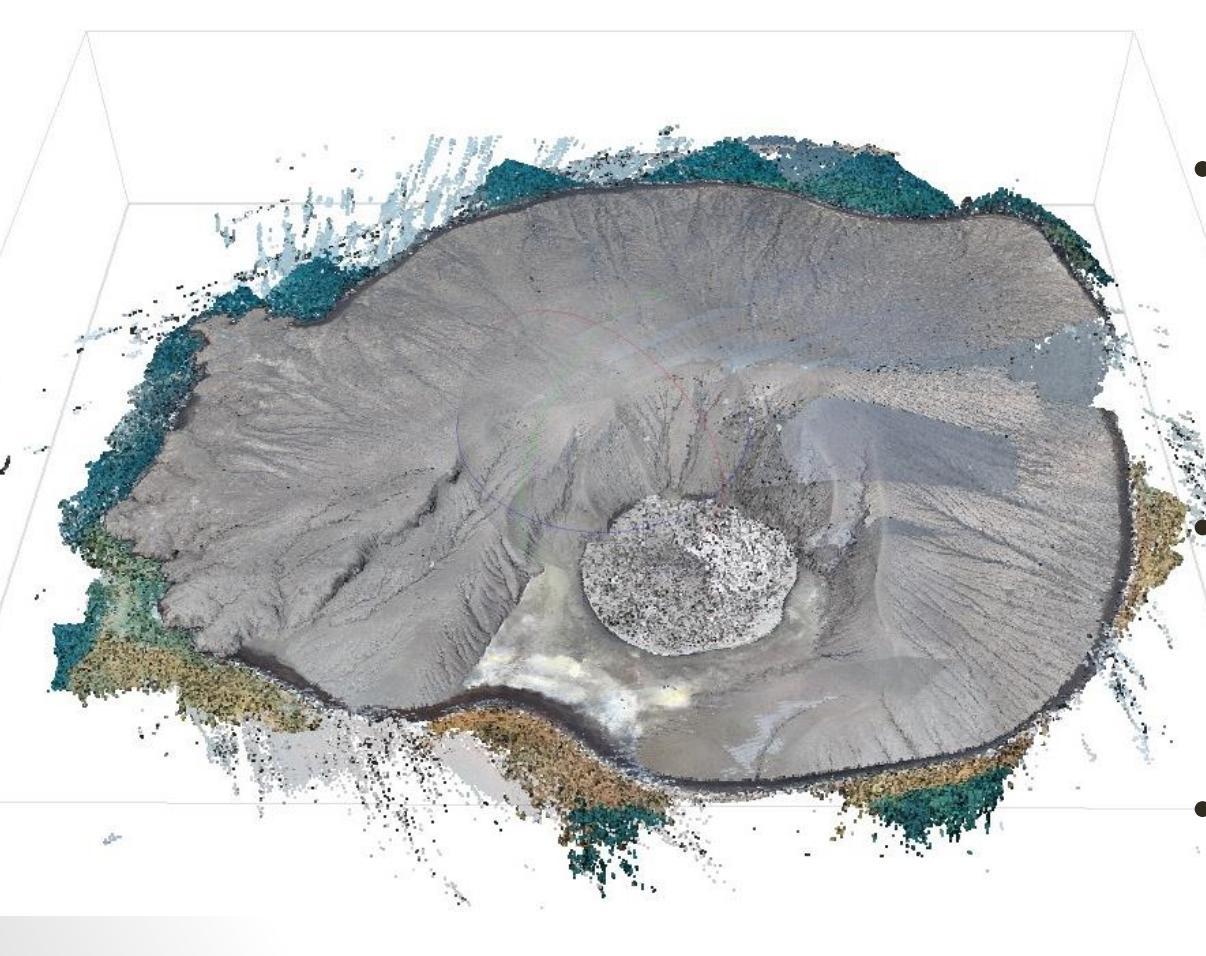
### Result of photogrammetry

- Left figure is a result of photogrammetry by using UAV pictures on Photoscan.
  - It can be obviously understood that caldera was created in Anak Krakatau after eruption. It is consistent with other researches and image on Google Earth.

In the front of caldera, flat ground area spreads. The color of this area was yellow probably because of including some sulfur compounds.

According to the DEM, maximum height was nearly 160 m, which can be somewhat agreement with 157 m from indication by the information of LCDV Tous Droits Réservé (2019).
