Current Accomplishments (2/2)

Achievements

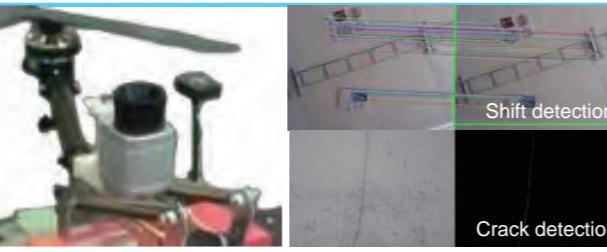
The camera unit enables to acquire the shift of the copter and senses crack by image processing. Quantitative analysis makes crack detection more

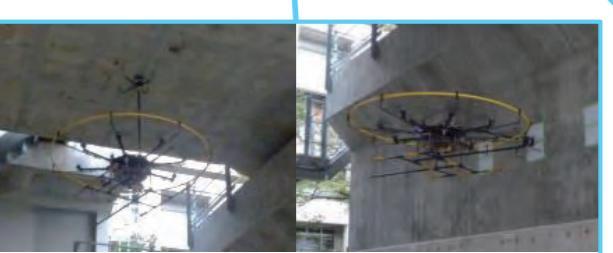
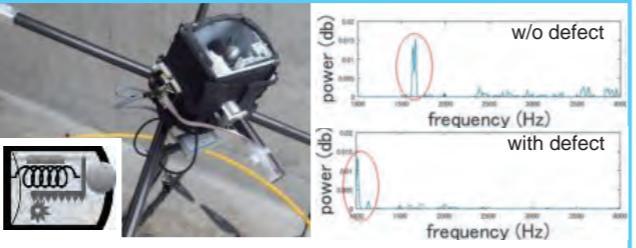
The hammering unit hammers object surfaces and is driven by a motor and a spring. The echo is captured using a microphone and is analyzed to see if there are defects. Quantitative analysis makes defect detection more precise.

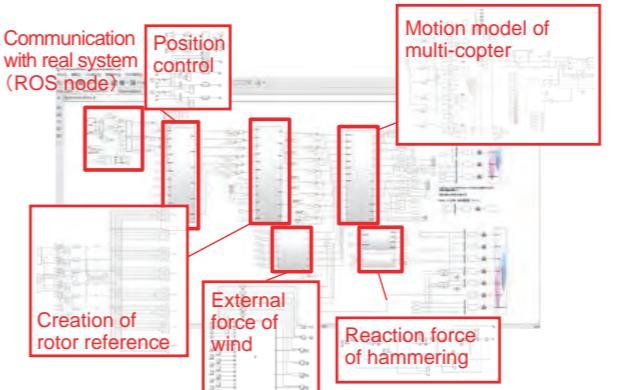
The motion simulator of the multi-copter accelerates R&D of the multi-copter system.
