# Investigation of wind damage processes by Typhoon Yolanda, identification of effective damage reduction measures, and its facilitation to recovery work

Japan–Philippine Urgent Collaborative Projects  
regarding “Typhoon Yolanda” within the J–RAPID Program

# Aim of the project

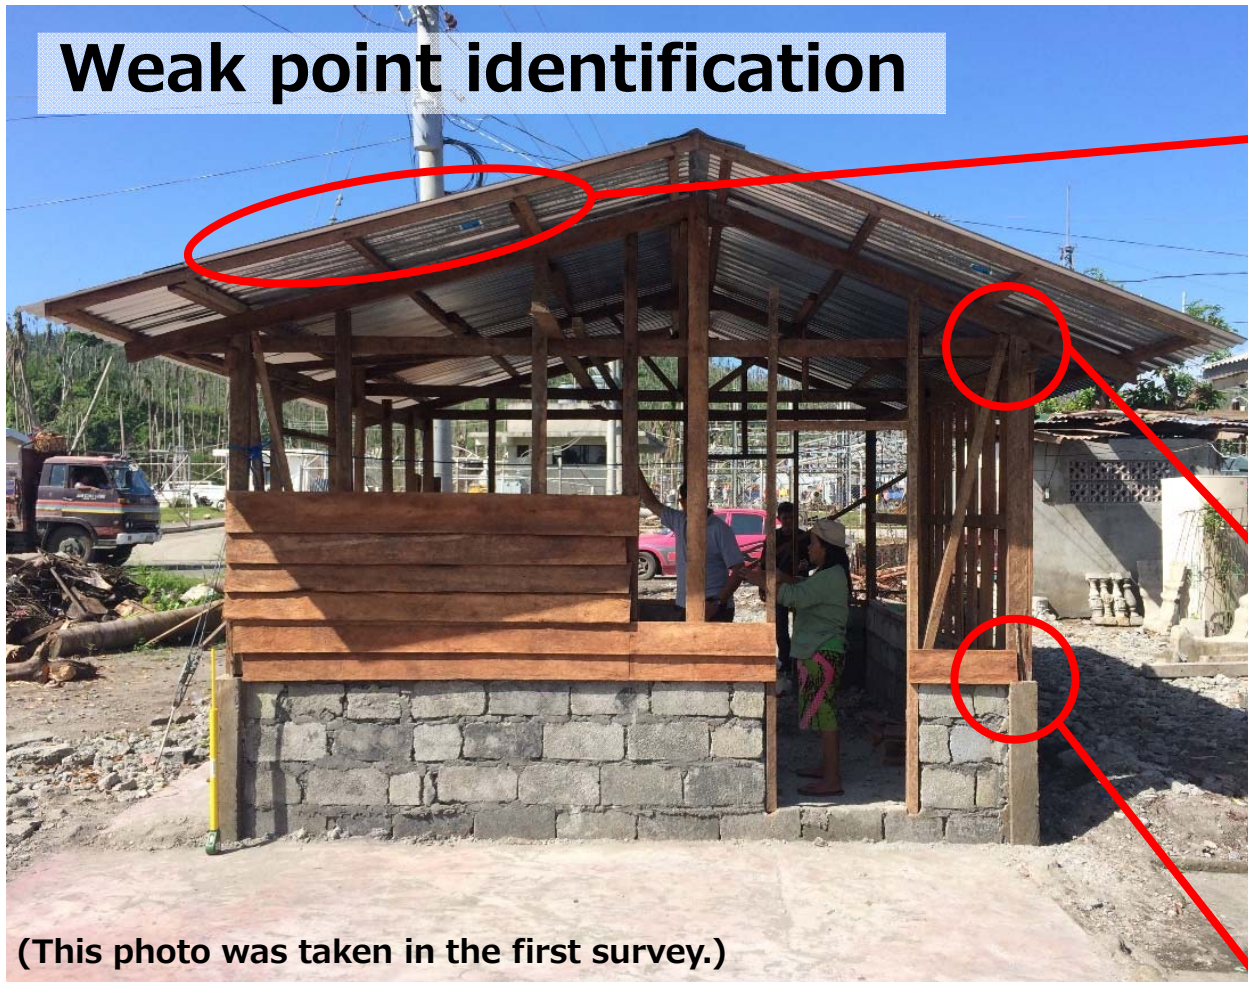
## Weak point identification

(This photo was taken in the first survey.)

- Roof covering
- Roof-column connection
- Column-foundation connection

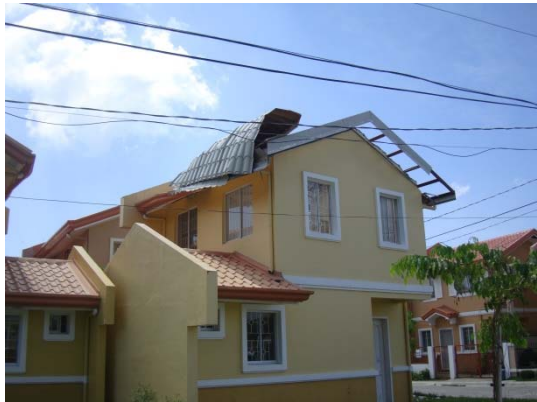
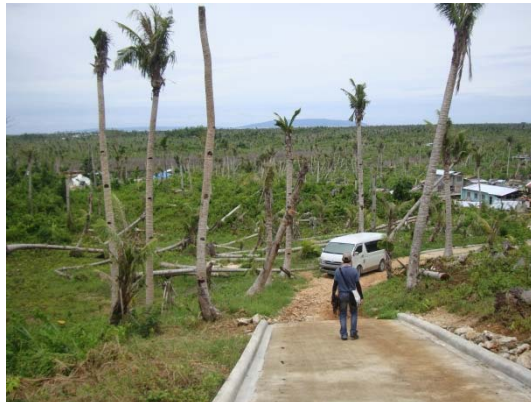
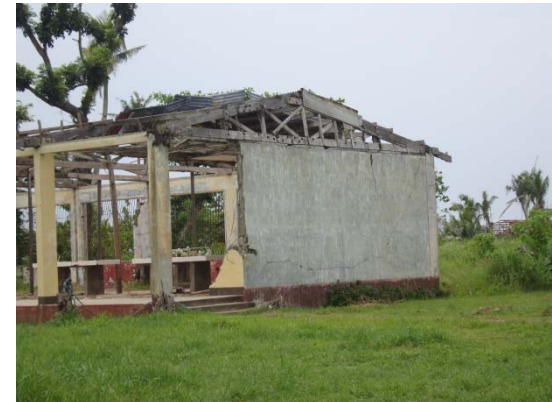
- o Assessment on the types of damage incurred on the architecture and structure of selected residential and school buildings by Typhoon Yolanda.

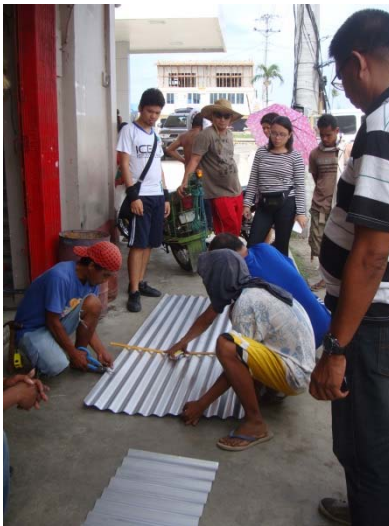
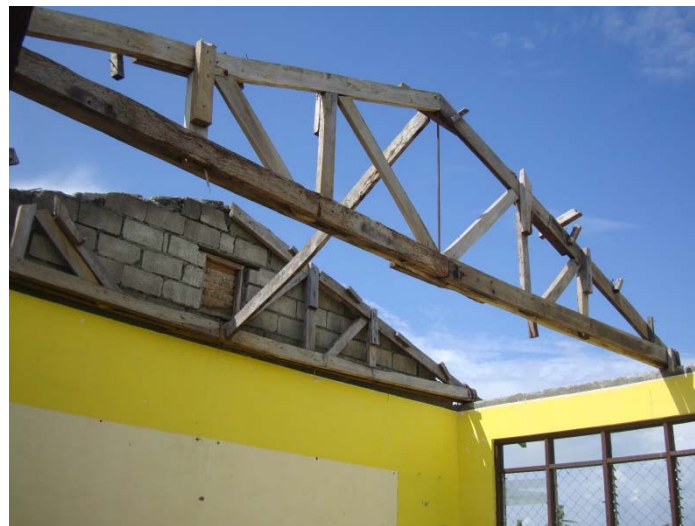
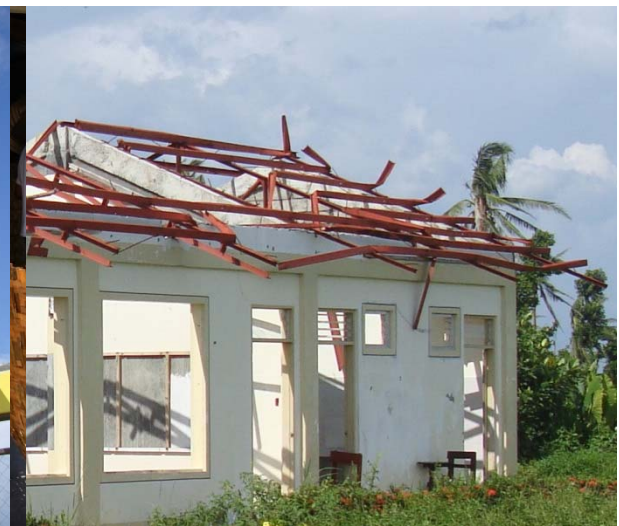
- o Assessment on the role of materials and construction methods of the surveyed buildings in the failure to withstand typhoon stress.
