Final Workshop on J-RAPID-Nepal
June 21st and 22st, 2016

Re-evaluation of seismic vulnerability on historic structures based on damage investigation of the 2015 Nepal earthquake and proposal of retrofitting methods (Research period: 2015.07~2016.06)

Final Workshop on J – RAPID – Nepal
June 21st and 22nd, 2016

Damages of Historical Structures Strengthening/Retrofitting Techniques

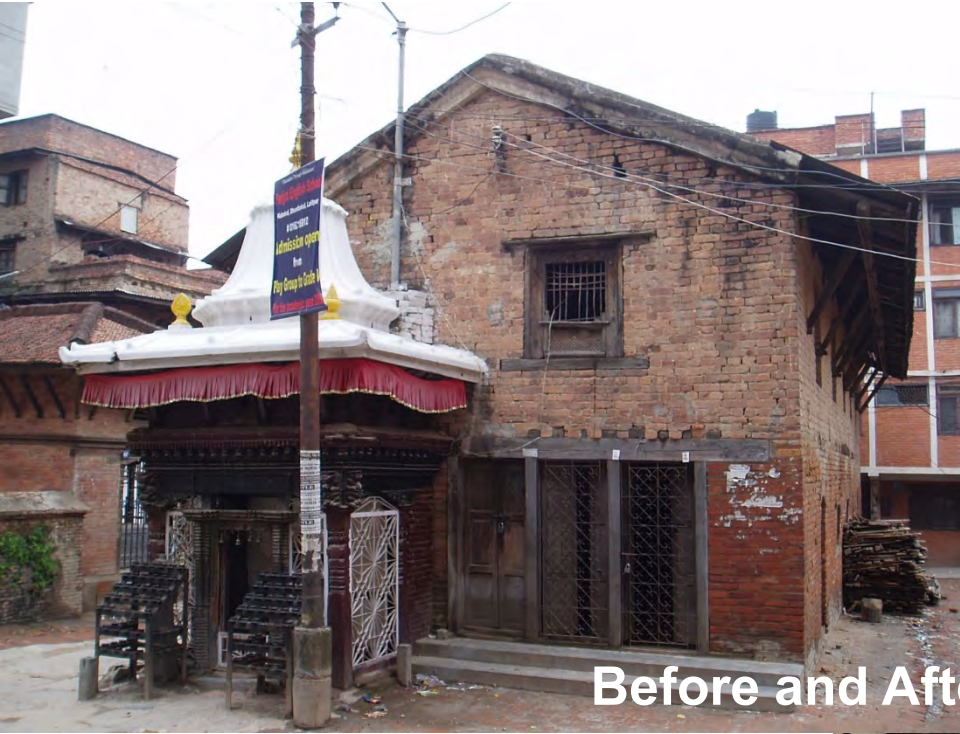
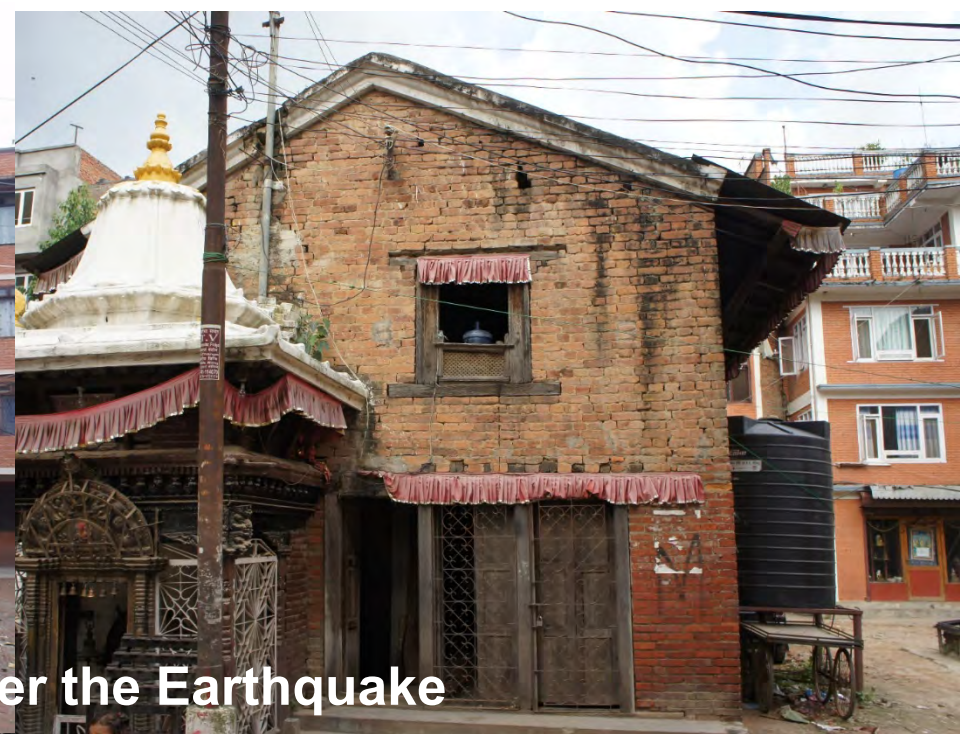
Microtremor observations in Jhatpole

Before and After the Earthquake

2009.5.27

2015.9.16
